## IR THERMOGRAPHY IN MOISTURE AND EARTHQUAKE DAMAGE DETECTION PERFORMED IN THE ŽIČA MONASTERY, SERBIA

Slavica RISTIĆ<sup>1\*</sup>, Suzana POLIĆ-RADOVANOVIĆ<sup>2</sup>

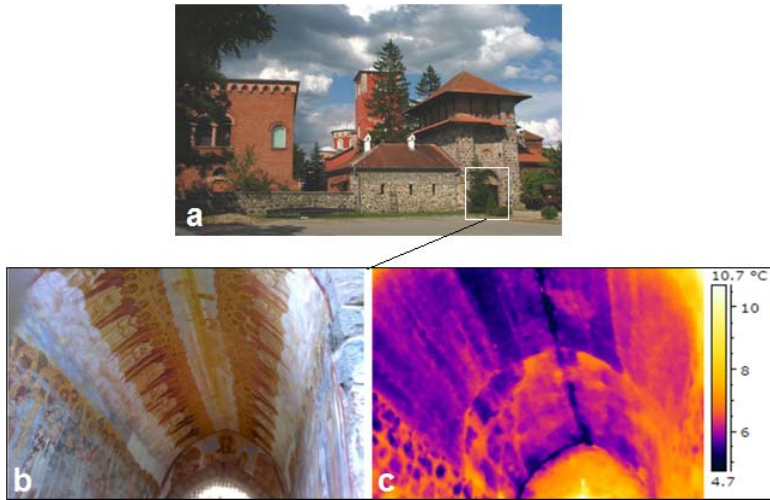
Fig. 2. Digital photos (a and b) and c thermogram of the monastery complex entrance

The video photos (Fig. 2a and 2b) and a thermogram of the monastery complex entrance, the ceiling of which was full of cracks and places with moisture (dark parts in Fig. 2c) illustrated the state of the monastery buildings. One major flaw is in the middle of the ceiling (Fig. 2c) and it presents the retaining moisture. Some parts of the frescoes appeared on the thermogram as areas with different temperatures and indicated the presence of moisture.

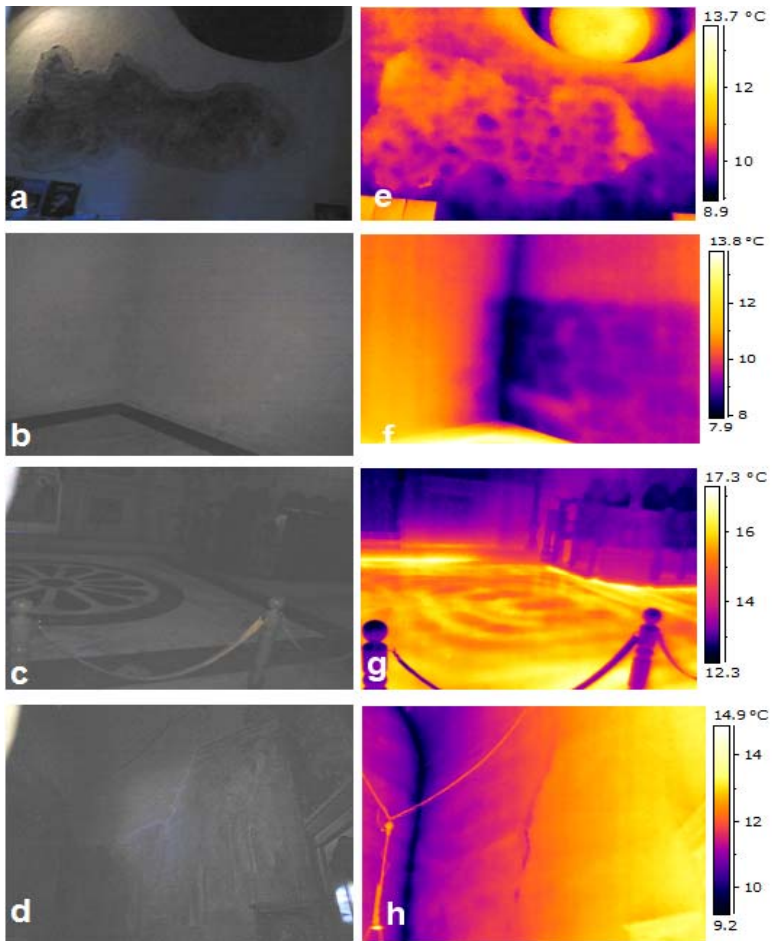
Fig. 3. Digital photos and thermograms of the interior areas of the Church of St. Savior

The badly damaged wall paintings allow distinguishing three chronological and stylistic periods. The most important frescoes from 1309 and 1316 are located in the main part of the church. After the fire damage at the end of 13th century, a great part of the original fresco layer was lost. During the 14th century, new fresco layers were added. The most significant frescoes from this period are those representing Apostle Peter and Apostle Paul. A part of the wall paintings on the right inside wall of the Church St. Savior can be seen in figure 3a. The presence of moisture is detected by thermography in this area (Fig. 3e).

Figures 3b and 3f show the damage of moisture in the corner and in the walls while figures 3c and 3g show the floor heating system. On the ground was a beautiful domed baptistry, reconstructed from some of the original fragments.

The cracks of the west church wall (Fig. 3d) can be seen on the thermogram (Fig. 3h) as colder zones. The cracks propagate through the total thickness of the wall, letting colder air enter inside and cool the church wall in the vicinity of the cracks.

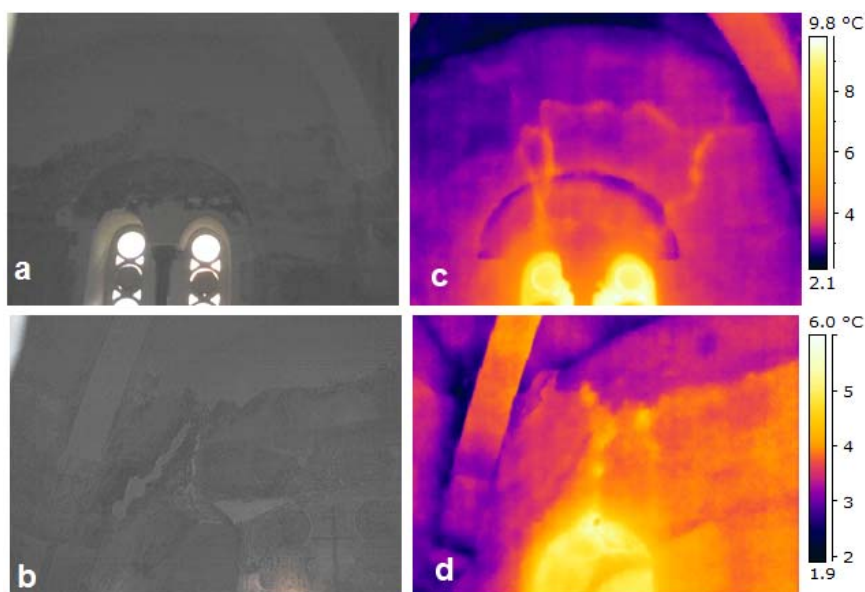
**Fig. 4.** Digital photos and thermograms of the tower interior

The temperature inside the tower was lower than the outdoor temperature for 4°C. The cracks are visible as light lines on the thermograms (Figs. 4c and 4d). Due to the fact that the plaster is detached in some areas, the plaster peeling layer was at a lower temperature when compared to the compact part of the wall (Fig. 4d). The moisture is present at the top of the wall and in the tower dome and it is registered as a darker area in comparison with the rest of the wall (Fig. 4c). The cracks are partially visible through visual inspection (Figs. 4a and 4b). Thermography has enabled a more precise definition of the position, length and width of cracks (Figs. 4c and 4d) [14].

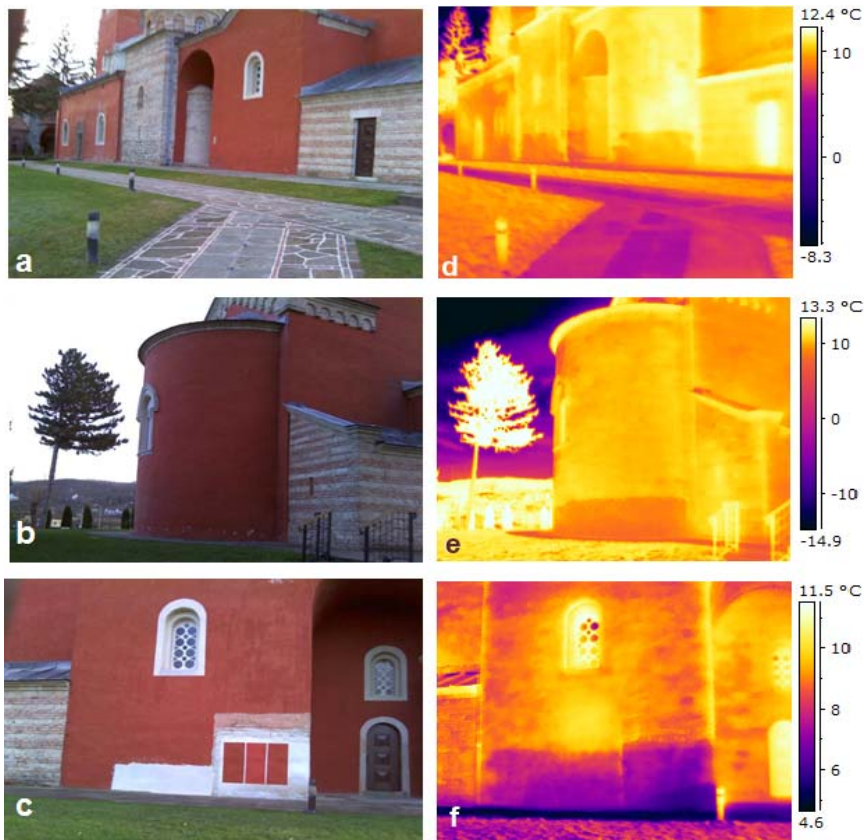
Fig. 5. Façade of the Church of St. Savior

Figures 5a to 5f show some results of the church façade moisture investigation. In general, the temperature of the damp areas can be colder than the dry ones due to surface evaporation, or it can be warmer because of the higher thermal inertia of water content versus building materials. The apparent discrepancies between the two results are a consequence of different micro climatic conditions of the scanning.

The south façade of the Church of St. Savior has a visible cold zone in the lower part due to the presence of rising damp. There is no moisture in the part of the building where the red plaster is missing because of drainage (Figs. 5a and 5d). The round eastern end of the church (where the altar is) is presented by a digital photo and a thermogram (Figs. 5b and 5e). Moisture is detected up to the height of 1.5m. The north side of the monastery façade (Fig. 5c) has moisture content up to the height of 2m. The thermogram (Fig. 5f) shows the complex structure of the wall as well.
