INTERDISCIPLINARY STUDIES OF THE “VISTA DO DESTERRO” PAINTING: HISTORICAL APPROACH, ANALYSIS OF MATERIALS AND PRESERVATION/RESTORATION TECHNIQUES

Abstract

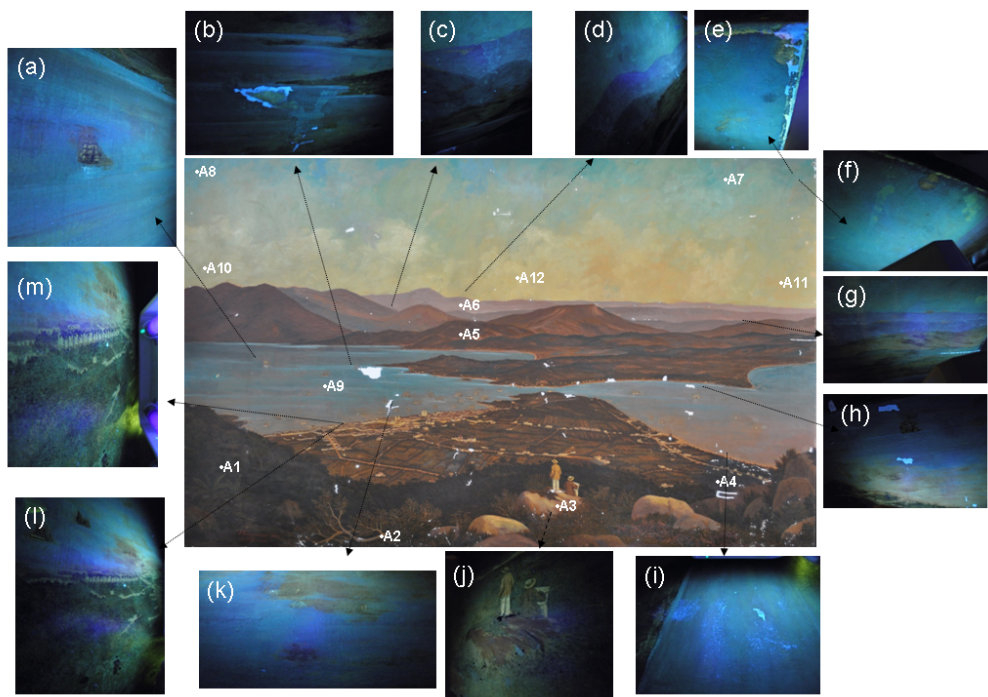
Fig. 1. Visible light photography showing the painting *Vista do Desterro* at the center, and UV photos revealing the interventions made

Figure 1 shows several areas that have materials with fluorescent characteristics. Figure 1a and b show a darker and lighter blue region, typical of ultramarine pigments ($\text{Na}_{8-10}\text{Al}_6\text{Si}_6\text{O}_{24}\text{S}_{2-4}$) [10]. Figure 1c and d are extremely important, as they show that part of the mountain (further above) has been repainted at some point in the history of the painting, and one can clearly see that this mountain has fluorescent material. The two other parts are characteristic of older materials and use of non-fluorescent material such as red ocher ($\text{Fe}_2\text{O}_3 \cdot n\text{H}_2\text{O}$), for example, or sienna, which contain compounds made of silicates and aluminates. Figures 1e and f, just like figure 1a and b, show the presence of the same type of material, and the same color pigment reacts similarly to ultraviolet radiation. Figure 1g confirms, once again, over coating of the top of the mountain and the non-fluorescence of the material used in the other two parts. Figure 1h reveals the same bluish region present in other regions, such as figure 1i, and the underside of the painting shows, again, a non-fluorescent brown color, confirming the use of red ocher. In figure 1j, two different areas can be observed: one displaying the older non-fluorescent brown color and a possible area of reintegration. Finally, figure 1k, l and m show the same situation of the other parts, proving the use of the abovementioned materials.

Sample A6 (Fig. 1c) showed the absence of Al and also the presence of Ba and some traces of lead as a result of contamination with the older pigment. Thus, this intervention was characterized by the use of permanent white, BaSO₄, and also a brown pigment with the absence of Al, possibly ochre brown, Fe₂O₃·H₂O and clay [10], proving the intervention that was evidenced by ultraviolet imaging.

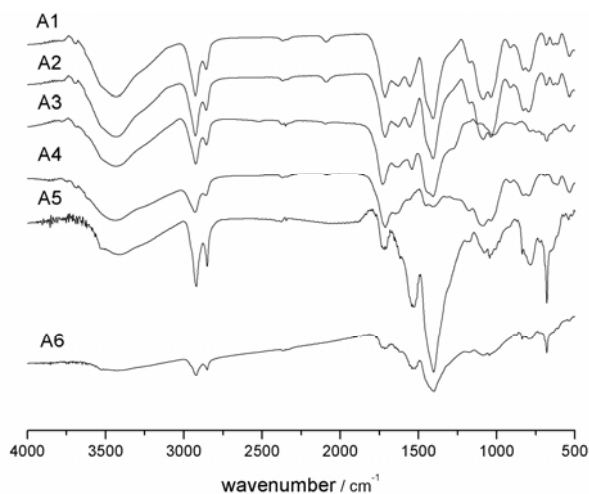
Samples between A1 and A6 are associated with brown and ochre pigments, whereas the older, supposedly original samples were identified by FTIR (Fig. 2) in bands at 1080 and 1040cm^{-1} , which could be associated with a terpenic varnish, because it presents a considerable rate of aging, making these areas yellowish [24].

Fig. 2. Infrared spectra of brown and ochre areas

Such aging is related to the exhibition of the painting in unsuitable conditions of humidity, temperature and even pollutants such as gases, sulfates, nitrates, etc. and also the proximity to the marine environment in an atmosphere rich in chlorides, especially, which can sharply accelerate degradation of the varnish. It was also possible to identify the absence of bands in the varnish in samples A3 and A6 (the stone and the third layer of the mountain respectively – Figs.1c, d and j), which is evidence of the interventions observed by UV light, whereby only the presence of pure paint can be seen, without the subsequent application of a layer of varnish. The analysis of these layers by EDS (Fig. 3) was crucial to determine the pigments used, and in all older areas, lead white - $2\text{PbCO}_3\cdot\text{Pb(OH)}_2$ - was identified as a basic compound of the coating primer used by the painter and elements such as Fe, Si and Al, typical of natural sienna, $\text{Fe}_2\text{O}_3\cdot n\text{H}_2\text{O}$, Al_2O_3 and silicates, were identified in the pigment used in areas A1, A2 and A5, characterized as being possibly original.

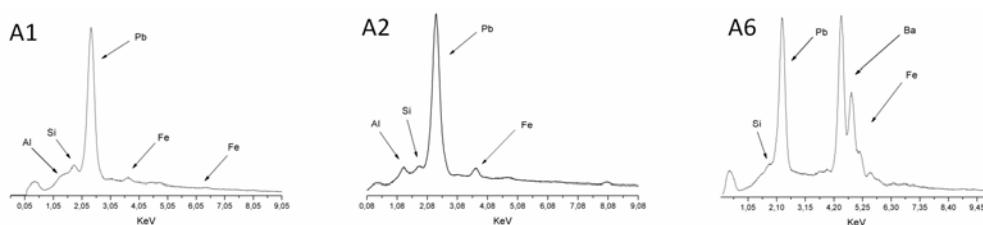
Fig. 3. EDX spectra of the brown and ochre pigments

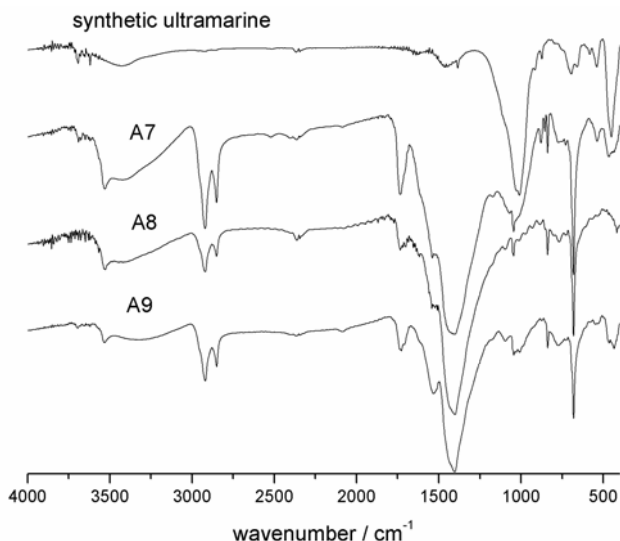
Samples A7, A8 and A9 refer to blue pigments which were also mixed with lead white when applied, at the FTIR spectra (Fig. 4) of the three samples. It is possible to notice a sharp signal at 1041cm⁻¹ which refers to the νSi-O-Si stretch, characterizing the ultramarine blue pigment [24]. The absence of the band at 2341cm⁻¹ was also noted, confirming that the pigments used are synthetic and consistent with the date of the nineteenth century [25]. Natural ultramarine blue was traditionally obtained from the mineral lapis lazuli with a complex process of selective extraction of blue particles, as reported in the literature [26]. On the other hand, it had already become available as a synthetic pigment by 1830 [27]. The FT-IR spectrum is used to differentiate between natural lapis lazuli and synthetic ultramarine. It was reported that the FT-IR spectra of natural ultramarine blue samples from Afghanistan showed a narrow at band 2341cm⁻¹, which was absent in the spectra of synthetic pigments.

Fig. 4. Infrared spectra of the blue areas and synthetic ultramarine standard

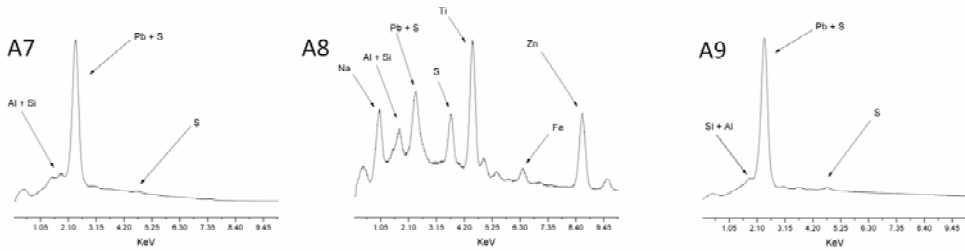
EDS analysis (Fig. 5) shows, in both samples, the elements Na, Al, S and Si, confirming the pigment used - Na₈₋₁₀Al₆Si₆O₂₄S₂₋₄ - as revealed by FTIR and ultraviolet photography. However, Ti was identified in sample A8, and associated with the white pigment titanium oxide, TiO₂, which began to be used only in the twentieth century and, thus, characterizes an intervention area. It is a different base pigment from the one used in interventions in the areas of the brown pigment, so it can be concluded that the painting had two interventions, one perhaps back in the nineteenth century and the other in the twentieth century. Another method for verification of synthetic ultramarine is the ratio between Si and Al atoms which is between 0.60 - 0.80 [28]. In the semi quantitative analysis, the weight ratio Al/Si was 0.66, 0.59 and 0.81 for samples A7, A8 and A9, respectively. The values were at the upper and lower limits, and this may be due to the limitations of the technique; nevertheless, it is a simple and effective means of proving the use of this synthetic pigment.

Fig. 5. EDX spectra of the blue areas

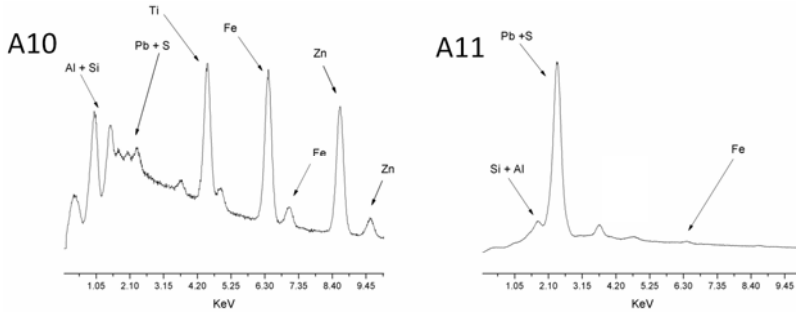
The yellow pigments present in the sky are characteristic of samples A10, A11 and A12. EDS spectra (Fig. 6) of sample A10 had the elements Al, Zn, Fe and Ti, featuring another intervention area, with the use of the pigments yellow ocher, titanium oxide and zinc white, possibly, since the absence of chrome rules out the possibility of zinc yellow and the typical IR bands (Fig. 7) showed only traces of terpenic varnish.

Fig. 6. EDX spectra of the yellow areas

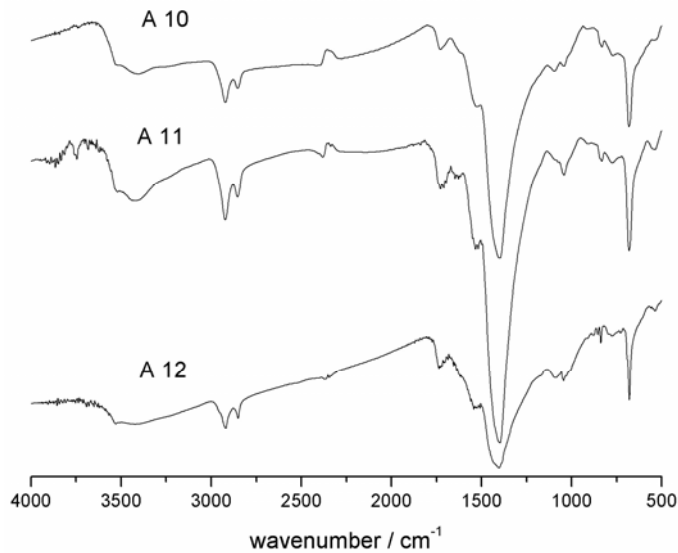
Fig. 7. Infrared spectra of the yellow areas

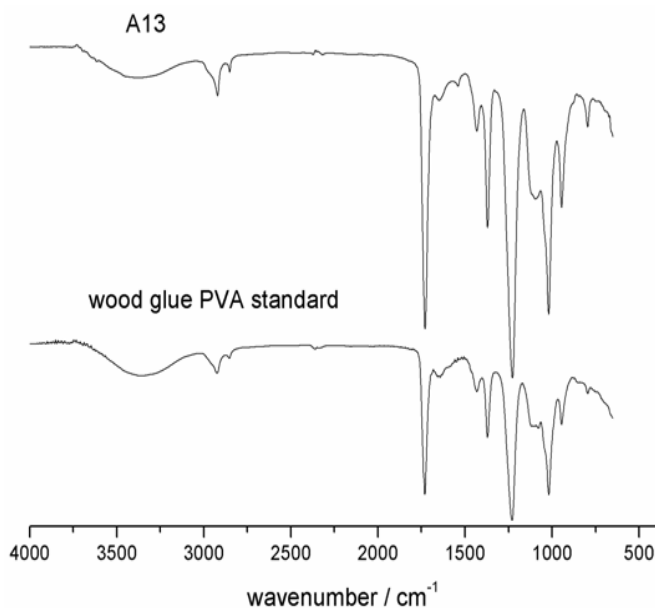
On the back of the painting, a process known as relining¹ was identified. It is an ancient and common restoration practice which strengthens the canvas with the original pictorial layer in areas with problems of degradation. The glue used in this process was collected, sample A13, and the result of FTIR (Fig. 8) showed mild features at 3379cm^{-1} referring to νOH and 1729cm^{-1} stretches assigned to $\nu\text{C}=\text{O}$.

Fig. 8. Infrared spectra of the glue found in the relining process as well as of the standard PVA wood glue

These spectra were evidence that standard wood glue could have been used. To prove this, a standard of type of glue was used in this study, proving that the type of glue used in this case was really standard wood glue. This investigation proves the second intervention abovementioned, because this type of glue got into use around 1915; this intervention may be associated with the last intervention to the painting because of the same material found as the basis for the paints (titanium white) dates from that time, as well.
