OIL PAINTING COLLECTION: RISK ASSESSMENT, EVALUATION AND MITIGATION STRATEGIES

Mafalda FERNANDES, Sara BABO¹, Maria Filomena MACEDO^{1,2*}

Keywords: Preventive Conservation; Risk Assessment; Oil Painting; Historic House.

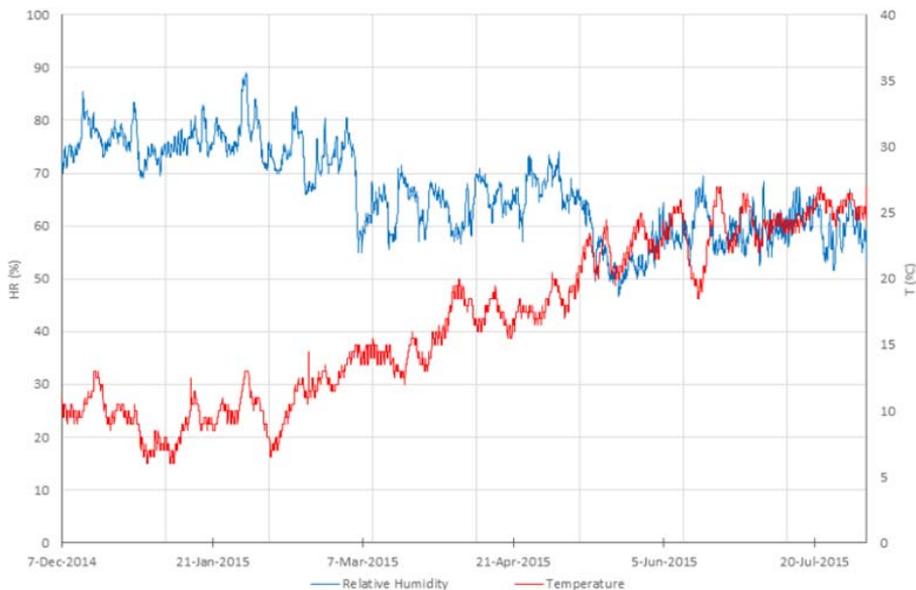
Fig. 4. Temperature (T) and relative humidity record from December 2014 to the end of July 2015 in the Green gallery (first floor).

Figure 4 shows the results from temperature (T) and relative humidity (RH) continuous measurements for a period of 6 months in the Green Gallery room (first floor). The data obtained for the other rooms are very similar, since there are no doors closed between the different rooms and the same air circulates all around the house.

As it can be seen by figure 4, the museum has a huge problem of relative humidity fluctuations. In the winter, the termohygrometers registered 90% RH in some rooms, and fluctuations of around 20% in only 48h were also observed. In the summer, the relative humidity levels are around 45% but it can go as low as 39,5%, as seen in Table 11. The museum has dehumidifiers in almost all the exhibition rooms. These equipments are working most of the time, but they are not capable of maintain a stable RH or within the levels suggested by the literature (Table 12). This is a common problem on historical houses, due to fact that, old, original windows provide poor insulation and the air from outside enters and circulates inside these historic houses.

Although average values of RH are between 62.4% and 66.4%, the problem is the huge difference between maximum and minimum values. The same problem occurs with the temperature values recorded (Table 11). Temperature inside the exhibition rooms has an average variation of 19°C between summer and winter. However, temperature values during the summer season are higher than 25°C. Those values are superior to the maximum values of temperature suggested in the literature (between 20 and 25°C) to prevent any damage to the objects [21].

The paintings collection survey showed that in this specific collection many paintings, some of them recently restored, present damages related to the fluctuations of relative humidity.

$MR = 1 \text{ (FS)} \times 0.75 \text{ (LV)} \times 1 \text{ (P)} \times 139/235 \text{ (E)} = \mathbf{0.443}$. Although some paintings are more susceptible than others to the RH fluctuations, for example, if they have backing board they will respond to the RH slower than the ones without a backing board, to this MR calculation it was taken into account that all paintings were equally susceptible to be damaged by RH fluctuation. Other damages caused by RH fluctuations could be warping of the wood, causing undulations on the support; the oxidation of the nails that are tacking the canvas to the stretcher, cracking and consequently detachment of the paint. All paintings in exhibition that have these damages, were taking into account to calculate the extension of the damages.

There are several damages of the paintings as a result of fluctuation and maintenance of the collection at incorrect RH and T values. The first step in order to control these two agents of deterioration is to increase the windows and doors isolation, to reduce the air exchanged with the outdoor. The second step is to continue monitoring the environmental conditions with termohigrometers, to see if the first action together with use of the ventilation/dehumidification, in every room, will be enough to maintain the RH between 50% and 60% and the T around 18-20°C. The implementation of a HVAC system that allows controlling these parameters in a historic house is a very expensive and complex task, since it is not allowed to change the building aesthetic and the stability of the structure has to be taken under consideration. This is why the application of a HVAC system, in historic houses, is usually not recommended. However, there are some cases in which HVAC systems were successfully implemented in historical buildings in order to control RH and T [22]. Nevertheless, simple and low cost measures need to be considered first.
