## CONSERVATION, MAINTENANCE AND REPAIR OF THE OLD BOMA HISTORIC BUILDING IN BAGAMOYO, TANZANIA

Charles LUCIAN \*

Ardhi University (ARU), P.O. Box 3516, Dar es Salaam, TANZANIA

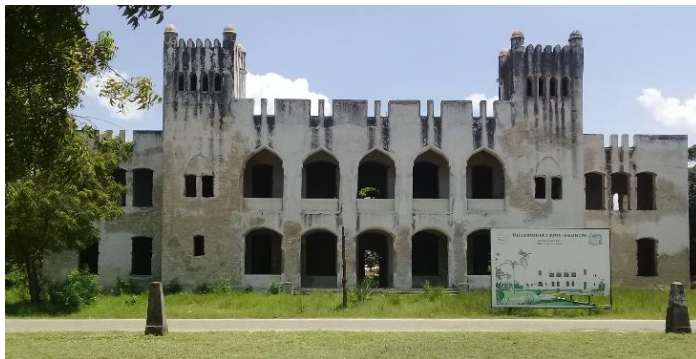
Fig. 2. Front View of the Boma

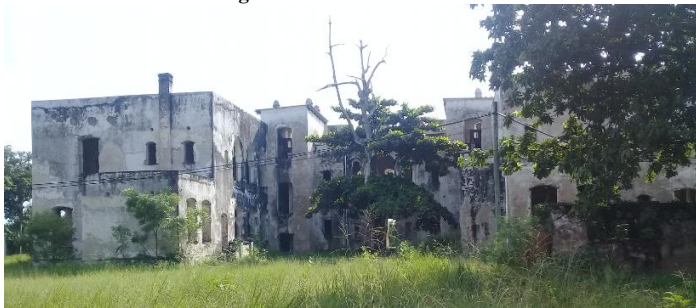
Fig. 3. Rear View of the Boma

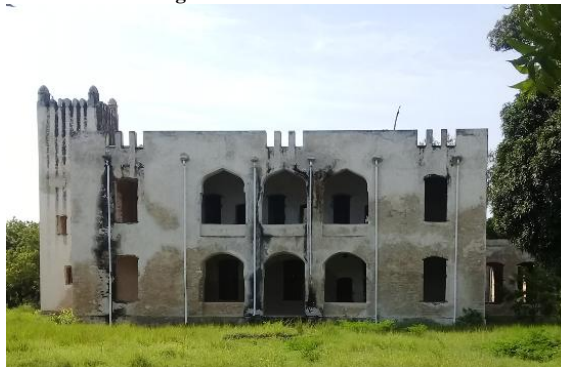
Fig. 4. Left Hand Side View of the Boma
