CONSERVATION TREATMENT AND ANALYTICAL STUDY OF EGYPTIAN GILDED BRONZE STATUE OF SEATED OSIRIS

Mohamed ABDELBAR^{1*}, Saleh AHMED²

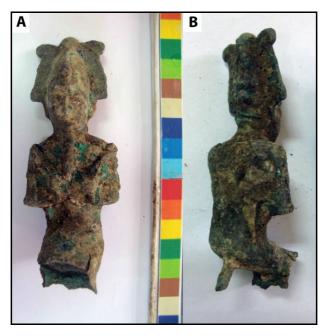
Fig. 1. A and B: The statue of gilded seated Osiris before conservation treatment

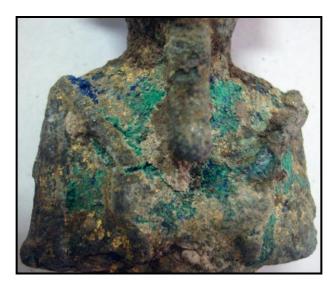
Fig. 2. Detailed view shows the gilding residues are embedded in corrosion products and soil inclusions

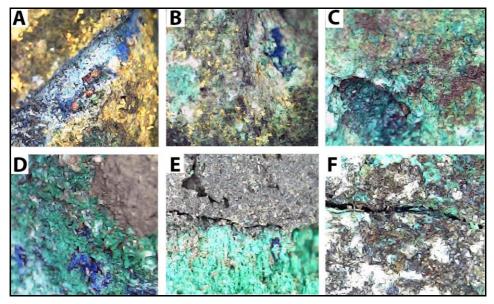
A detailed examination showed that gilding layers were observed on various areas in the front, while they were not found in the back as shown in figure 5a and b. It is likely that the statue was completely gilded, but that when it was lying down on its back in the soil, the gilding was lost. The eyes were inlayed with a white stone while the eyebrows were inlayed with a lime-paste.

Red, green and blue corrosion products were observed on the surface as shown infigure 5c-e. Cracks are clearly visible on the surface of the head as shown in figure 5f. Cross-section was examined by digital and SEM microscope showing the following layers: gold leaf, cuprite

Fig. 5. Microscopic image of the surface morphology: A and B - gilding residues are embedded inside corrosion products and soil deposits; C and D - blue and green corrosion incorporated with soil deposits covering the surface; E - pale green corrosion products are existed beside the interior core; F - cracks in the head from the back

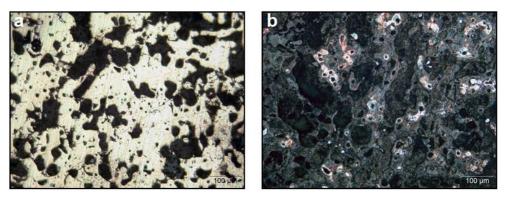
A cross-section sample was subjected to metallographic and SEM investigations, and the results are presented in figures 8 and 9. It can be noted that a matrix composed of α -phase (light colored) and δ phase (dark colored) of the bronze alloy, lead particles (black colored) distributed between the dendrites because of the limited solubility of Pb in Cu-Sn alloy. The abundant segregated lead appears as masses (40x50µ) all over the bronze matrix which indicates the slow cooling rate of the alloy [36-38].

Fig. 8. Metallographic images showing the bronze matrix contains α -phase, $(\alpha + \delta)$ eutectoid and Pb irregularly shaped dispersed inclusions: **a.** Un-etched sample; **b.** etched sample

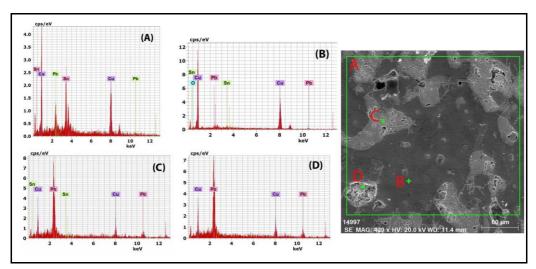
SEM/EDS investigations of the alloy microstructure are given in (Fig. 11 and Table 1). Figure 12 shows non-destructive in situ analysis by pXRF, the analysis results of the corroded gilded bronze are given in Table 2.

Fig. 11. SEM image shows the microstructure of the bronze alloy, a-d: the corresponding EDS analysis of some phases of the alloy

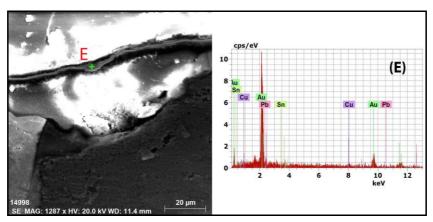
SEM image shows the gilding layer measuring 22μ thick in average, as shown in figure 13. EDS analysis shows the elemental composition of the gilding layer as shown in Figure 13 and Table 1. It consists of more than 90% wt. Au. This purity may be indicative of refined gold. The Cu, Sn and Pb content isn't actually a part of the gilding metal, it is derived from the underlying bronze, since it is very difficult to prepare gold leaf containing this much copper, tin and lead [45]. Ghoneim [49] investigated gilded group statues and found that the gilding was made of gold leaf (>85%).

Fig. 13. SEM image and the corresponding EDS analysis of the gilding layer

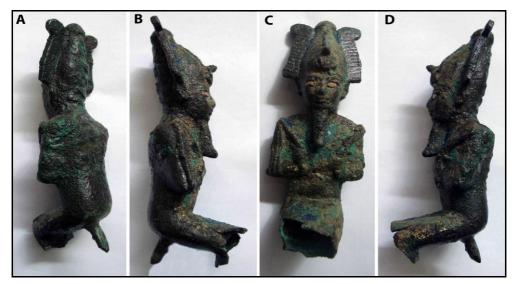
Fig. 18. The statue after treatment processes.

BTA 3% in Alcohol was applied in the areas of active corrosion. Finally, the protection process of Osiris statue was accomplished using two layers of Permalac, as shown in figure. 18.
