## THE STUDY OF CONSERVATION STATE OF A WOODEN CHURCH FROM BOZ VILLAGE, HUNEDOARA COUNTY, ROMANIA

### *Abstract*

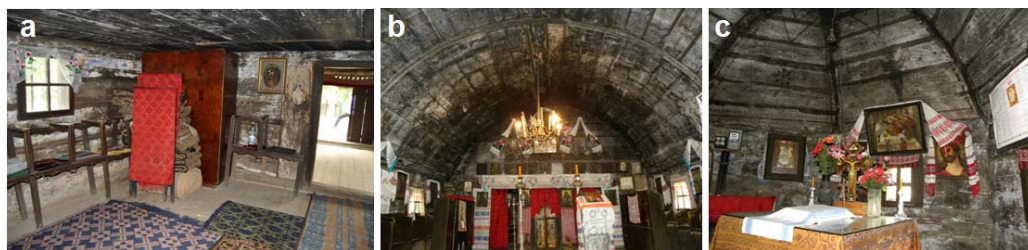
In the narthex may be found only traces of ground and colour on the walls and fragments from the decoration of the ceiling (Fig. 2a). Inside the nave we can admire a symmetric

painting, organized on registers, but it is difficult to recognize the scenes and the saints, because of their highly degraded and deteriorated state. The icon support inside the nave is remarkable since it was painted in the same period with the walls and represented Saint Simeon Stâlplnicul (Fig. 2b).

Fig. 2. Interior of the church – a) Narthex, b) Nave, c) Altar

In the altar, the paintings on the walls are highly deteriorated and few saints may be identified, while the symbolic representations on the arch are better preserved (Fig. 2c). In the church are also preserved some icons on wood dating from the 20<sup>th</sup> century and icons on glass.

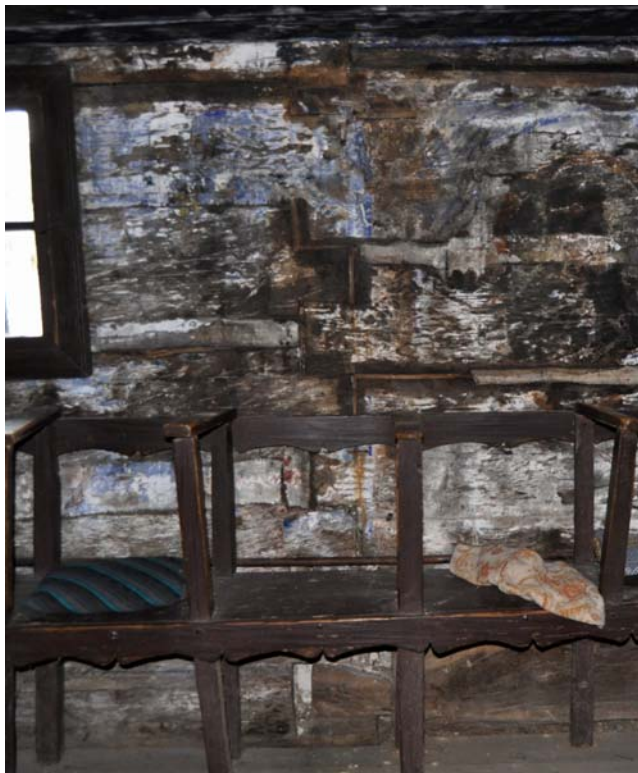
This wooden church was enlarged to the western part. At the northern wall was fixed a vertical pillar and on the south side, tow pillars (one corresponding to the Northern part – in the middle of nave and the second one to the western one). Horizontal beams are jointed on these pillars by tongue and groove joints (this technique was used for the extension of the walls, because the length of the beams was not enough). In the narthex we may observe the extension of the wall, because the old dovetail joint was preserved here (on the west wall of the church)

and the new wall was jointed to it (Fig. 3.). This extension was made before painting the interior spaces.

**Fig. 3.** Old joint, from where was enlarged the North wall of narthex

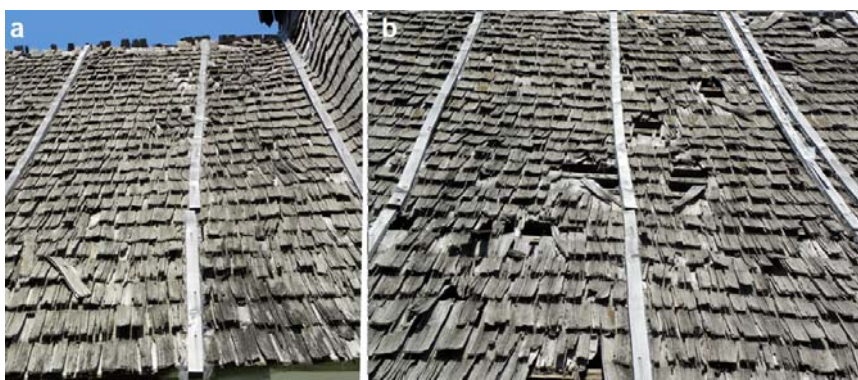
The main cause for this deteriorations and degradations is the losses of tightness of shingles cover. The roof suffered biodegradation and mechanic damages (Fig. 4.). The shingles, exposed to weathering and direct sun light were degraded, and cannot provide protection to the monument, if they are not changed in time, in 30 – 40 years [17]. We noticed the existence of lichens and fungi over the whole surface of shingles cover, especially on the north side, at the base of the bell tower, at the intersection of the porch with the narthex roof and at the level of changing of the tower roof's inclination.

Fig. 4. Damages at shingle roof from 2011: a - North side, b - South side

Emergency interventions are necessary outside for renewing the shingle roof cover. The shingle changing must be carried out with other handmade shingles from high quality wood (spruce) and respecting the traditional techniques. The outside plaster must be carried, consolidated, completed and blanched. The basement has to be rebuilt with stone, above the ground without filler.

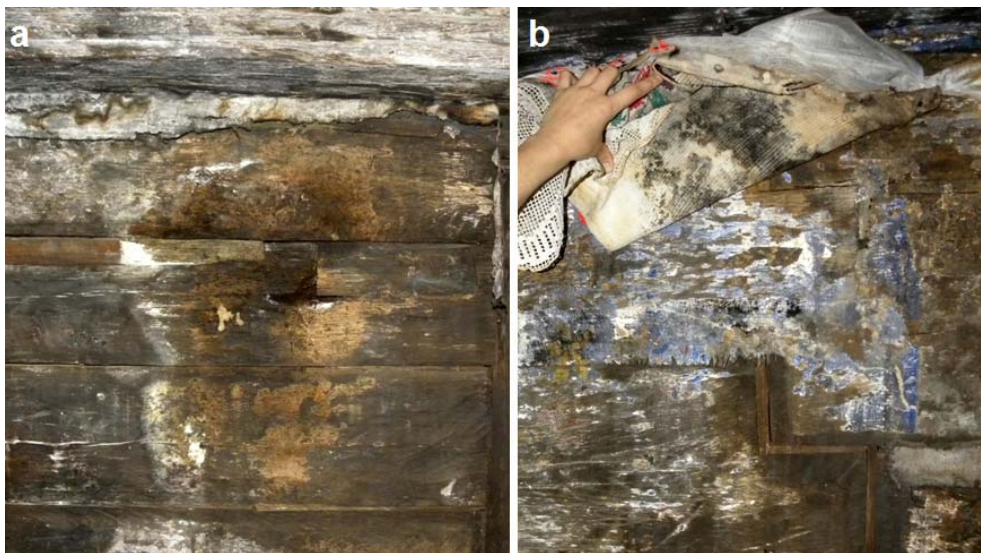
We can observe from these averages that the humidity from the infiltration and upward water are present inside the monument especially in the covered areas, where the low ventilation cannot dry it enough. Where the humidity was bigger than 14%, we found fungi attack under covered areas (Fig. 5a). Where the humidity was bigger than 18%, we found rot (Fig. 5b).

**Fig. 5.** Biodegradation of beams: a - North wall in narthex, under a towel, b - South wall in nave, under an icon

Inside, at the boards' floor insecticide treatments, water isolation between the ground and the boards by free spaces or with aggregate are required. The wall beams need insecticide and fungicides treatments, but we must be careful with the effects on the mechanical and chemical properties and their visual appearance on the wood and the painting [7].

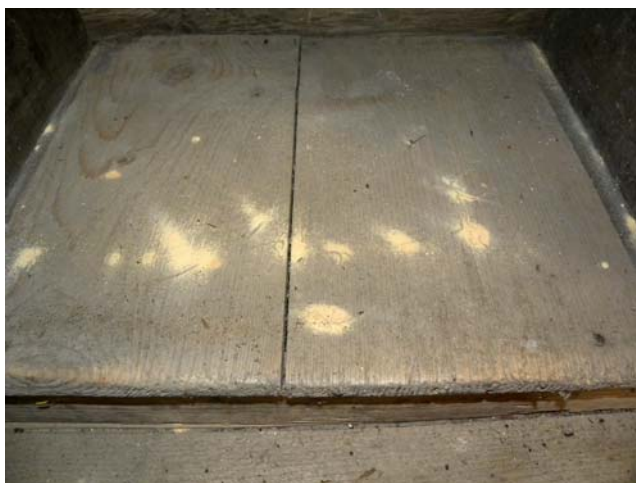
Advanced attacks of *Anobium punctatum* are very frequent at boarded floors, ceilings, arches, furniture and elements of iconostas all over the church. At wooden churches they appear also on the painted walls and they prefer the areas under the interstitial cloths with glue residues [18]. We observed at Boz wooden church an active attack of beetles, *Anobium Punctatum* at the boards' floor (which is partially covered with carpets) (Fig. 6.). The oak wood present fewer insects attacks than the fir boards (this attack is also active).

**Fig. 6.** – *Anobium punctatum* attack on boards' floor

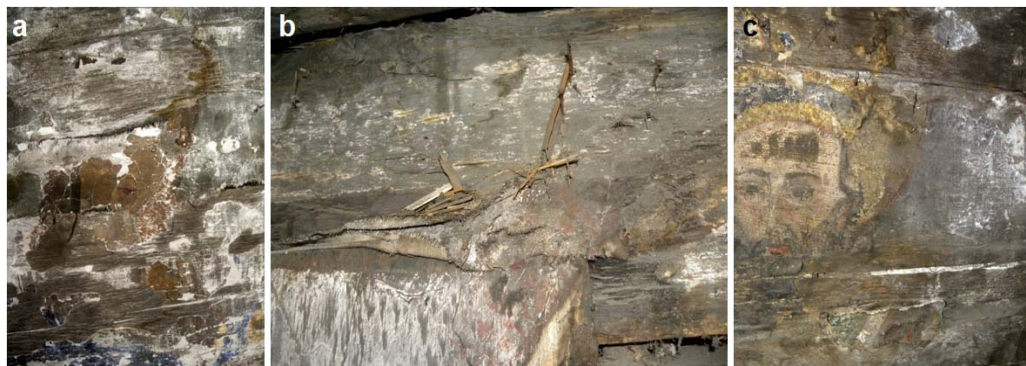
The interior paint is in an advanced state of degradation and deterioration, with considerable losses. All painting layers have washed part and dirt stains on preserved painting. On the narthex ceiling, on the nave and altar arches, on all walls there is moisture halos and stains, washing, losses, flaking, cracks, breakings out, attenuation and very fragile paint layers of a considerable surfaces, the main cause being the infiltrations (Fig. 7.). The most exposed parts are the upper areas of the walls and the bases of the arches (Fig. 7b). Another major cause with negative influence on the paintings is the insufficient ventilation of the entire space.

The entire painting is covered with smoke, dust, dirt, spider cloths, deposits of plants and insects scraps, sand, etc. Most of the interstitial canvases are lost. Those that have been preserved are fragile, rigid and present rot, breakings and rags.

Fig. 7. Degradation of paintings layers and interstitial canvases: a - Narthex, b - nave, c - altar

Regarding the interior painting, emergency interventions for the consolidation and preservation of the painting layers, wooden support and interstitial canvases (insect and fungi treatments, prophylactic consolidation of painting layers, consolidation of wood, gluing of interstitial canvases, removing of all unconstitutional objects) are prescribed and in the near future the restoration of entire painting. We want to point out the fact that all intervention has to start after the preventive conservation of the painting layers. The icons, tetrapodes, rush holders and other valuable objects must be soon included in a conservation, preservation and restoration process.

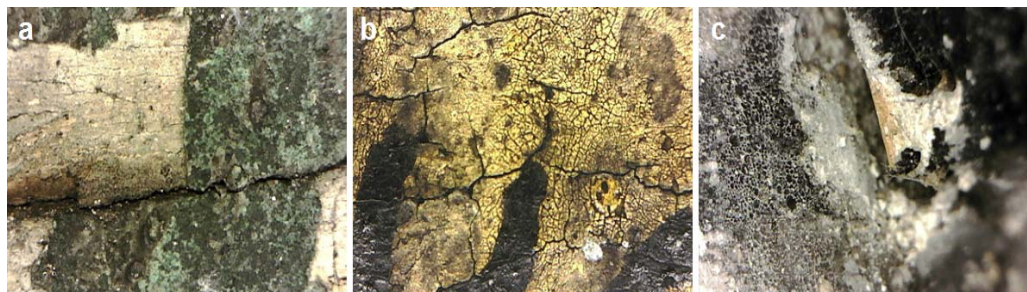
The wood panels of the icons and icon supports are deteriorated as a result of beetles attack, functional used, covering with towels and rugs. These present flaking, breakings, wears, losses, dirt, smoke, oil varnish crusts (Fig. 8.). On the front of the icons we observed many interventions with repainting of the faces of saints and of the lost parts (Fig. 9.).

**Fig. 8.** Macro photos at painting layers: a - wall painting, b - icon, c - icon support

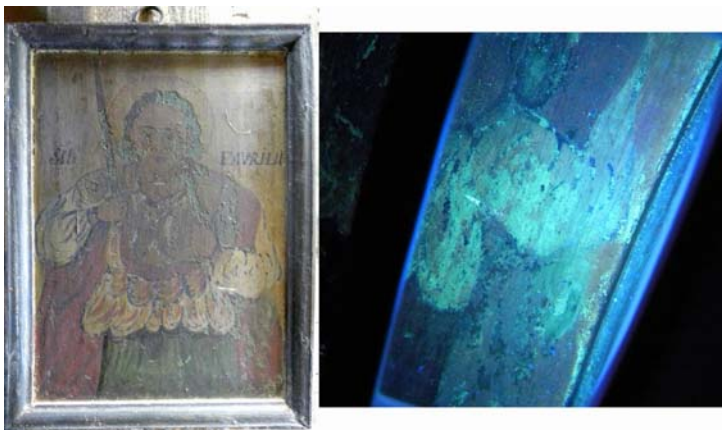
Fig 9. Detail of repaint area on St. Mikhail icon – using a UV lamp
