## RESTORATION AND PRESERVATION OF ARTISTIC ELEMENTS APPLIED ON ISLAMIC ARCHITECTURAL FAÇADE OF SHAHIN AGHA SEBIL, CAIRO, EGYPT

### Abstract

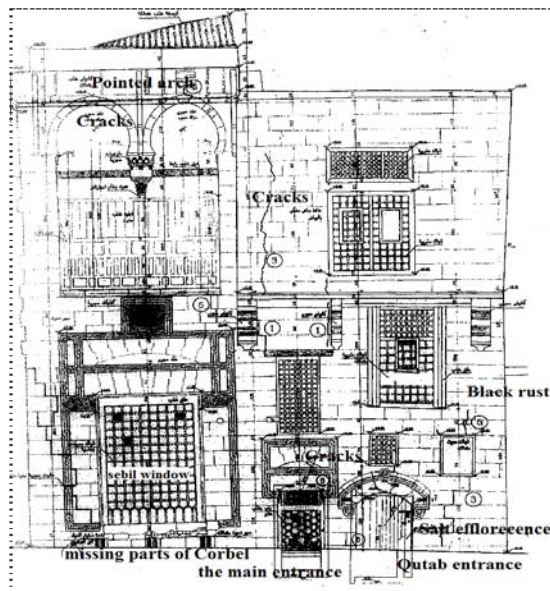
Detailed survey of stone decay phenomena was carried out on the façade of Sebil in order to establish the typology, causes and processes of the major weathering forms observed. Several weathering forms were identified and recorded at the plane of the façade (fig.4).

Fig. 4. The plan of the façade of Shahin Agha Sebil shows the missing parts and cracks.

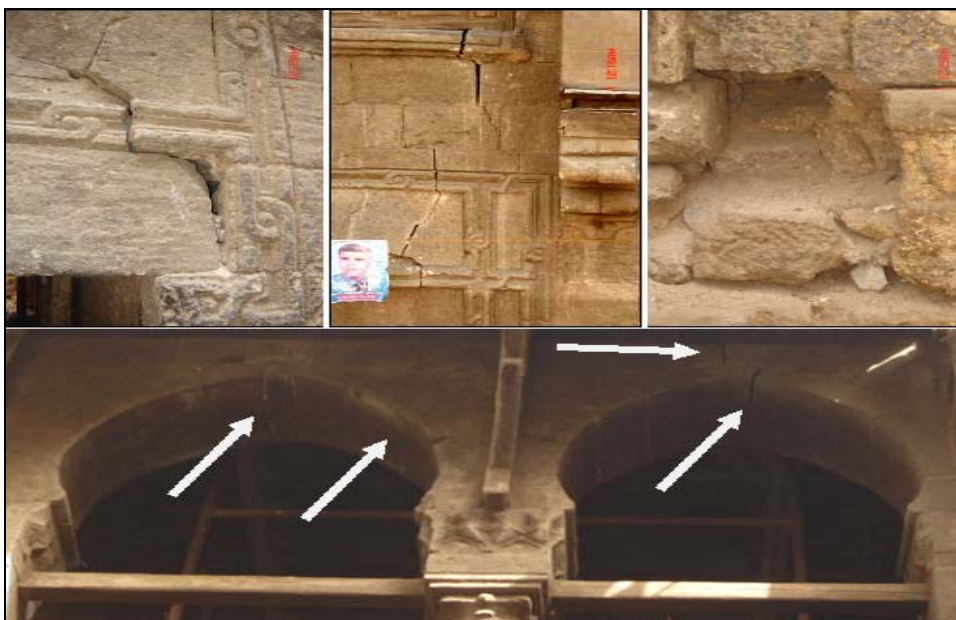
The façade of Sebil shows some clear indications of yielding cracks and partial collapse at several locations as a result of the physiochemical and architectural effects of deterioration factors. The structural damage is represented by walls cracking, stone surface decay, partial collapse of some parts of the wall and rock disintegration especially noted at lowest parts and mass wasting from architecture elements of the façade. Most of current damage conditions of the facade are mainly due to the earthquake, which occurred on October 1992. Almost all the causes of damage and deterioration appeared on the facade are related to the problems that affect the multiple leaf masonry walls. Also, Age of the building, it had survived for nearly 350 years' time-stresses effect on construction materials, lack of maintenance during its service life, loss of mechanical characteristics of the walls at foundation level due to moderate aggressive environment (ground water and soil) [2]. So, many vertical, diagonal and fine cracks in the walls were noticed as shown in Fig.5, which led to dangerous deterioration in the architectural elements like arches, gifts and threshold. More cracks were found at top of the façade. The cracks at top of facade and at the end of facade are indicating thermal movements. Vertical cracks generally indicate poorly bonded material or material that has lost its cohesion and is therefore weak. Diagonal cracks indicate failure of shear, due to ground settlement or subsidence, shear cracks may combine with thermal cracks. Crack wider at bottom-ground may be sliding horizontally as well. Fine cracks also appeared due to wind and salt crystallization [3].

**Fig. 5.** Examples of cracks, deformation of architectural and artistic elements at the facade of Shahin Agha Sebil.

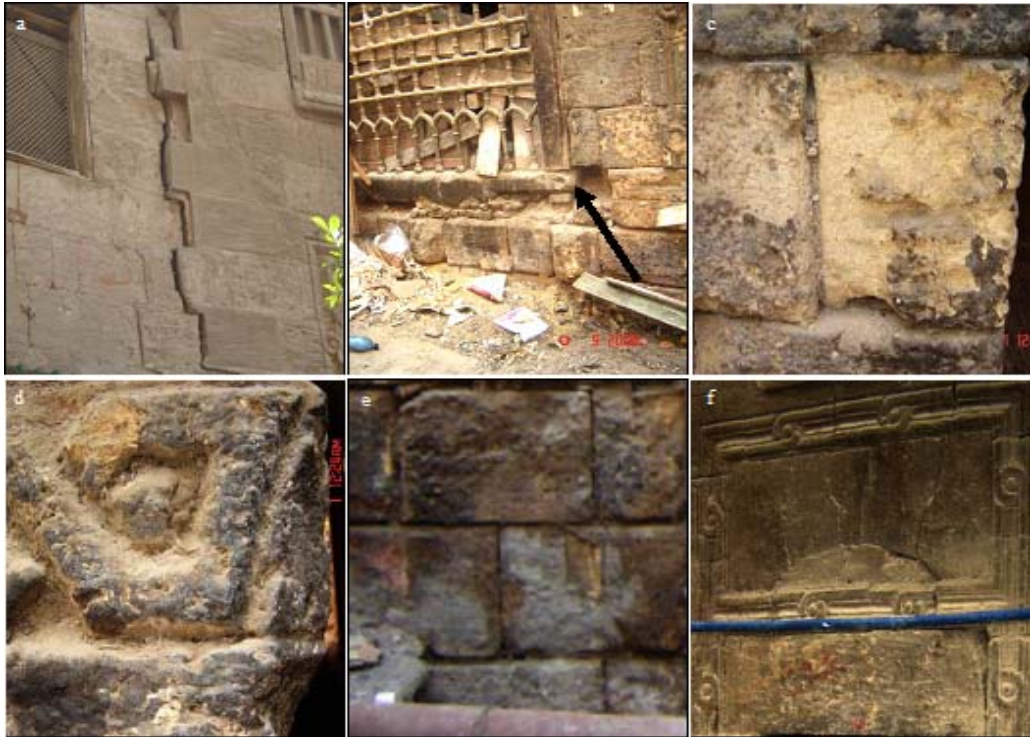
Sebil façade has deformation, buckling, leaning and brittle with loss of stiffness in the structure elements (Fig.6). Serious internal stress and vertical loads are the main cause of damage or collapse of structure (cracking, deformations, leaning, crushing, etc.). Also, the movement of core material may also be a source of new stresses, thus making the faces unstable, according to Drysdale et al [4]. Deformations may not only result from taking uploads, but from seasonal changes in temperature or internal heating, from changes in moisture content of materials and from differential settlements, movements of the ground or alterations to the structure that introduce a new pattern of equilibrium [3].

**Fig. 6.** Photograph of decay features common at Sebil facade **a** - buckling and leaning, **b** - deformation, brittle failure with loss of stiffness in the structure elements of the façade (lost cantilever (Corbel), **c** - Scars of flaking, **d** - hard crust and scars of flaking **e**-Efflorescence's to light-colored crust tracing the surface, **f** - soiling by particles from the pollution.

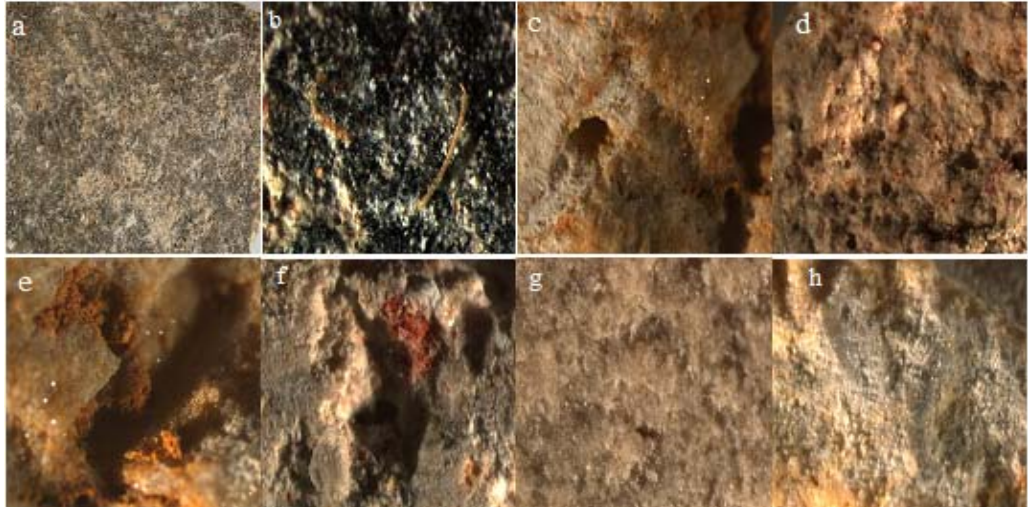
Optical microscopy revealed a wide range of deterioration features as shown in (Fig. 7a-h). Dust, smoke on the surface of calcite grains, eroded pits, cavities, loss of internal cohesion, efflorescence salts and the presence of some iron oxide (limonite and hematite) were noticed.

**Fig. 7.** Micrograph of investigated samples by LOM **a-** dusting form covering all stone surface **b-** smoking in outer surface of limestone **c-** eroded pits **d,e** cavities, voids and iron oxide as limonite **f** cavities and hematite, **g** loss of internal cohesion, **h** efflorescence salts.

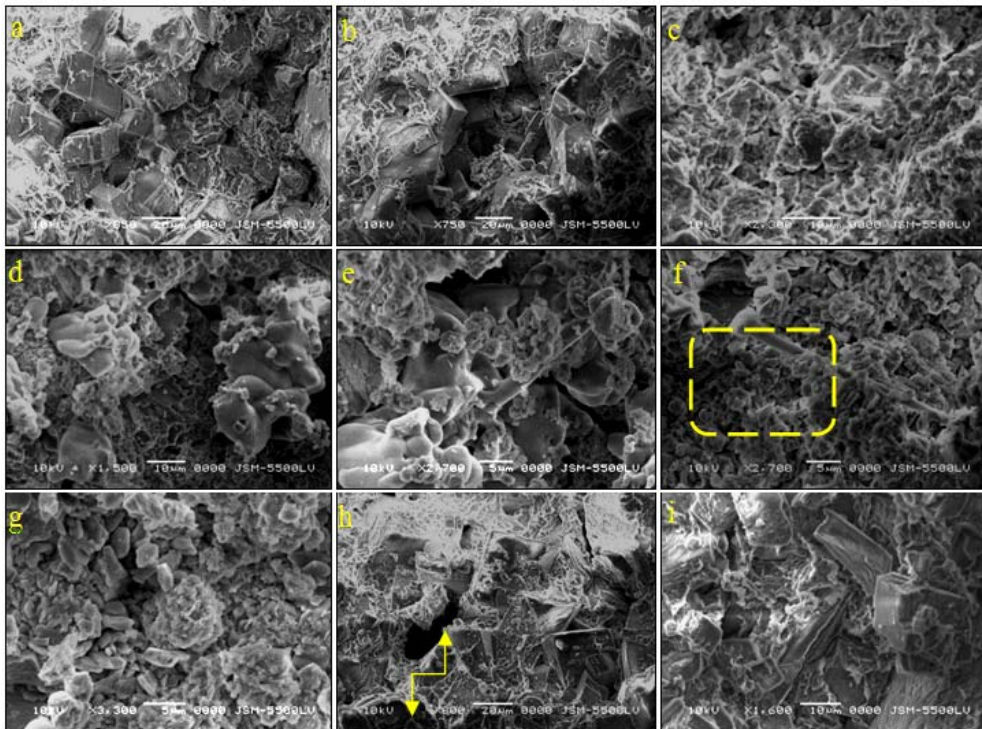
The obtained results showed that there is a wide range of deterioration features in the samples. Microscopic investigation revealed dissolution of cements occurred on the limestone, which lead to an increase in porosity (Fig. 9a-b). Moreover, the physical structure of stone has seriously collapsed and most stones became fragile and lost their cohesion (Fig. 9c). The SEM investigation showed that the soluble salts deeply move into the stone and destroyed their mineral constituents, the calcite crystals being seriously deformed and they have lost their original crystalline form (Fig. 9d, m, e). Sodium chloride in long and needle form and calcium sulphate were found between calcite crystals and the other mineral constituents of stone (Fig. 9f,g and h). Also, the study showed eroded pits, small fissures, micro cracks, dusting, splitting and micro exfoliation and cavities (Fig. 9i). The SEM investigation of the mortar samples which were taken from between stone blocks in the Sebil façade showed that two kinds of mortar were used: lime mortar, which consists of calcite and sand (Fig. 10a-b) and gypsum mortar (Fig. 10c). SEM photomicrographs showed the collapse of internal structure, voids, loose of binding material and NaCl salts crystallization between mineral grains. NaCl precipitation caused a considerable increase in the porosity of the building stone, increase of cavity and pore sizes, increase production and acceleration of micro fracture growth in the surface of the lime mortars and stones due to crystal pressure, and acceleration of the rate of stone exfoliation.

**Fig. 9.** SEM images: **a, b and c** - dissolution of cements and loss of cohesion between calcite crystals, **d, e** – porous crystalline salts, **f** - crystalline salts are long and then needle form, **g**- sulphide salts, **h and i** - splitting and exfoliation.

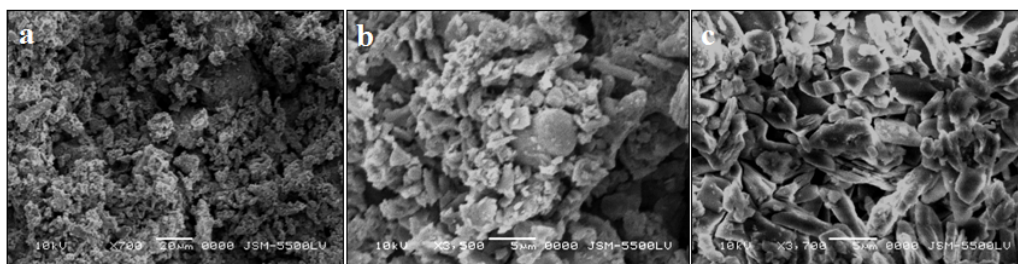
**Fig. 10.** SEM photomicrographs of mortar sample showing the collapse of internal structure, voids, loose of binding material and salts crystallization between minerals grains.

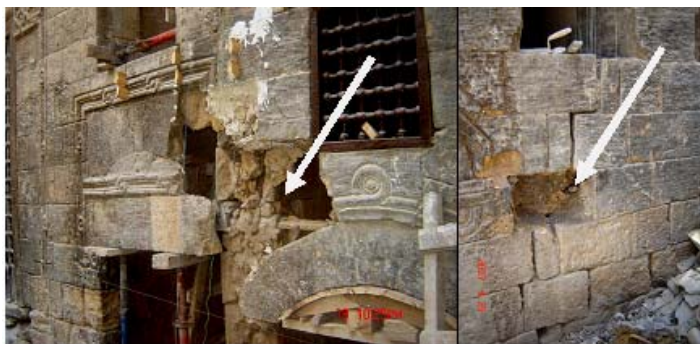
Fig. 13. Removing of all deteriorated and deformed mortar and stone blocks

- Removal of all deteriorated and deformed mortar and stone blocks was done (Fig. 13)

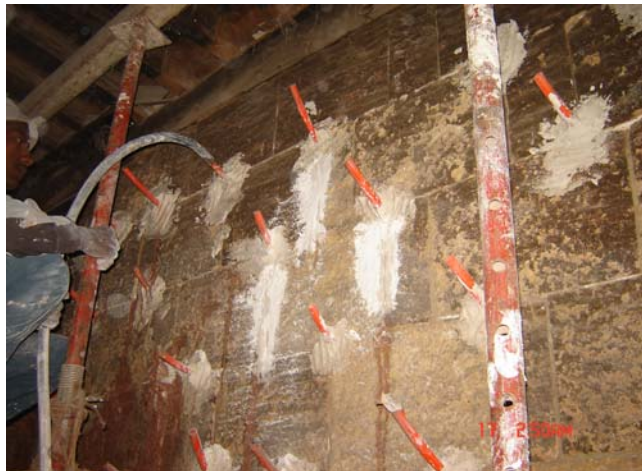
**Fig. 14.** Grout mixture was injected by air pressure into the open joints in the stonework at the Sebil façade and large areas of walling was need these treatment.

- b. Improvement of wall characteristics by lime injection (Grouting): The object of grouting is to strengthen and consolidate decayed wall which is weakened by large fractures and voids as the Sebil façade. Grouting is the insertion of a fluid cementations mix, called grout, with good flow characteristics into the cracks and fissures of walls, [3]. The experimental study proved that the mix of lime+ sand+ white cement (2:1:0.5) mixed with Edibond15% in water gave the best results under the mechanical testing. Before inserting the grout, it was first necessary to clean out the voids and wet all the surfaces. The grout was inserted with an air-operated pump (Fig. 14).

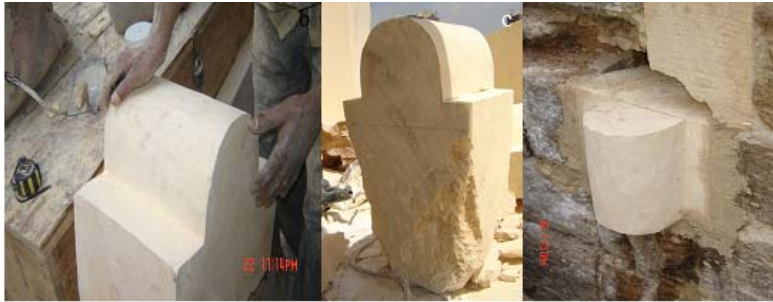
**Fig. 15.** Missing parts completion: a, b - Reproduction of lost Cantilever (Corbel) below the Sebil window from dolomitic limestone, c - using the reproduction corbel for façade conservation.

- c. Completion the missing parts of architectural and artistic elements by reproduction process: Cantilever (Corbel) below the Sebil window and Meima which was lost and deteriorated were restored by reproduction. Reproduction entails copying an extant artifact, often in order to replace some missing or decayed parts, generally decorative, to maintain its aesthetic harmony. Reproduction of the lost and deteriorated architectural and artistic elements from the Sebil façade was done from dolomitic limestone from Mokattam quarry because the lab analysis indicated similarities between the Sebil stone with these the kind of limestone. Stonecutters carved structural and decorative elements of the façade following the direction of the cut of a stone block and dressed to the original profile and designed to match the original one (Fig. 15).

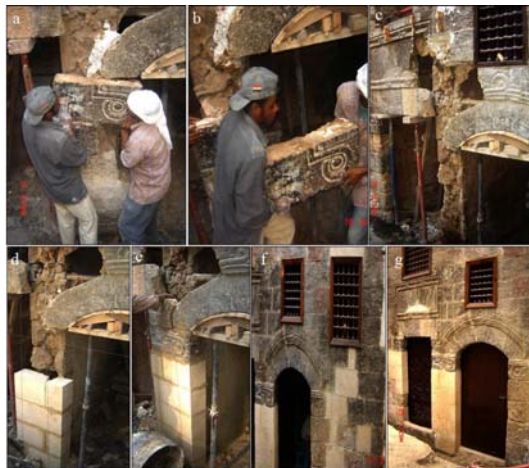
**Fig. 16.** Replacement and reconstructing the missing stone blocks of the Sebil façade by dolomitic limestone and lime mortar, **a, b, and c** - show the separation of the architectural elements paving to resistance the Multiple-leaf walls behind it, **d, e** - completion and replacement of the lost and deteriorated of the stone blocks at the Sebil façade, **f and g** - after restoration.

- d. Replacement and reconstructing the missing blocks were done to compensate, anchor and fit the loss of the deteriorated stone on the Sebil façade with the original materials; similar dolomitic limestone bases and lime mortar consisting of 2 sand + 1 lime + ½ white cement. We tried to use the original stone for repair because it had the same appearance and nature and doesn't damage the original stone physically, mechanically or chemically.

The stone blocks which were used for replacing were dressed to the original profile and designed to match the original (Fig. 16).

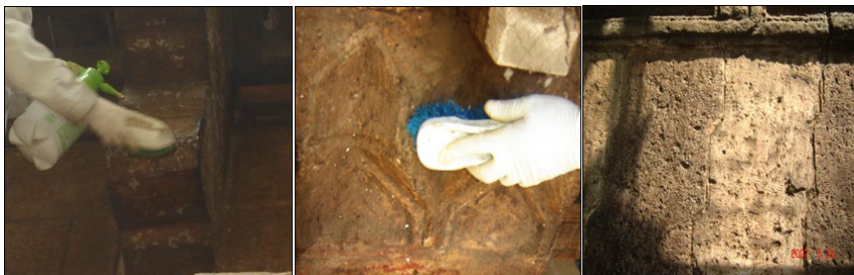
**Fig. 17.** Wet cleaning with warm water and soft brushes

- a. Cleaning the stones** with warm water and soft brushes as seen in figure 17.

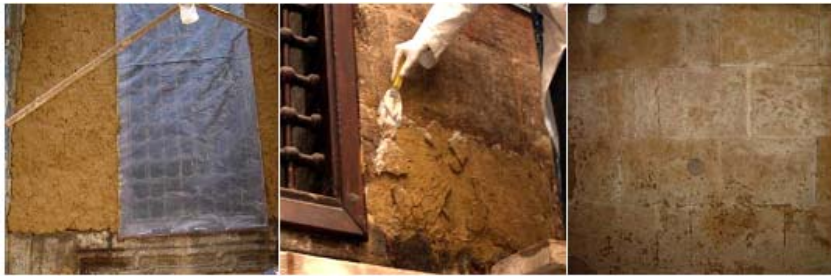
**Fig. 18.** Salt extraction by Sepollite poultice: **a** - The poultices completely covered the stone surface to a uniform thickness of about 1.0cm, **b** - removing the poultice, **c** - after restoration.

- b. Salts extraction:** According to the obtained data from the lab analysis and evaluation of the conservation start of the façade, it was found that the salt which threatened the stone was sodium chloride. So, mechanical methods (brushing) were used for removing the fine grains of crystallized salts and scalpels were used to remove thicker layers of salts. Sepollite poultice with distilled water was applied to the stone surface, to draw out the halite salts; this poultice is often favored by conservators of stone used for desalination, to draw out soluble salts or as a cleaning method on substrates such as limestone that respond to water cleaning [12-15]. The poultices completely covered the stone surface to a uniform thickness of about 1.0cm (fig. 18). They were allowed to dry over a period of about 48 hours. During this time, white salt crystals formed on the peaks of the clay poultice. When these salts were removed and tested, they matched with those that had been found in the water droplets. The poultice treatment was repeated five times. It is noticeable: the first and two poultices were easily removed and did not require an intervention layer of clay.

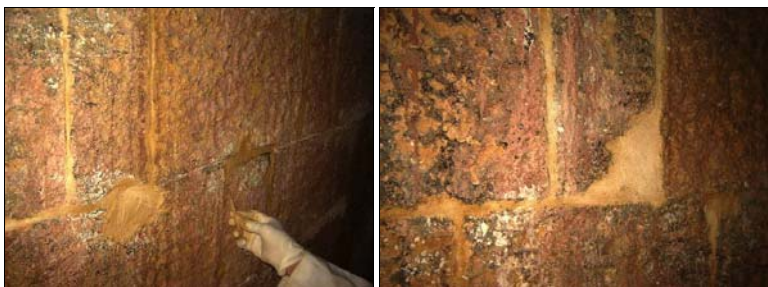
**Fig. 19.** Completion of missing parts

- c. Completion of Missing Parts:** It was decided to proceed to complete the missing parts of the stone units, especially if they were in poor condition and in need of rapid intervention to avoid future collapse. According to the conservation principles, and architectural/constructive specification of the Shahin Agha facade, the filling and completion material of the joints between limestone blocks should meet the following demands: compatibility with the limestone by the density and thermal expansion (similar to limestone); compatibility with the lead by the expression, appearance, texture and form. The experimental study referred that the lime mortar consisted of 2 sand + 1 lime + ½ white cement + Ediobond 65 (Basic of Latex Botadin Stearin) polymer in water (20%) provides the necessary hermetic joints between stone blocks. So, this works were carried out by conservators with lime mortar. The filling material was applied with a spatula to flatten the putty and smooth it out until it comes well to the edges of the archaeological stone surface (Fig. 20). After finishing, iron oxide was used to approximate its color to the patina of the original parts.
