DAMAGE ASSESSMENT OF THE ROMAN NYMPHAEUM IN AMMAN, JORDAN: AN ANALYTICAL AND DIAGNOSTIC STUDY

Abstract

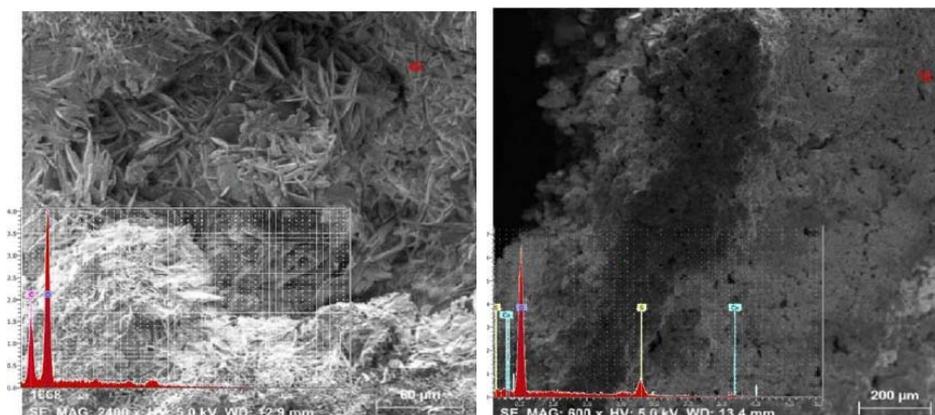
Fig. 3. Chemical characterization of sample (4B) By SEM with EDX

The chemical characterization of sample (4B) as in Table 3 shows the presence of (26.74%) carbon and (73.26) oxygen. The presence of these elements indicates the formation of a layer of hydrocarbon that resulted from direct burning of organic materials. The sample (7B) shows the presence of sulphur (12.87%), calcium (24.33%) and oxygen (62.80%). These elements give an indication on the formation of gypsum ($\text{CaSO}_4 \cdot 2\text{H}_2\text{O}$).

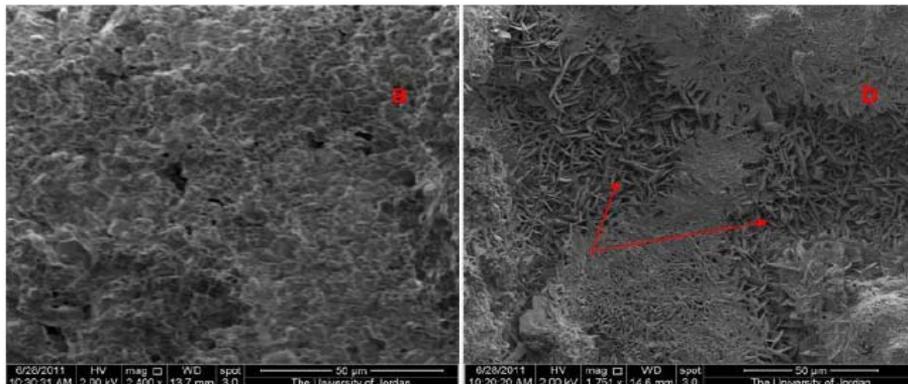
Fig. 4. SEM micrographs of sample (4B) a) showing the accumulation of Gypsum with calcite. B) Showing the needle like shape (gypsum) on the surface of the stone.

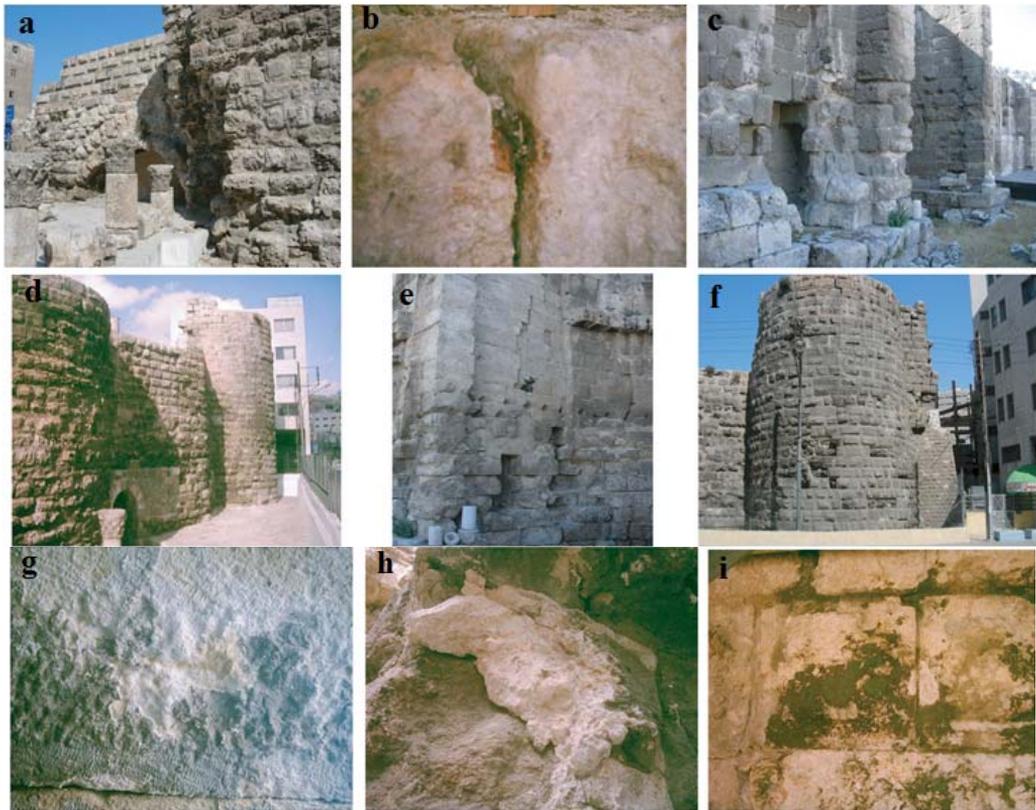
Fig. 10. Classification of deterioration causes and features at the Roman Nymphaeum in Amman:
 a – erosion, b – staining, c – crumbling, d – chipping, e – cracking, f – detachment,
 g – flaking, h – peeling, i – biological damage.

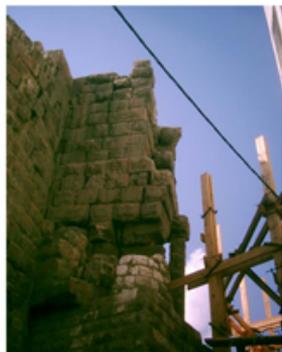
External Stress

Loads critical situation of the northern part after it was demolished

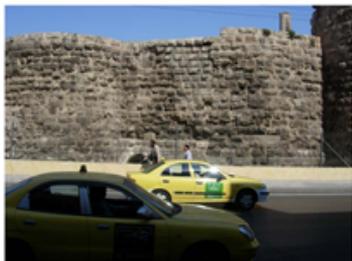
Attack by Rainwater and pollution

Main Street in the downtown passes by the Nymphaeum and forms a serious polluting source on the monument.
