## AN ITALIAN ANTI-SEISMIC SYSTEM OF THE 18<sup>TH</sup> CENTURY DECAY, FAILURE MODES AND CONSERVATION PRINCIPLES

Nicola RUGGIERI<sup>1\*</sup>

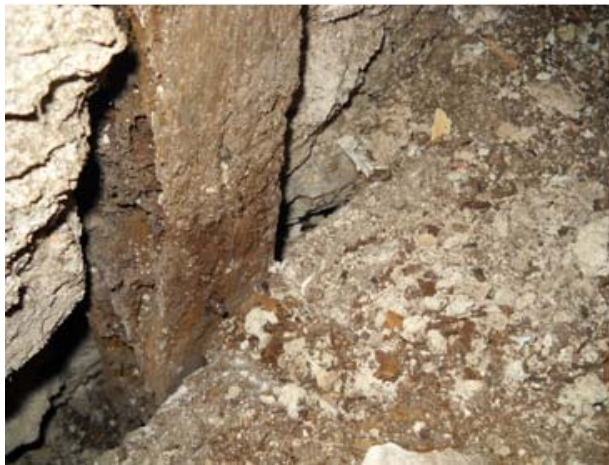
A high inclination to establish fungi and insects of that kind of constructive organization witnessed by the bad state of conservation of the timber structures of *Palazzo Vescovile* in Mileto (Calabria region) [12]. Such construction, built at the end of 18<sup>th</sup> century according to the recommendations contained in the anti-seismic code for the *ricostruzione dei paesi diruti della Calabria* [1], highlights the scarce durability of timber embraced by masonry. That condition is aggravated by other threats in particular the state of abandon<sup>6</sup> and the partial lack of the roof.

Fig. 3. A decayed wooden post of a frame in which the damaged timber is reduced in powder.

A fungal phylogeny characterizes numerous structural elements with different intensity attacks. The decayed timber presents peculiar longitudinal and transversal fissures, typical of brown rot<sup>7</sup> with a minor wood mass and consistency in respect to sound material; moreover it is characterized by scarce cohesion and low resistance to transversal pressure. The inspection has recorded some cases in which the damaged timber is reduced in powder (Fig. 3). Based on a visual analysis the agent might be individuated in the *Serpula lacrimans*<sup>8</sup>, Basidiomycota phyla, *Meruliaceae* family.

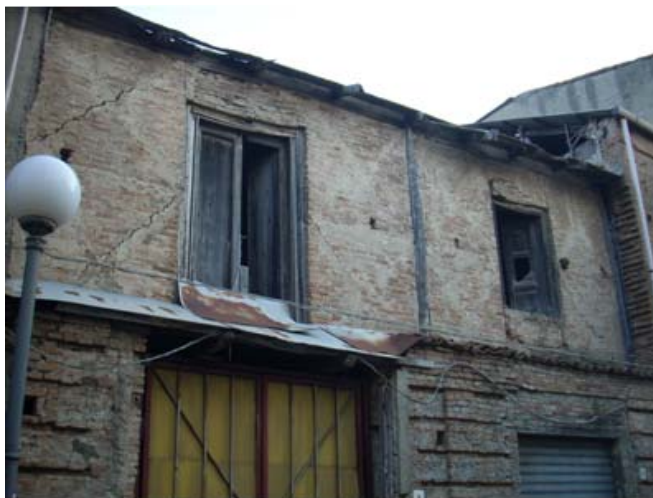
The case of a framed building in Seminara (Rc) is singular (Fig. 4). The consistency loose of the wooden member has generated on the brickwork 45° degree cracks tracing precisely the saint Andrew crosses<sup>9</sup>, pointing out, by now, their ineffectiveness.

**Fig. 4.** Seminara (Rc). The consistency loose of the inner wooden member has generated on the brickwork 45° degree cracks tracing precisely the saint Andrew crosses.

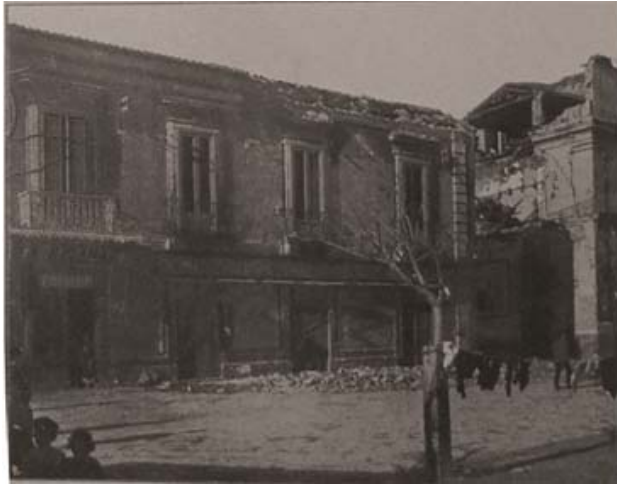
Fig. 5. Reggio Calabria. A *baraccata* building damaged by the 1908 earthquake.

The failures are delimited to the facade cornice. The seismic action probably hit the building parallel to the front, deduction deriving from the analysis of the overturning motion of the contiguous construction. The occurred failures emphasize a possible low entity thrust originated from the king post truss constituting the roof structure. The upper part of the building reached the largest displacements and the earthquake loading had not been adequately counteracted by the roof wooden ring, hence it had not been totally effective<sup>13</sup>.

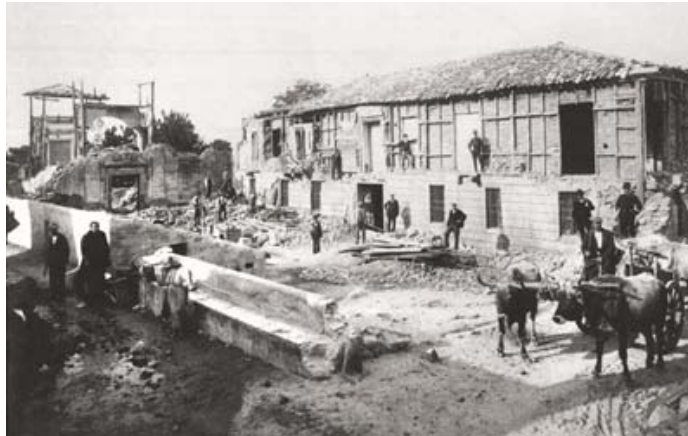
The loss of equilibrium and the consequent overturning of a part of the wall was the most recurring failure during the earthquakes of the 20th century (Fig. 6).

Such a failure mode is mainly due to an improper execution of the masonry. In fact, the analyzed collapses emphasize a fabric constituted by small size and round stones and a probable scarce mortar quality. Moreover, the slender external leaf is not constrained to the remaining wall by means of transversal stones (*διάτονος*). A similar arrangement implicates a significant

overturning vulnerability, although limited to the external leaf, even under moderate accelerations.

**Fig. 6.** Messina. A *baraccato* building characterized by the overturning of the external masonry leaf after the 1908 earthquake.

However, it is worth noticing that the seismic perpendicular action did not provoked any damage to the wooden framing and, the partial overturning, at any rate toward the building exterior, did not cause the roof and floors collapse, guaranteeing the people life safety.

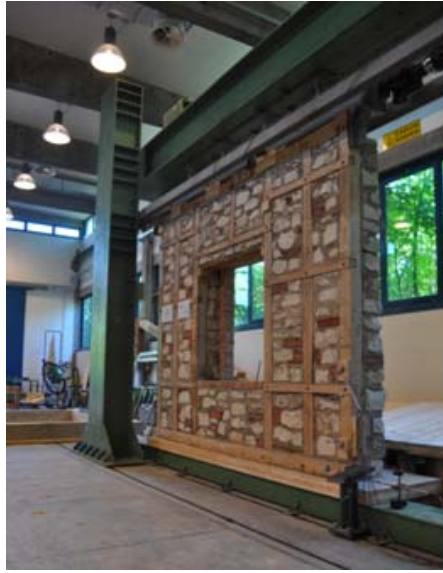
An experimental campaign including quasi static cyclic tests on samples of framed masonry in full scale (Fig. 7) has been carried out in 2013 in the CNR Ivalsa laboratories<sup>14</sup>. The tests, limited to horizontal parallel action to the wall, provided indications about the seismic performance of the Borbone constructive system. The numerical results deriving from the experimental investigations [2], synthesized in the table 1, and the qualitative analysis of the damage progression confirmed a proper behaviour of the Borbone masonry stressed by cyclic loads.

The tests highlighted a non-linear behaviour with a discrete amount of energy dissipated (a peak of 1579kNmm corresponding to a displacement of 80mm). The system, according to the definition contained in the European standard UNI-EN 12512:2006 (*Timber structures – Test methods – Cycling testing of joints made with mechanical fasteners*), showed a negligible degradation of the resistance, a strength impairment constant value of about 10% and a significant value of the ultimate displacement (about 80mm), reaching a ductility of about 8.

With regard the damage analysis, the timber joints and members didn't point out, during the entire test, any failures; hence they answered to the imposed stresses in elastic field. The masonry infill underwent few case of stones expulsion and cracks in the fragile bed-joints. Concerning the latter, it worth emphasizing that the presence of the timber frame prevented a further cracks growth. The major contribution to the energy dissipation was represented by the friction mainly generated by continuous structure disarrangement and resettling due to the reversed cycles. Moreover, detachments between the masonry infill and the timber frames were recorded.

**Fig. 7.** The full scale sample of Borbone constructive system tested under quasi static cyclic loading
