A CONTRIBUTION TO THE CONSERVATION OF 20TH CENTURY ARCHITECTURAL HERITAGE IN KHEDIVAL CAIRO

Ahmed ELYAMANI¹*, Mohamed Saad EL-RASHIDY²,
Mahmoud ABDEL-HAFEZ¹, Hany GAD EL-RAB²

This paper discusses the restoration works carried out to save a balcony in a historic building dating back to the beginning of the 20th c. The corrosion of the steel beams carrying the balcony resulted in severe problems and the decorative units at the balcony bottom were detached. An intervention was carried out in which the steel beams were cleaned from corrosion products and strengthened using newly added plates. As well, the decorative units were restored. For revealing the adequacy of the intervention, a static loading test was carried out. The interventions presented here represent a good example that could be applied to many other similar balconies widely found in Khedival Cairo, in specific, and other similar floors made of steel beams and concrete.

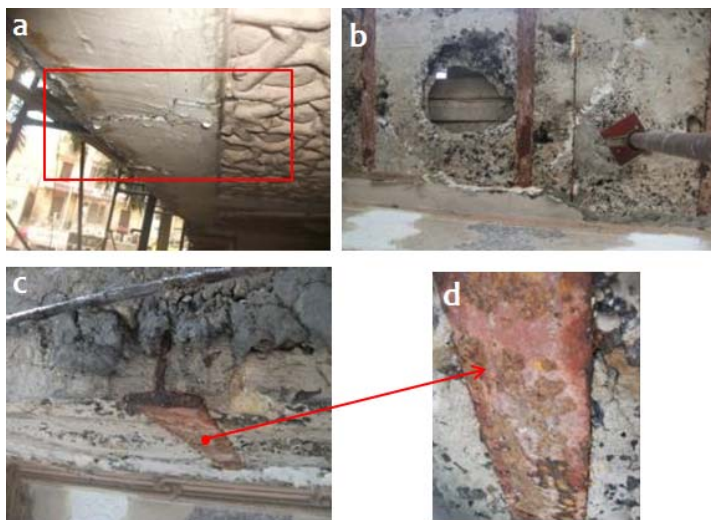
The air-conditioning unit installed in the balcony was the main source of the problems and the observed damage. The leaked water from the air-conditioning (Fig. 3a) infiltrated in the balcony's floor and resulted in series corrosion problems in the steel beams (Fig. 3b, c and d) and the steel bars used to reinforce the decorative units (Fig. 6).

Fig. 3. Damage of the balcony floor: a. Source of damage: leaked water from air condition infiltrated to the balcony bottom; b. Losing of some parts of the floor and corrosion of beams; c. Zoom to a corroded beam; d. A zoom to the beam bottom flange showing the severe corrosion

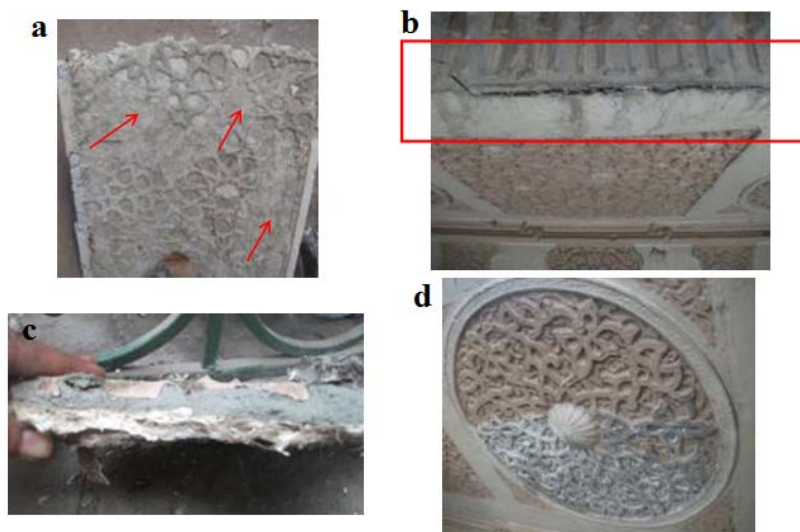
In addition, a narrow crack developed between the parapet and the balcony floor due to the deflection of the steel beams (Fig. 4b).

The decorative units at the balcony bottom suffered from: 1) inappropriate previous interventions in which the arrangement of the decorative units was changed (Fig. 5); 2) peculiar materials, not similar to the original ones, were used in that intervention. Instead of making all the decorative units from gypsum, a mix of an internal layer of gypsum reinforced with linen and external layer of cement was used (Fig. 4c). To connect the decorative unit with the steel beams and also to reinforce it, a mild steel bar was used (Fig. 6). Peculiar paints were used on the external cement layer (Fig. 4d); 3) complete deterioration of some parts (Fig. 4a) and 4) corrosion of the steel bars used in connecting the units to the steel beams (Fig. 6). In the aforementioned intervention, the original gypsum parapets were replaced with reinforced concrete ones.

Fig. 4. Problems and damage of the decorative units: a. Disappearance of some parts; b. A crack between the parapet and the decorative units; c. Inappropriate materials used in previous intervention, internal layer of gypsum reinforced with linen and external layer of Portland cement; d. Using of peculiar paints

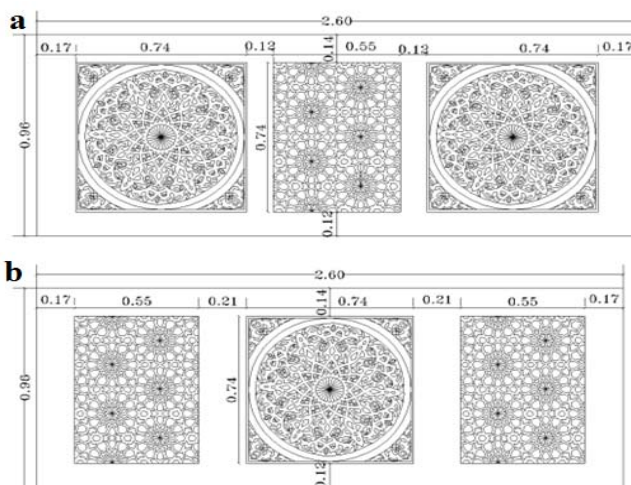
Fig. 5. The found arrangement of decorative units at the balcony bottom (a), and the correct arrangement (b) (dimensions in meters)

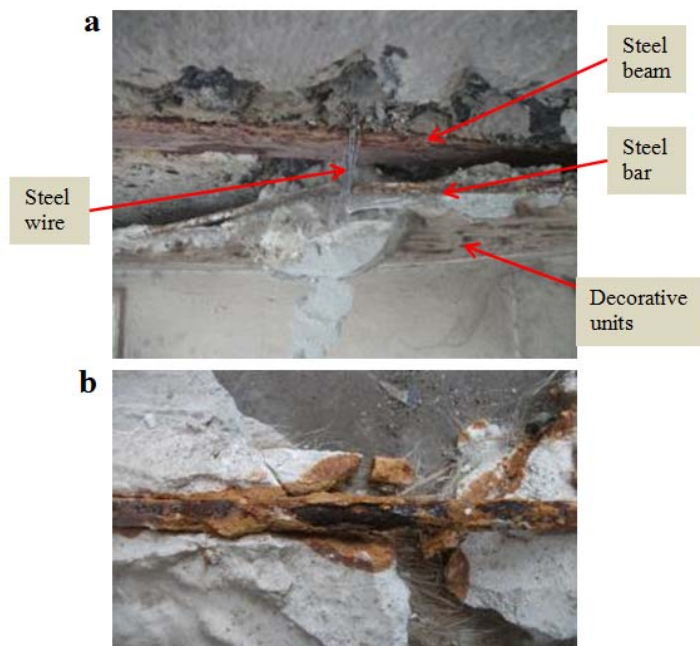
Fig. 6. The corrosion of the steel bar connecting the decorative units to the steel beam (a), and zoom to the corroded bar (b)

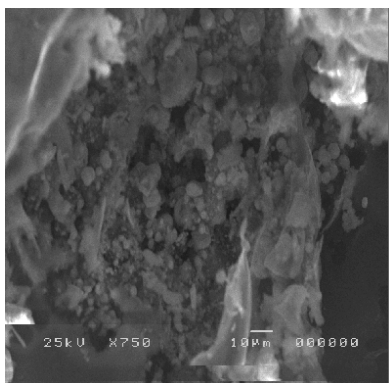
It is worth mentioning that SEM investigation showed that there was a clear interference between the concrete components (aggregate and binding material) and the corrosion products resulted from the corrosion of the steel beams (Fig. 13). Similarly, it showed the interference between the decorative units' components and the corrosion products of the corroded steel bar (Fig. 14).

Fig. 13. SEM image showing the interference between the concrete (dark color) and the corrosion products (light color).

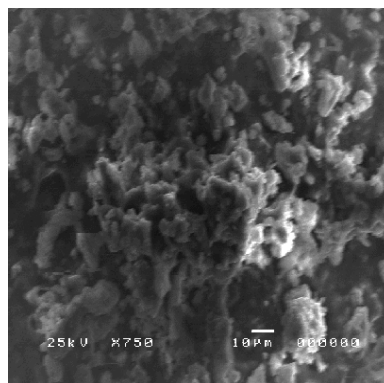
Fig. 14. SEM image showing the interference between the decorative units' materials (dark color) and the corrosion products (light color).

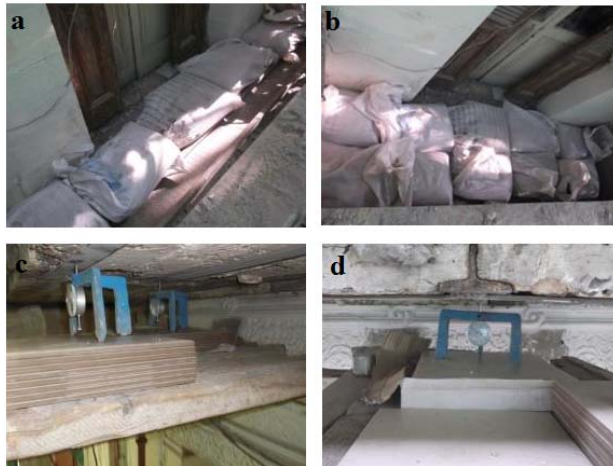
Substituting in the above equation δ_{max} was found as 0.288mm. This allowable deflection was higher than the maximum measured one 0.175mm. Therefore, the balcony after strengthening satisfied the code provisions.

Fig. 18. Static loading test: a. and b. Loading; c. and d. Measuring deflection
