RESTORATION OF A CASELLA BROTHERS' ACOUSTICAL GUITAR AND CONSTRUCTION OF AN IDENTICAL COPY

Stylianos ANDREOU, Panagis SKLAVOS,
Anastasios A. KOKKINOS, Dionysios T.G. KATERELOS*

Applied Mechanics – Acoustics and Musical Instruments Design Lab, Department of Sound and Musical Instruments Technology, Faculty of Music Technology, Ionian Islands Technological Educational Institute, S. Typaldou ave, Lixouri, Kefalonia, GR-28200, Greece

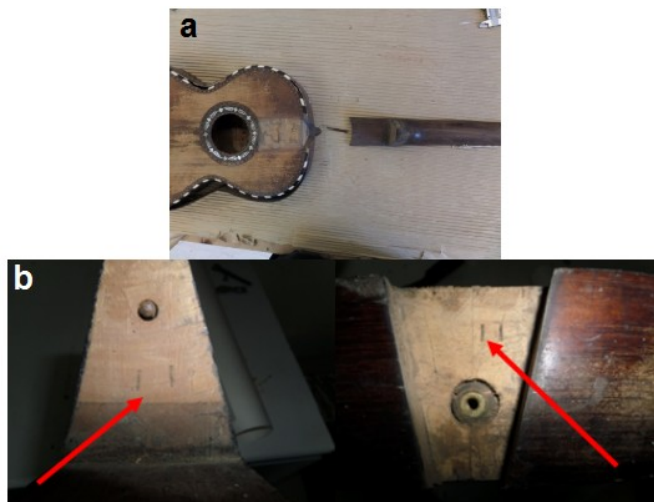
The first procedure in order to restore the guitar is the disassembly of the various parts that compose the instrument, in order to reach the damage points, to restore them and conserve them. The first part that was removed from the instrument was the neck. The neck was assembled on the body in a particular manner not common today for acoustical guitar. As it can be seen in figure 2a the joint was in the form of a wedge.

Fig. 2. (a) The guitar body and the neck removed; (b) The screw that stabilizes the neck on the body. The arrows point the marks made to note that this neck fits that nick

The neck was wedged in the guitar body, without any gluing between it and the body nor the top-plate (as is done today). In addition a screw was placed between the neck and the back chock of the guitar, in order to keep the neck stable at its right position (Fig. 2b). The constructors had marked the neck and the chock to remember that the specific neck fits perfectly in the specific nick (Fig. 2b).

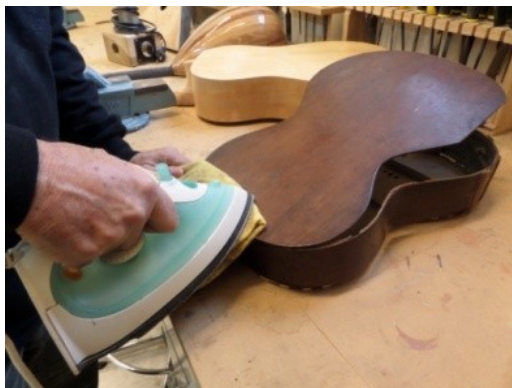
Fig. 3. The ungluing process

In all the glue joints animal glue was applied. As mentioned before this type of adhesive is easily removed by heating and hot water. This process was followed here (Fig. 3). Thus, the top-plate, the back-plate, the bracing struts, the saddle and the bridge, and the sides of the guitar were unglued and separated from each other disassembled completely the instrument in its parts. When the bracing struts were unglued, their positions on the top-plate were marked in order to be put back in their original places after repair.

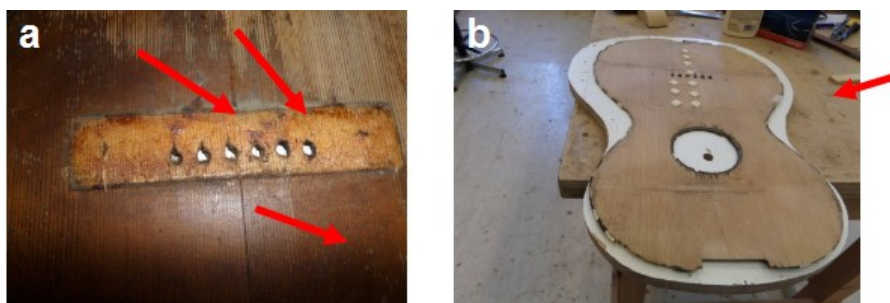
Since the instrument is in parts the restoration process was started. The first part to be repaired was the top-plate. The top-plate was made by a piece of picea excels (European Spruce). The top plate was cleaned from dirt and from glue using a piece of sandpaper. Next, small holes were drilled, filled with animal glue and pieces of spruce were added in the holes at the back side of the top-plate and near the bridge position in order to patch the cracks and to reinforce the position of the saddle and the bridge, where the strings exert mechanical loading (Fig. 4).

Fig. 4. (a) Arrows point the positions of cracks at the top-plate. (b) Small spruce patches added on the top-plate to repair cracks and reinforce the saddle/bridge position (arrow)

The next step was to clean the glue remaining around the patches and place back the bracing struts after cleaning them first. Thus, the top-plate is considered to be repaired and functional (Fig. 5). Some more work needed to be done for the top-plate to take its original picture will be completed during the assembly of the guitar.

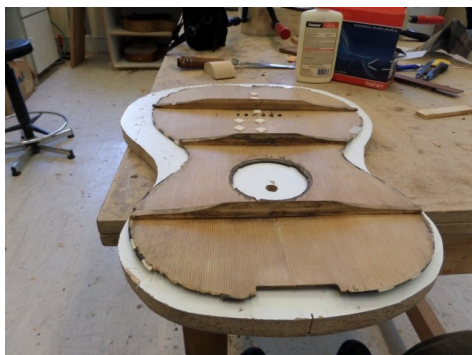
Fig. 5. The top-plate after finishing repair procedure

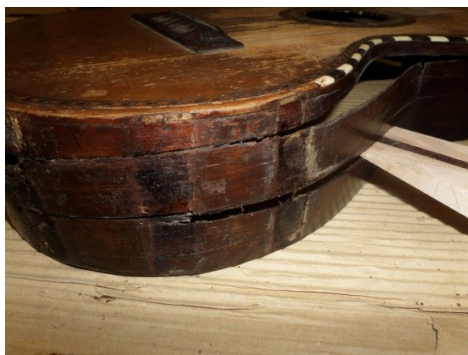
The guitar ribs were the most damaged parts of the instrument. They contained longitudinal cracks separated them into three pieces and portions of wood were missing (Fig. 6).

Fig. 6. The damaged ribs

In order to repair the ribs a mould was constructed by pine wood, which is tough and strong enough to withstand the pressure of clamps when the ribs will be putted inside. The ribs were then cleaned from dirt and glue. Following, the ribs were placed in the inner part of the mould and the broken parts were glued between them. A thick gauze filled with animal glue was used to stabilize the ribs. Pressure was applied using clamps and the ribs repair was completed.

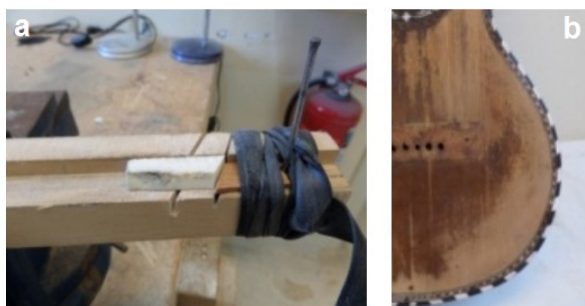
As mentioned before, the instrument decoration was damaged and some parts of it were missing, especially at the top-plate perimeter. Decoration materials were mainly ebony, bone and linden. Generally, the decorative wood sequence from the inner part of the top-plate to the outer is: ebony-bone-ebony-bone, followed by a series of linden-ebony diamonds. Then there are again two consequent series of bone-ebony pieces and the decoration completes with bone-ebony diamonds. The most damaged place was the last series of bone-ebony diamonds. Pieces of bone and ebony were cut. Bone was treated appropriately in order to expel any oil and fat contained.

Fig. 9. a. The self-made jig used to cut equal size diamonds for the guitar decoration; b. The restored part of the guitar restoration

Using a self-made jig, all diamonds were cut at the same size and the guitar decoration was replaced. In figure 9a the jig for diamonds cutting is presented, while in figure 9b the replaced decoration is shown.

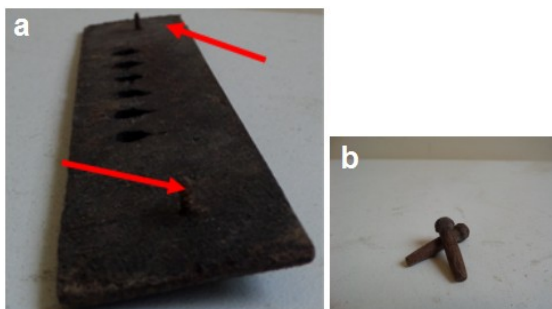
Examining the guitar bridge, the age of the instrument was verified for one more time from the way that the bridge is glued on the top-plate. Besides the adhesive (animal glue) it is stabilized at its right and left with small nails (Fig. 10a). This way of attachment is no longer present.

Fig. 10. a. Bridge attachment. Red arrows show the locations of nails; b. The pins that hold the strings on the bridge

After ungluing the bridge, it was cleaned and the rusty screws were removed. The bridge is manufactured by rosewood to withstand the strings applied stresses. Strings are hold on the bridge by wooden (rosewood) pins (Figure 10b). Then the bridge was attached back on the top-plate.

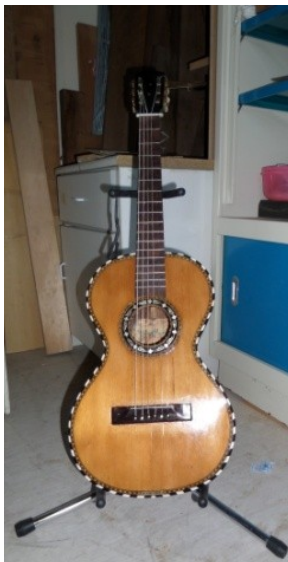
Fig. 11. The guitar after restoration processes completed

After varnishing, the last procedure in order to complete the guitar renovation, was the assemblage of guitar parts. The neck was attached on the guitar body in the way it was done by the manufacturers. The keys were screwed on the neck and the strings were put on the keys. The upper saddle, made by a piece of bone, was put at the beginning of the fretboard. The down saddle that is attached on the bridge is not made by bone, like in the contemporary instruments, it is just a piece of fret. Finally, strings were tied on the bridge pins and tuned with small correction in the neck slope, in order for the strings to touch only one fret at each time and not more. The final finished instrument is shown in figure 11.
