## NOT JUST SIMPLE WATER DRIPS: THE CASE OF AN EARLY 1900s OIL PAINTING ON STONE

**Keywords:** Water drips; Oil painting; Degradation; Wall painting; Oil on stone

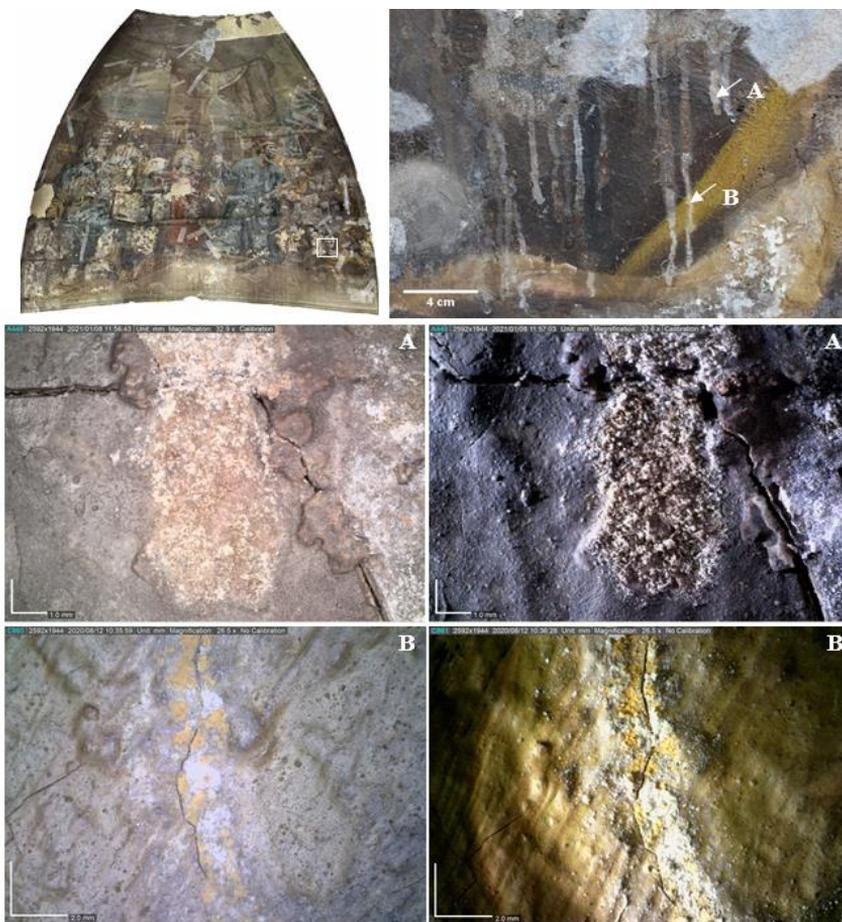
**Fig. 1.** Context images shows the appearance of the long white drips running down the surface of the paintings, with a macro image on the right. The two sets of micrographs, at the bottom, show the same drip in diffuse and raking light showing the lack of colour and increase in texture in comparison with the surrounding, unaffected area.

In 2020 in view of a conservation project, a new condition assessment and a series of investigations were carried out. Compared to 2004, in 2020 the condition of the paintings was found to have considerably worsened, whilst several areas of the painting had collapsed. One of the aspects that was investigated over the last campaign was the presence of numerous long white drips, probably generated by rainwater infiltration. These drips marks, from now on referred to as "drips" in this contribution, were particularly interesting since along their trail the upper paint layer appeared thinner than in the unaffected areas, while white material was also found to have deposited along the edges and at the end of the drips (Fig. 1).

The white drips are, therefore, likely to be a result of the migration of oil paint components due to water infiltrations that have seeped through the external stone cracks and through the entire stratigraphy of the painting. Recurrent water infiltrations in this case have caused the unbound oil components out of the paint system. The gypsum, on the other hand, was instead probably leached out from old plaster repairs and mortar joints of the stone masonry.

In spite of its limitations, this study pointed out the detrimental effects that prolonged exposure to liquid water can generate in oil-based wall paintings. Besides activating salt activity and related salt deterioration, water can also leach out oil paint components. This emphasises the need of strict preventive measures aiming to avoid rainwater infiltrations, and also of a cautious use of water during conservation treatments.

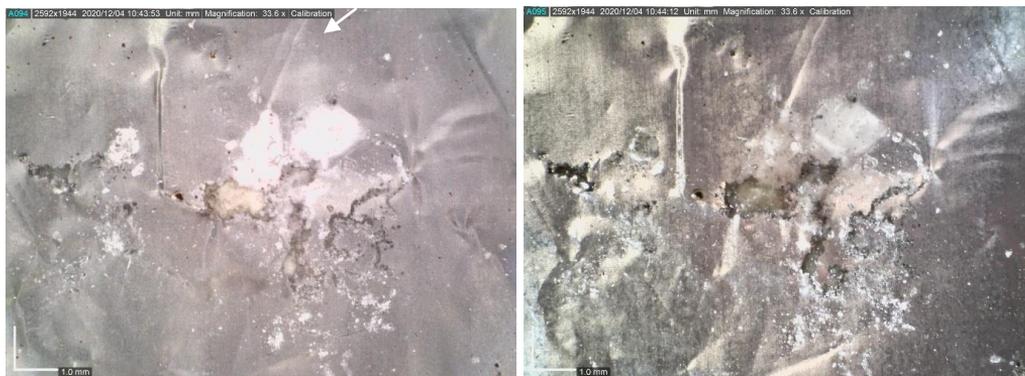
The first few scrapings of the “drips” were collected and stored in aluminium foil then placed in a sealed plastic box. In less than a month, the samples were found to have reacted with the aluminium foil, which as a result, was found punctured and darkened at the edges (Fig. 2). In few cases upon the opening of the aluminium foil a faint, foul smell was perceived. On the spot, the pH of the liquid was tested. It gave a rough result of a neutral pH.

**Fig. 2.** Micrographs in diffuse and raking light of the reacted aluminium foil.  
The arrow points at the droplet found within the aluminium foil

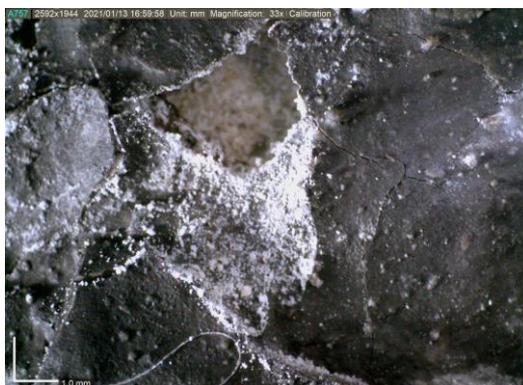
The “drips” were generally found to have a white colour, although in some instances they also appeared light brown. “Drips” were present on all four bays but were particularly evident and numerous on those two bays, that were reported to suffer the most from water infiltration. Visual observations indicated that the water drips emerged from paint craquelure and losses and ran down on the surface of the wall painting (Fig. 3). White material deposited on the edges of the drips’ path while the paint layer was missing or thinned, as well as rougher in texture in comparison with the unaffected adjacent areas.

**Fig. 3.** Micrograph of drip emerging from a paint loss

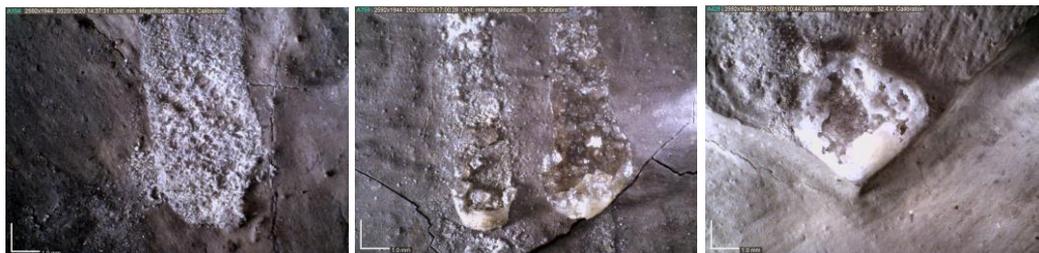
With the aid of digital microscopy, the deposited material at the end of the drip was characterized into three distinctive morphologies: “needle-shaped”, “cubic” and “amorphous” (Fig. 4). No specific pattern relating to the location of these diverse formations seemed to be apparent.

The “needle-shaped” formation was mainly found to be composed of multiple, thin micro-crystalline structures, usually spread out as a thin layer, more rarely as a thicker deposit. This formation was always found to be white, and while sampling, it was found to be powdery. The deposited material of the “cubic” and “amorphous” formation occasionally had a light brown-tinge. The former was often found to be transparent while the latter was composed of a white porous crust. With substantial deposition of the “cubic” material, a “wall”-like structure similar to the “amorphous” deposition forms at the tip of the drip (Fig. 4). While sampling, the “cubic” formation seemed to be tacky, while the “amorphous” drip was brittle.

**Fig. 4.** Micrographs in raking light showing the “needle-shaped”, “cubic” and “amorphous” formations respectively

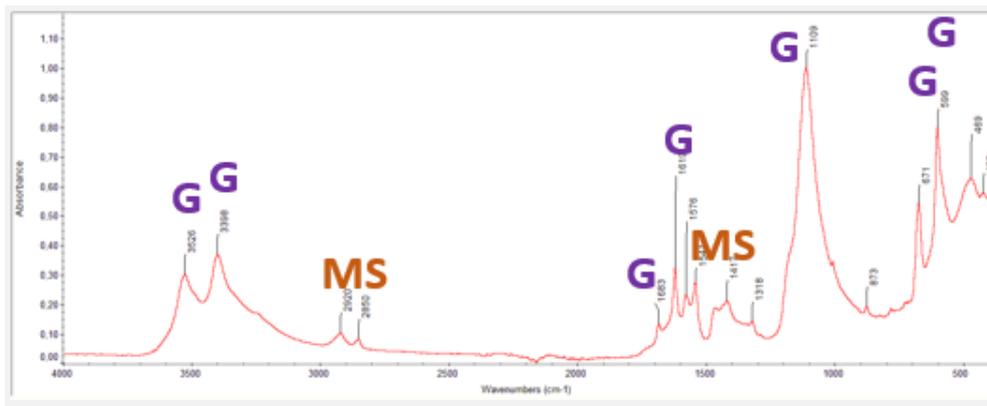
FT-IR in ATR mode and Raman spectroscopy performed on scrapings representing all three morphology of the “drips” gave insights on their organic and inorganic composition. All samples were found to include gypsum and metal carboxylates, also known as metal soaps (Fig. 5). Research in the degradation of oil paintings implies that the metal soap formation within oil paintings is fairly common, however, this research is mostly carried out and aimed for easel painting conservation [13-20]. The characterization of the specific metal soaps, however, was not possible due to the similarities in the IR vibrations of the different metal carboxylates and considering the instrumental resolution ( $4\text{cm}^{-1}$ ).

Fig. 5. FT-IR spectroscopy showing peaks for gypsum (G) and metal carboxylates (MS)

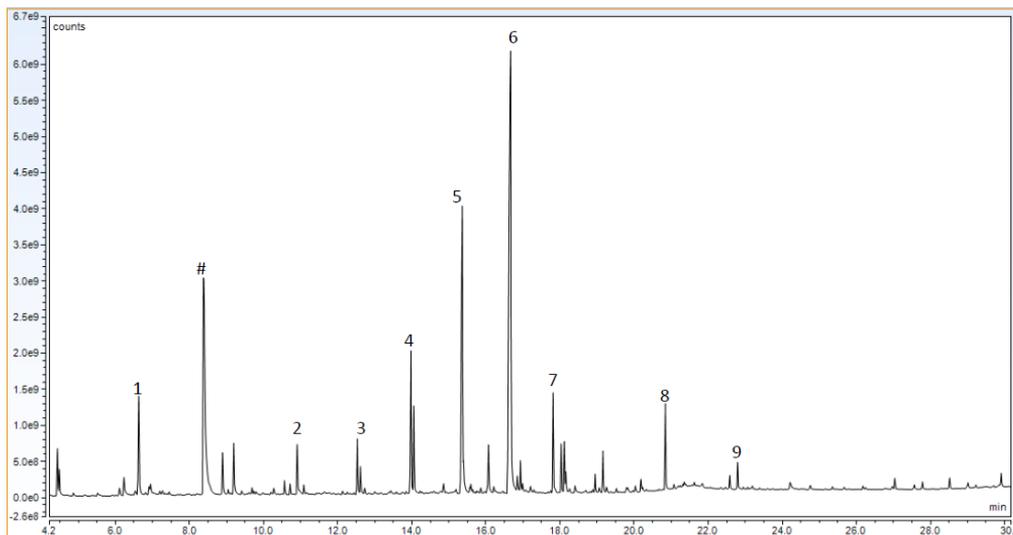
According to Py-GC/MS, the majority of the “drips” was composed of a substantial amount of difatty acids (such as adipic, glutaric, pimelic, azelaic, suberic and sebacic acids, being azelaic the most abundant) (Fig. 6). In the chromatograms of the deposited drip material some differences were observed according to the drip morphology. In comparison, the amorphous formations had higher amounts of difatty acids than both the “cubic” formation and

Fig. 6. Py-GC-MS results after thermal desorption and thermal degradation using TMAH. Difatty acids (2 = glutaric, 3 = adipic, 4 = pimelic, 5 = suberic, 6 = azelaic, 7 = sebacic acids as methyl esters) are mainly present, together with 1 = glycerol, 8 = palmitic and 9 = stearic acids as methyl esters. Peak labeled as # is due to TMAH

It almost seems that there has been leaching that, with percolating water, has conveyed the most hydrophilic part of the lipidic binder, specifically the difatty acids. Within the “liquid drip” samples only traces of fatty acids and alkenes were identified. This indicates high amounts of fatty acids found in the former solidified drips is likely to be a build up after recurrent water infiltrations. Meanwhile, the presence of the alkanes possibly relates to the traces of beeswax found in the painting mixture in the 2004 technical study [3-5]. However, beeswax is known to be insoluble in water hence this outcome of migration of the alkanes with the presence of water is not yet understood.
