CONSERVATION OF THE LATE ROMANESQUE SANDSTONE PORTAL OF THE CHURCH OF THE PREMONSTRATENSIAN CONVENT IN KRAKÓW, POLAND

Abstract

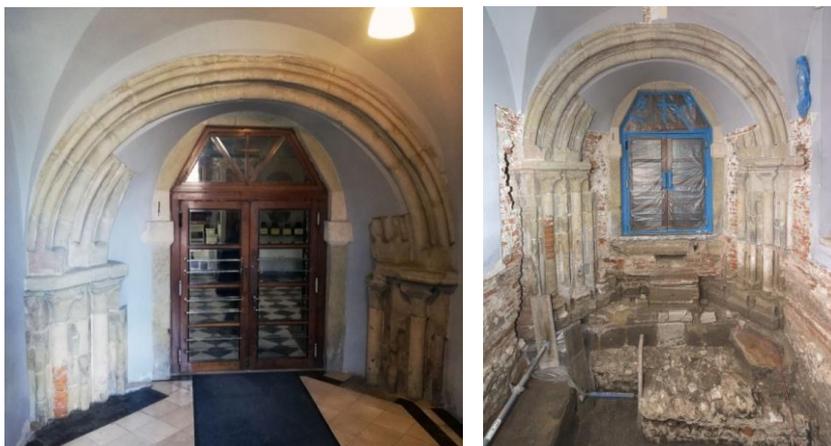
Fig. 1. The condition of the portal before the works in 2019 and after the completion of archaeological research in 2020

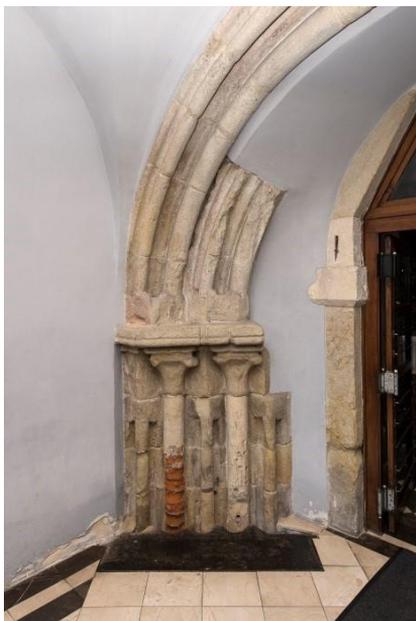
Fig. 2. A section of the portal, with visible decay of the material and the brick infill replacing a section of the former column. Condition before the removal of the bottom parts

5. In parallel, the brick infill added later to the portal will be replaced. A study of the distribution of salt concentration in the samples collected from the brick infill in the portal confirmed the typical feature of salt accumulation in the parts close to the surface. This indicates the ongoing process of migration of moisture to the surface of the materials, and the need to replace the brick infill due to the concentration of salt within it [33]. The infill ideally fulfils the role of a “compress”, which should be repeated by installing a new one, on principle with greater capacity of absorption by weight and porosity higher than that of the original

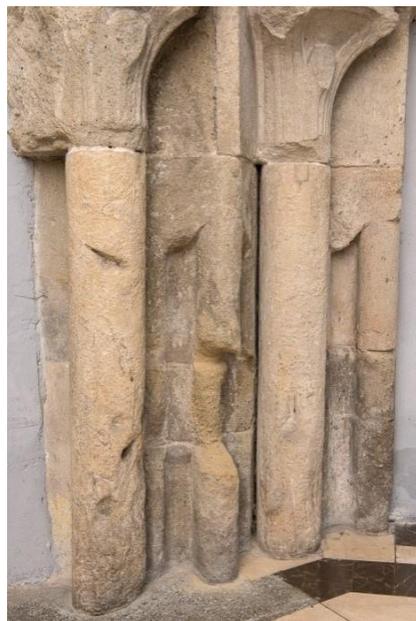
Fig. 3. A section of the portal, with visible damage of the elements of the portal jamb. Condition before the removal of the bottom parts

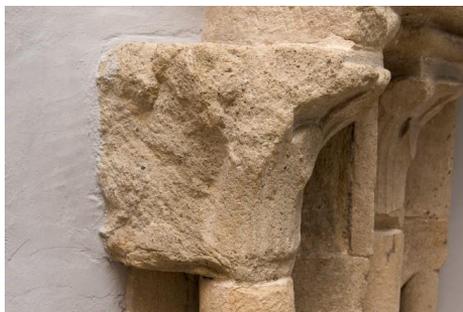
Fig. 4. Damages of the stone column capital

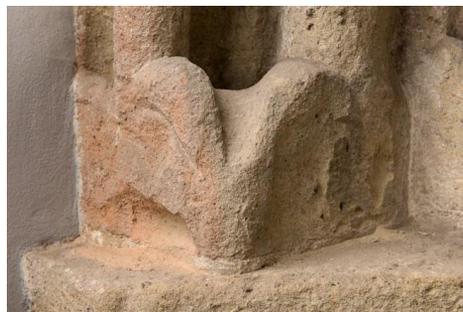
Fig. 5. Damage of the wavy archivolt base

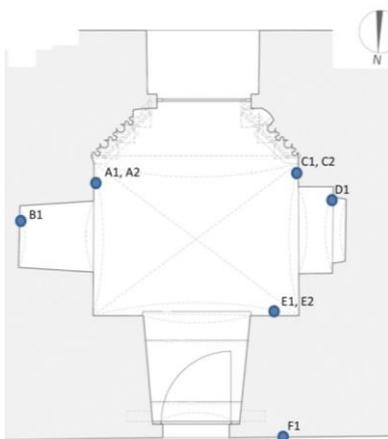
Fig. 6. The plan of the porch by the portal of the Church of St Augustine and St John the Baptist in the complex of the Premonstratensian Convent in Kraków's district of Zwierzyniec. Blue marks the locations of boreholes used to collect samples for examining dampness and salt contamination of the walls by the portal

In most cases the level of moisture indicated moderate to severe wall dampness. There are no regular moisture trends in the walls, and mass humidity does not decrease with the distance of the measuring site from the floor. In most cases, the samples collected from the deeper sections of the wall had higher concentrations of moisture.

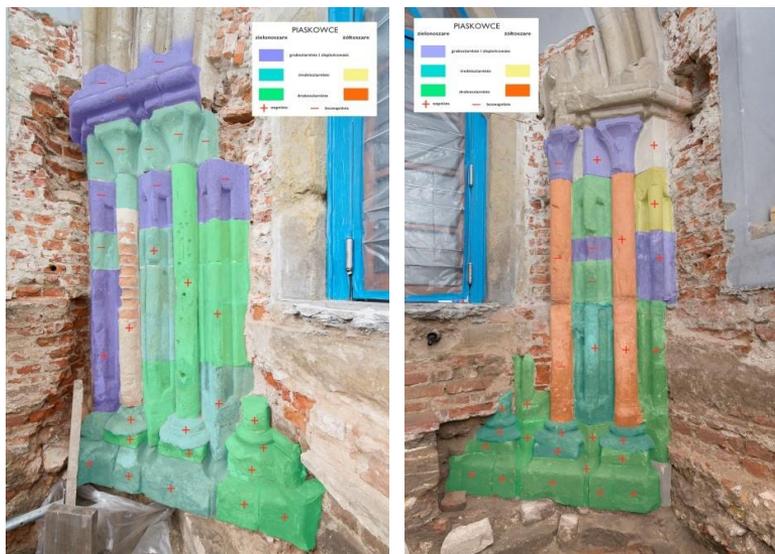
Fine- and medium-grained sandstones of green-grey colour with calcite content, most of them compact, have been well preserved (Fig. 7).

Fig. 7. Breakdown of the sandstones used for the jambs of the portal according to their colour, grain, and presence of calcium carbonate

They were chiefly used for the base and plinth of the portal. Some of the fine-, medium-, coarse-grained, and conglomerate sandstones of low or no calcite content of green-grey and yellow-grey colours are compact while others are hardly compact and crumbling. They were used for the columns and their capitals, and the archivolt.

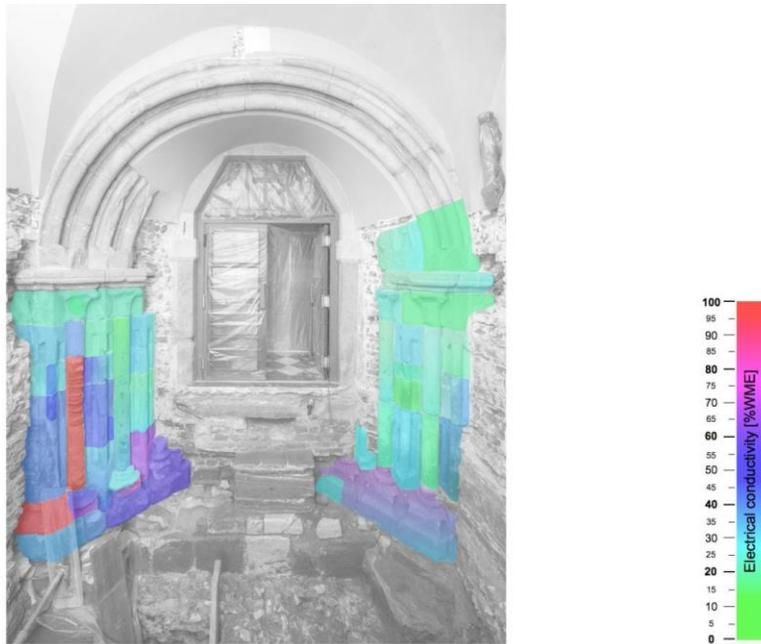
The lower parts of the portal and the left-hand jamb, in particular the brick portal infill and a section of portal base adjacent to it, conduct electricity better. Electric conductivity of materials depends on a number of factors, including the density of the tested material and the share of hygroscopic salts. However, it is moisture that provides the main factor influencing the

Fig. 10. Results of tests of electric conductivity of the stones of the portal

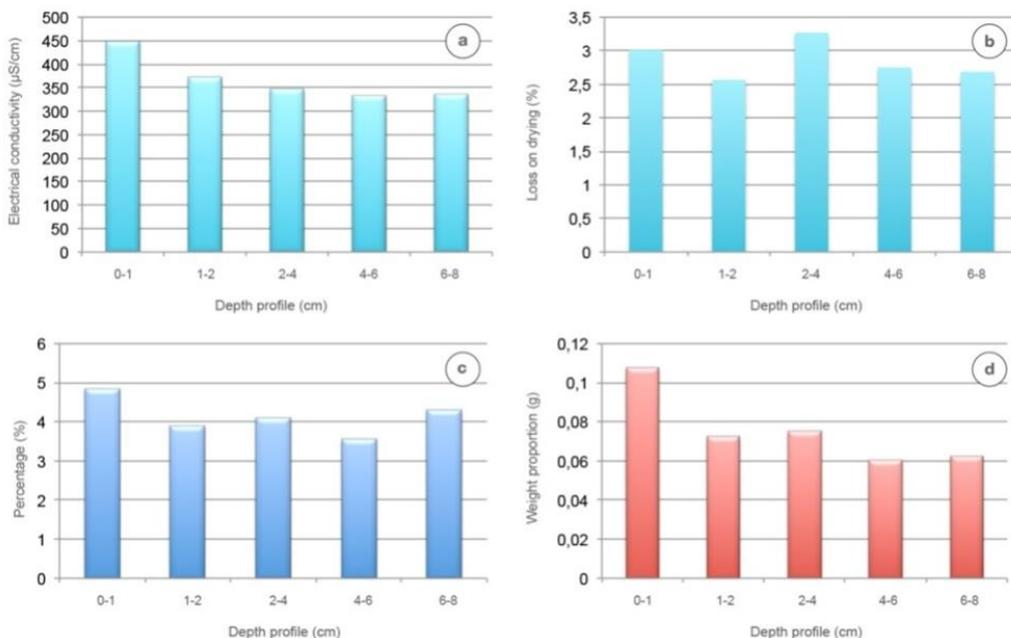
Salt concentration inside the later brick infill was examined at a specified depth. The salt concentration in the depth profile of the examined sample follows the typical pattern [36, 37]. It is highest in the first four centimetres of the profile depth (Fig. 11a and d), while the values for the last four centimetres show levels that are generally constant (Fig. 11a, b, and c). The electric

conductivity ranged from 448 to 332 μ S/cm. Salt is present at the levels ranging from close to 5 to 3.5% (Fig. 11a). The same observation applies to moisture loss of the sample after drying, where salt content ranges from 2.5 to 3% (Fig. 11b).

Fig. 11. a) Electric conductivity, b) The loss on drying of the samples, c) % share of salt in the drilling dust from the samples d) Soluble matter in the samples by weight
