## INVESTIGATION ON THE SURFICIAL STAIN ABOVE THE OUTDOORS SANDSTONE SCULPTURE IN CHONGQING CHINA THREE GORGES MUSEUM

### Abstract

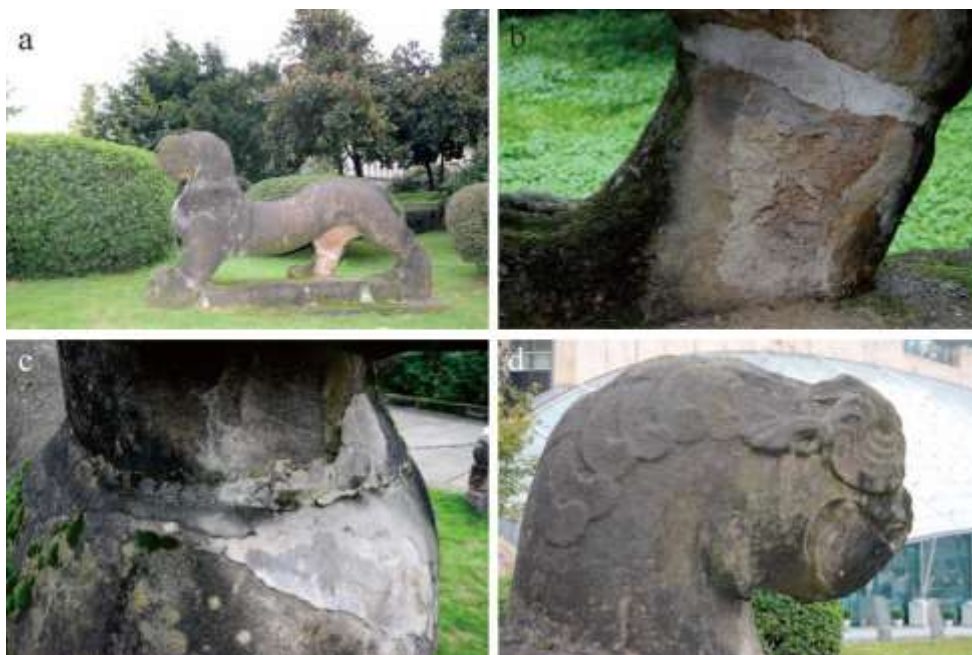
Figure 1 shows the picture of the sandstone Bixie (Fig. 1a) with the efflorescent leg (Fig. 1b), the repair concrete (Fig. 1c), and the mouth with yellow staining (Fig. 1d). The efflorescence of sand sculpture is observed on the inside of its right hind calf, where rain can't wash and will accumulate the soluble salts by rainwater infiltration and diffusion. The efflorescence sample from its right hind calf, the exfoliation sample from its platform, the repair concrete from its neck, and the yellow crust from its mouth were collected to evaluate the weathering properties of this sand sculpture in the open storage environment, as listed in Table 1.

**Fig. 1.** The picture of Bixie (a), the efflorescent sample from the right hind calf (b), the repair concrete (c) and the mouth with a yellow crust (d)

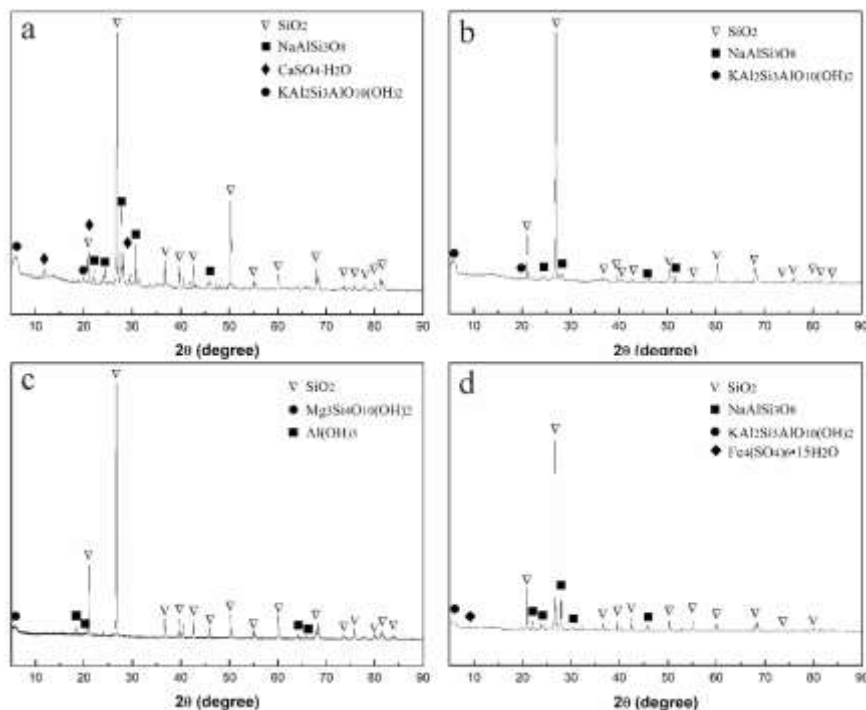
**Fig. 2.** The XRD patterns of Bixie, the efflorescent sample from the right hind calf (a), exfoliation sample from the platform (b), the repair concrete (c), and the mouth with yellow crust (d)

As shown in Figure 2a, the XRD pattern of the efflorescent sample for the right hind calf shows the existence of quartz ( $\text{SiO}_2$ ), alibite [ $\text{Na}(\text{AlSi}_3\text{O}_8)$ ], muscovite [ $\text{KAl}_2\text{Si}_3\text{AlO}_{10}(\text{OH})_2$ ], and gypsum ( $\text{CaSO}_4 \cdot 2\text{H}_2\text{O}$ ). Gypsum is an important salt cause of chemical weathering for sandstones [21], which comes from sulphide in the atmosphere, indicating that the main salt on the surface of sandstone Bixie is sulphate.

Peaks appearing in Figures 2b and d are similar to those in Figure 2a; they can be indexed to quartz ( $\text{SiO}_2$ ), alibite [ $\text{Na}(\text{AlSi}_3\text{O}_8)$ ], and muscovite [ $\text{KAl}_2\text{Si}_3\text{AlO}_{10}(\text{OH})_2$ ], which is the material composition of a sandstone body. The difference is that Figure 2c shows the existence of  $\text{Al}(\text{OH})_3$ , probably due to the element Al released in the carbonation process of the repair concrete.

As Balsamo reported, when  $\text{O}_2$  diffuses into stagnant  $\text{Fe}^{2+}$ -rich water, it causes the formation of Fe-rich concretions [22], and stagnant  $\text{Fe}^{2+}$ -rich water on the surface reacts with sulphur oxides in the atmosphere. So  $\text{Fe}_4(\text{SO}_4)_6 \cdot 15\text{H}_2\text{O}$  is detected, and  $\text{Fe}^{3+}$  is a colour component in the yellow crust, as shown in figure 2d.

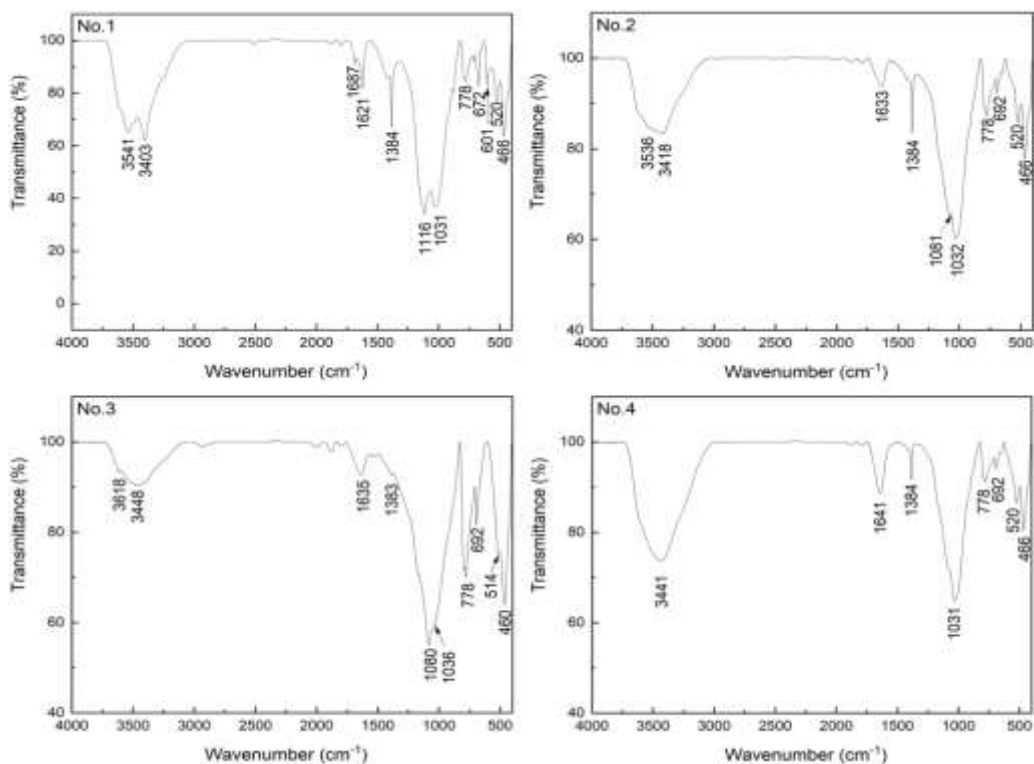
**Fig. 3.** FTIR spectra, the efflorescent sample (No. 1), the exfoliation sample (No. 2), and the repair concrete (No. 3) and the yellow crust (No. 4).

For sample No. 1, the presence of IR absorption peaks at 466, 601, 672, 1116, 1621, 1687, 3403, and 3541 $\text{cm}^{-1}$  are corresponding to gypsum ( $\text{CaSO}_4 \cdot 2\text{H}_2\text{O}$ ). It was shown in sample No. 1–4 that the band at 1031 $\text{cm}^{-1}$  arises from stretching vibrations of silicic acid salts. The 1384 $\text{cm}^{-1}$  sharp band is the fundamental  $\nu_3$  characteristic of alkali and alkaline earth nitrates [23]. For sample No. 3, the peak at 3618 $\text{cm}^{-1}$  is belongs to the OH-stretching vibrations from  $\text{Al}(\text{OH})_3$  groups [24]. The peaks at 778 and 1081 $\text{cm}^{-1}$  detected in samples No. 2 and No. 3 are ascribed to quartz ( $\text{SiO}_2$ ). An intense absorption band located at 1635 $\text{cm}^{-1}$  due to the bending H-O-H of water molecules attributed to the formation of the hydrated silicate. A wide band at around 3436 $\text{cm}^{-1}$  generated by O–H bond stretching vibration associated with the water molecules from the hydrated silicate [25].

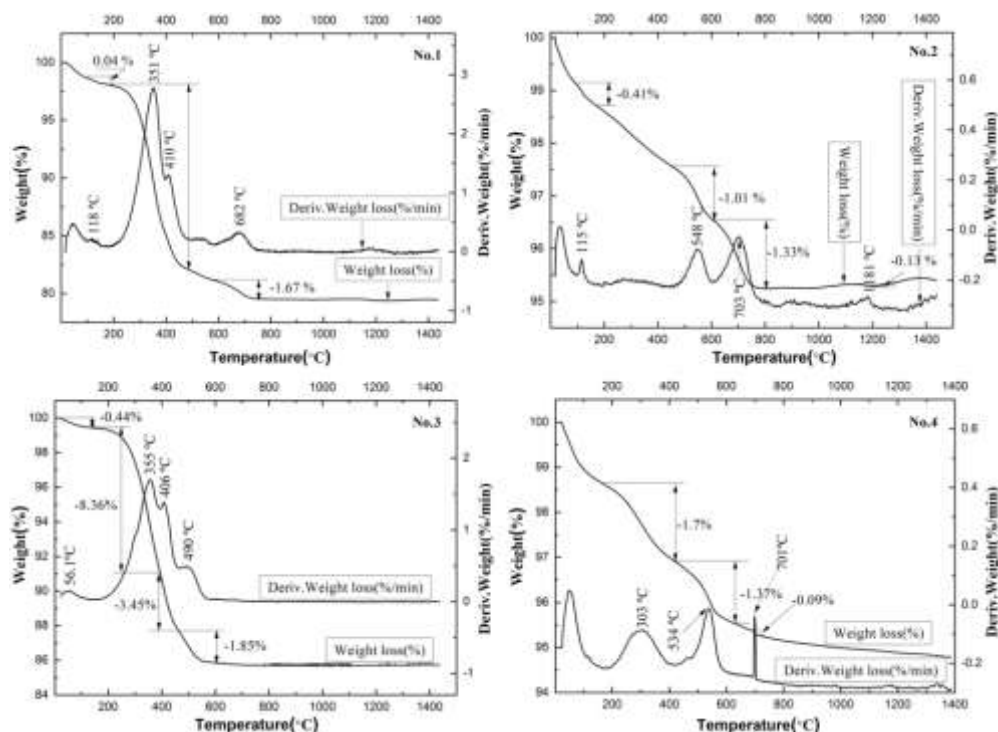
Fig. 4. TG plots of analyzed samples

The TG analysis results of the samples are shown in Figure 4. The variations that occurred at temperatures below 100°C were due to surface-adsorbed H<sub>2</sub>O [26]. Additional gypsum decomposition occurred between 100 and 130°C, with a weight loss of approximately 0.04% in sample No. 1, reaching the maximum decomposition rate at 118°C [27]. The weight loss between 280 and 370°C is related to the deacidification and dehydrogenation of organic components [28]. The small endothermic peak at 410°C reflects the decomposition of silicate [29]. In the region of each of the DTG curves, the weight loss is centred at the temperature interval of 450–600°C. Peaks at 548°C in the sample No. 2, 490°C in the sample No. 3, and 534°C in the sample No. 4 correspond to the dihydroxylation of aluminosilicate, such as Muscovite [KAl<sub>2</sub>Si<sub>3</sub>AlO<sub>10</sub>(OH)<sub>2</sub>]. However, addition peaks at 68°C in the sample No. 1, 703°C in the sample No. 3, and 701°C in the sample No. 4 were detected, which is likely to correspond to a more thermally stable and more ordered polymorph of aluminosilicate [30-32].

In the range 450–750°C of the DTG curves, a dehydroxylation process is observed, hydroxyl groups in the mineral structure of the sandstone were lost as water, and structural water was also lost in the process.

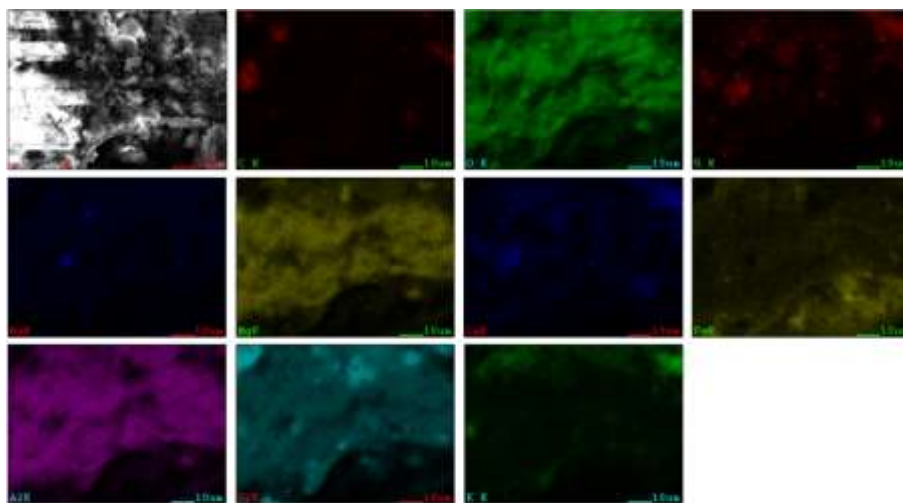
The efflorescent sample is observed on the inside of its right hind calf, where rain can't wash and will accumulate the soluble salts by rainwater infiltration and diffusion. Figure 5 shows the elemental distribution mapping, from which the surface morphology and distribution information of each component can be obtained.

**Fig. 5.** SEM-EDS maps of the efflorescent sample from the right hind calf (No. 1)

It showed that the distribution pattern of Ca was consistent with the distribution pattern of S, corresponding to the existence of  $\text{CaSO}_4$ . The distribution pattern of Si showed that the areas with high Si content are dispersed, which indicates that the salt damage has completely destroyed the body structure of cultural relics.

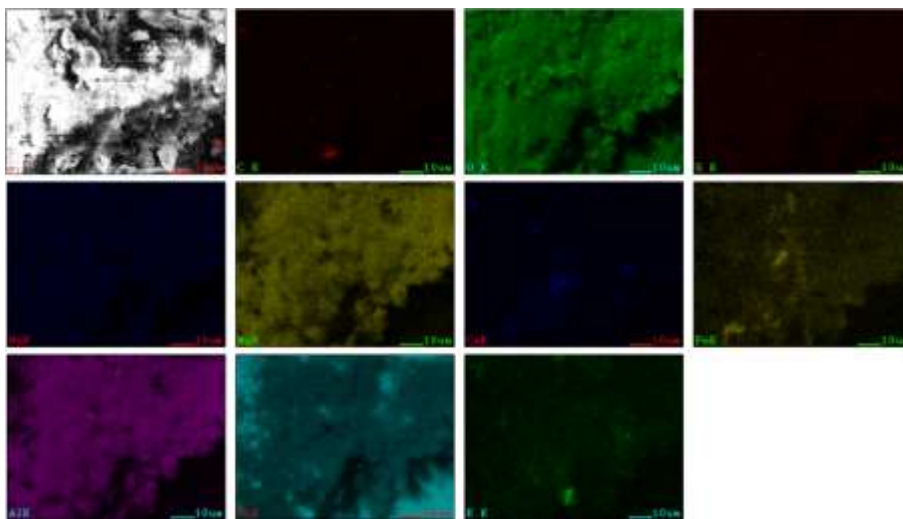
The exfoliated sample was collected from the platform of Bixie. The SEM-EDS elemental distribution maps of sample No. 2 are shown in Figure 6.

**Fig. 6.** SEM-EDS maps of the exfoliated sample from the platform (No. 2)

It showed that the distribution patterns of C and S are relatively uniform, which reflected that the salt has not formed a bigger aggregate. And the area with a high content of Si became tiny. The distribution of high-content Al and Si elements is characterised by a regional surface, and there are many fine holes among the particles, showing loose microstructure.

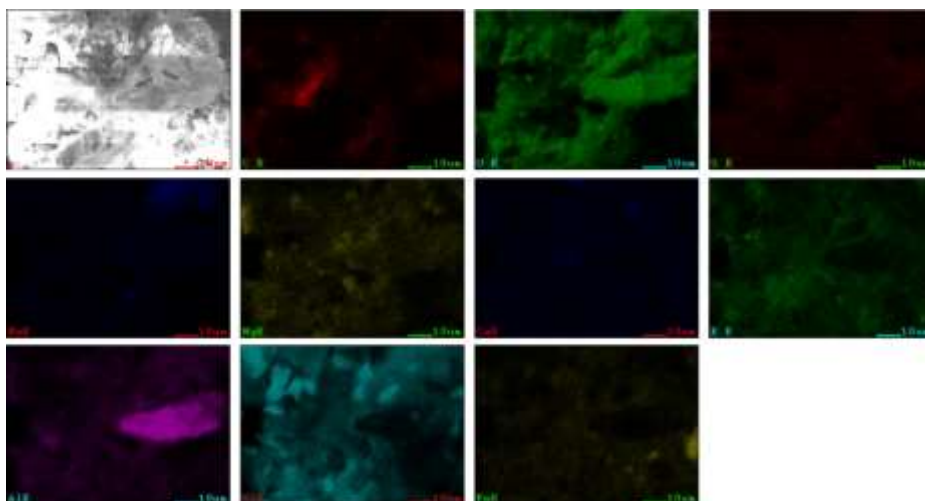
The repair concrete sample was collected from the neck of the Bixie. The SEM-EDS elemental distribution maps of sample No. 3 are shown in Figure 7.

**Fig. 7.** SEM-EDS maps of the repaired concrete (No. 3)

It indicated that the sample had a porous stacking structure. The distribution of Al in large areas was related to the aluminate in cement. The cement is mainly composed of  $\text{CaO}\cdot\text{SiO}_2\cdot\text{Al}_2\text{O}_3$  and  $\text{Fe}_2\text{O}_3$ . The  $\text{CaO}\cdot\text{SiO}_2\cdot\text{Al}_2\text{O}_3$  and  $\text{Fe}_2\text{O}_3$  in clinker do not exist as separate oxides but as aggregates of various minerals formed by two or more oxides through high-temperature chemical reactions. They are mainly tricalcium silicate ( $3\text{CaO}\cdot\text{SiO}_2$ ), dicalcium silicate ( $2\text{CaO}\cdot\text{SiO}_2$ ), Tricalcium aluminate ( $3\text{CaO}\cdot\text{Al}_2\text{O}_3$ ), and tetracalcium ferroaluminate ( $4\text{CaO}\cdot\text{Al}_2\text{O}_3\cdot\text{Fe}_2\text{O}_3$ ). Usually, the content of tricalcium silicate and dicalcium silicate in clinker is about 75%, and the theoretical content of tricalcium aluminate and tetracalcium ferroaluminate accounts for about 22%.

$\text{Fe}_4(\text{SO}_4)_6\cdot 15\text{H}_2\text{O}$  was the coloured substance of the yellow crust from the mouth, which caused the stone carving surface to turn yellow. Cement is easy to deteriorate due to carbonization and corrosion of gypsum in outdoor environments, so it is not suitable to be used as a cultural relic repair material and should be replaced in the follow-up repair.

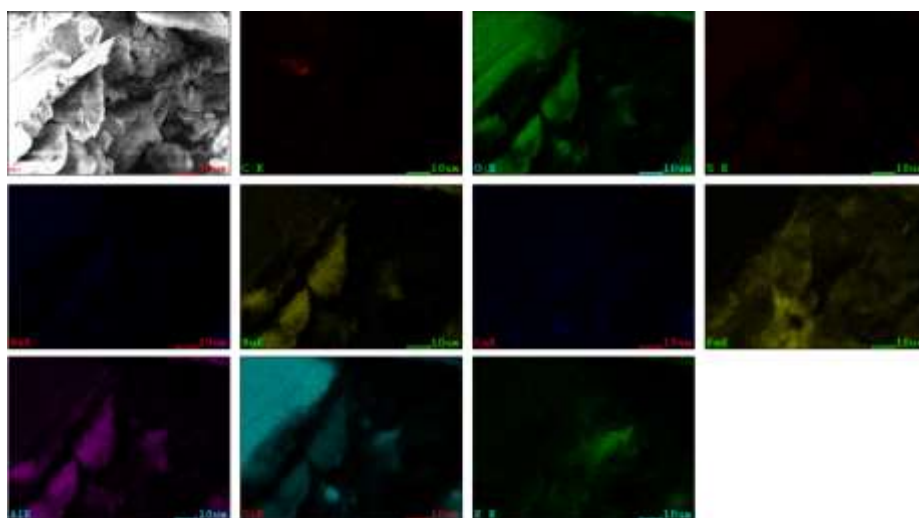
The yellow crust sample was collected from the mouth of the Bixie. The SEM-EDS elemental distribution maps of sample No. 4 are shown in Figure 8.

**Fig. 8.** SEM-EDS maps of the yellow crust from the mouth (No. 4)

It indicated that the sample is mainly composed of Si, O, and Al with a multi-layer flake crystal accumulation structure. This morphology is significantly different from the granular sandstone body, which is likely due to the crusty material formed by water-soluble silicate. The distribution patterns of O, Si, Mg, and Al are similar, while the distribution pattern of Fe, which is distributed outside the areas of O, Si, Mg, and Al, is obviously different. Fe is an important element for the colour of yellow crusts.

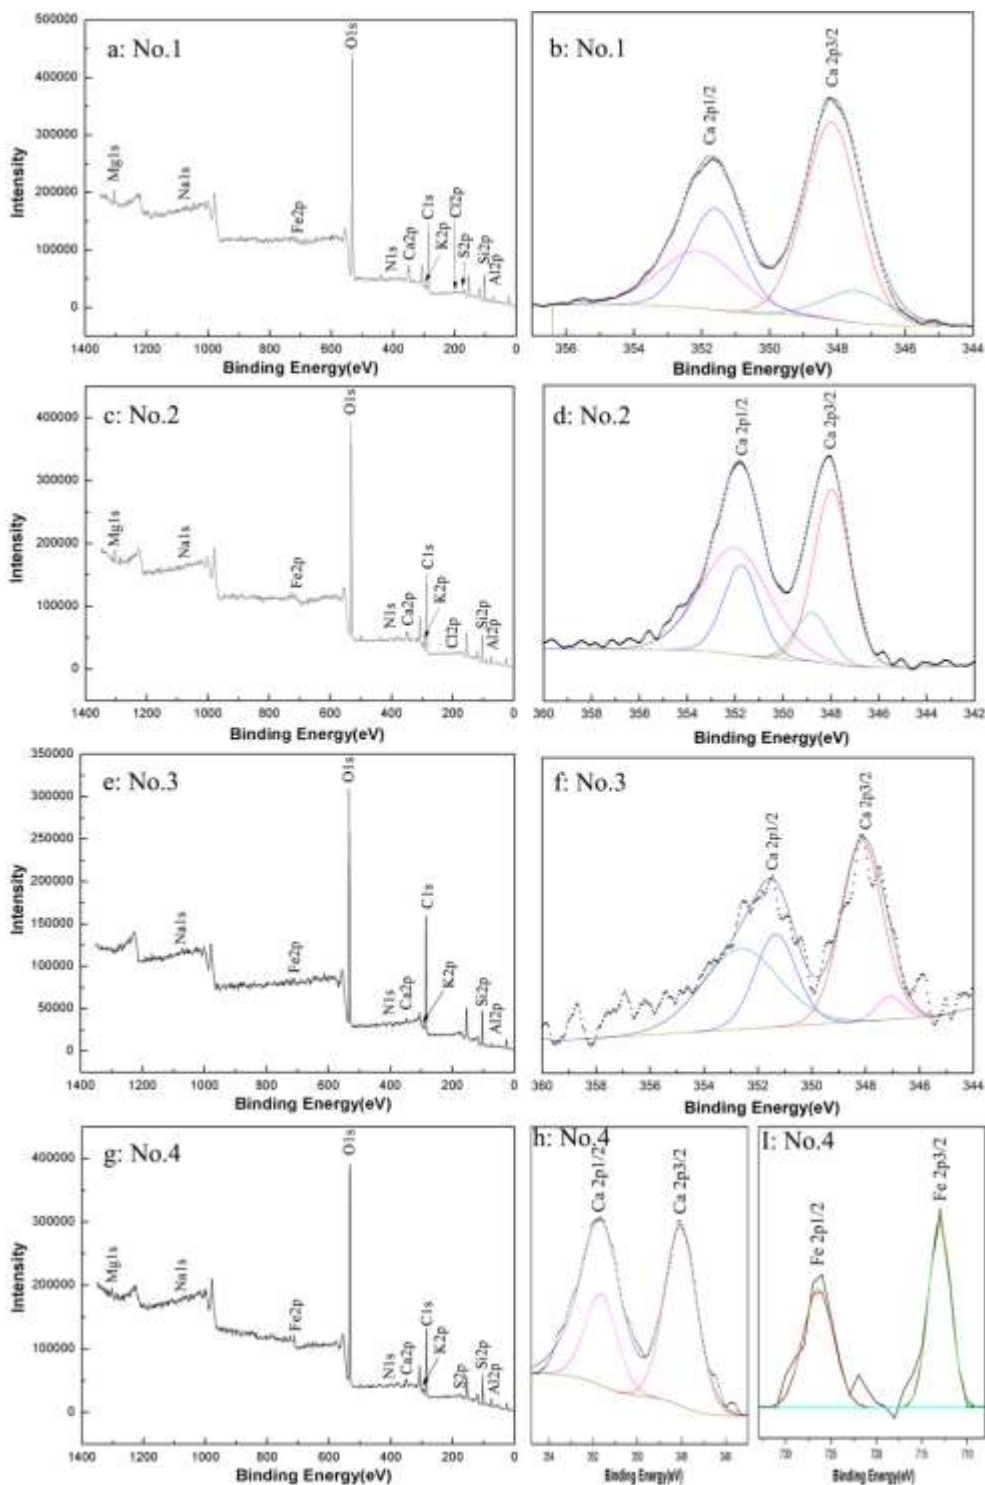
Figure 9 shows the XPS survey scans and the atomic concentration was listed in Table 4. These samples were very similar in atomic composition, the Si 2p peak at energy binding of 102.85eV, assigned to SiO<sub>2</sub> and the O 1s spectrum has a main component at approximately 532.02eV, which includes the contribution of SO<sub>3</sub><sup>2-</sup>, SO<sub>4</sub><sup>2-</sup> and OH<sup>-</sup> ions. For the No.1, a weak peak at 407.37eV is related to nitrates. The binding energy for the S 2p peak at 169.3eV belongs to SO<sub>4</sub><sup>2-</sup> and the Ca 2p<sub>3/2</sub> peak was observed at 347.8eV assigning to gypsum (CaSO<sub>4</sub>•2H<sub>2</sub>O) [33, 34].

The components of the exfoliated sample No. 2 are similar to those shown in No. 1, but the atomic concentration of S and Ca is lower than that of No. 1, while the atomic content of N and Cl is higher. A weak peak at approximately 197.77eV is related to chloride. The N 1s peak at approximately 400eV corresponds to organic components containing N due to air pollution. For the repair concrete sample, the peak at 74.25eV is attributed to Al 2p<sub>3/2</sub>, and O 1s was also detected at 532.17eV, indicating the existence of Al(OH)<sub>3</sub>.

Figure 9 (g, I) shows the XPS spectra of Fe to explore the colour components of the yellow crust. The peak at 169.01eV is due to S 2p<sub>3/2</sub> in Fe<sub>4</sub>(SO<sub>4</sub>)<sub>6</sub>•15H<sub>2</sub>O and Fe 2p<sub>3/2</sub> can also be observed at approximately 713eV [35].

**Fig. 9.** XPS survey spectra of No. 1, No. 2, No. 3, and No. 4, and XPS spectra of Ca 2p and Fe 2p.
