CONDITION SURVEY AND RECOMMENDATIONS REGARDING THE REPAIR OF THE FACADES OF THE HISTORICAL BUILDING IN THE BESARABSKYI QUARTER IN KYIV

The article describes the work carried out during 2021 – 2022 on the condition survey of building facades in the so-called historical Bessarabian quarter in Kyiv. The purpose of the survey is to identify defects and damage that were acquired during the operation of the facades and can reduce their durability. The following methods were used: visual – when determining the technical condition of structures based on external features; analytical – when assessing the technical condition of the surveyed object, instrumental – when studying the physical and mechanical indicators of structures. Based on the received survey data, recommendations were formulated regarding the facade restoration technology. It is recommended to focus specifically on the method of dismantling the existing decorative layers of the facade and replacing them with new ones. This approach will maximally extend the service life of the facade of the historic building.

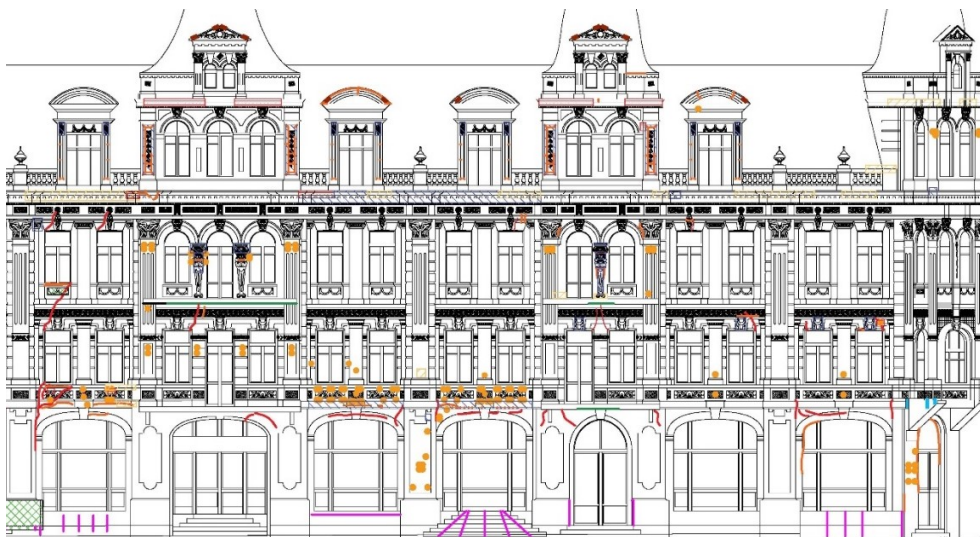
The condition of the structures was determined by visual and instrumental inspection, taking into account the defects and damage (Figs. 5 and 6) that were detected during the visual inspection, as well as their quantitative and qualitative indicators, as well as the physical and mechanical characteristics of the structures under inspection. Thus, it can be stated that the examined part of the walls of the facades of building 1-3/2 at the corner of Velyka Vasylkivska and Basseina streets in Kyiv can be classified as technical condition 3 – unsuitable for normal operation.

Fig. 5. A fragment of the facade of the building with applied defects and damage.

In case of local restoration of defects and damages, obvious defects and damages that can be seen visually on the facade are subject to restoration (Figs. 5 and 6).

It is recommended to repair the force cracks of the facade by "stitching" them. This is achieved by inserting high-strength steel rods into the body of the structure, perpendicular to the

Damaged areas of the facade decoration must be removed, after which a new decoration layer of plaster should be placed in their place. In order for the color and texture of the plaster to match the appearance of the main part of the facade, it is planned to paint the plaster with the subsequent application of imitation brickwork seams.

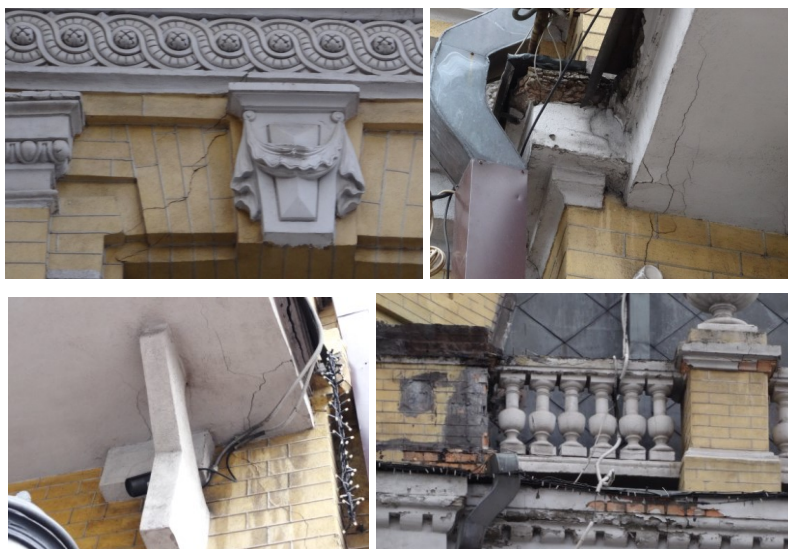
Fig. 6. Typical facade damages. Photos by Oleksandr Molodid, 2021
