## PRELIMINARY DIAGNOSTIC SURVEY OF DETERIORATED PAINT LAYERS AT THE MARITIME STATION OF ROCHA DO CONDE DE ÓBIDOS, LISBON: A MULTIANALYTICAL RESEARCH

*This paper reports the preliminary diagnostic survey of the six controversial mural paintings painted in 1946–49 at the Maritime Station of Rocha do Conde de Óbidos in Lisbon, considered the artistic epitome of Almada Negreiros mural painting art. Four research questions drove this research: a) What are the main decay phenomena present and their sources? b) Which are the paint layers most affected, and are they linked to a particular pigment? c) Is there any relation between the painting technique used and the deterioration or stability of the paint layers and pigments? And finally, d) Are there differences in the decay phenomena present in both maritime stations of Alcântara? The analytical setup comprised in-situ and laboratory analysis by way of technical photography documentation (TP), handled optical microscopy (h-OM), handheld X-Ray Fluorescence (XRF), complemented by optical microscopy of microfragments and cross sections (OM-Vis-UV), X-Ray Diffraction (XRD), and Scanning Electron Microscopy coupled with Energy Dispersive Spe

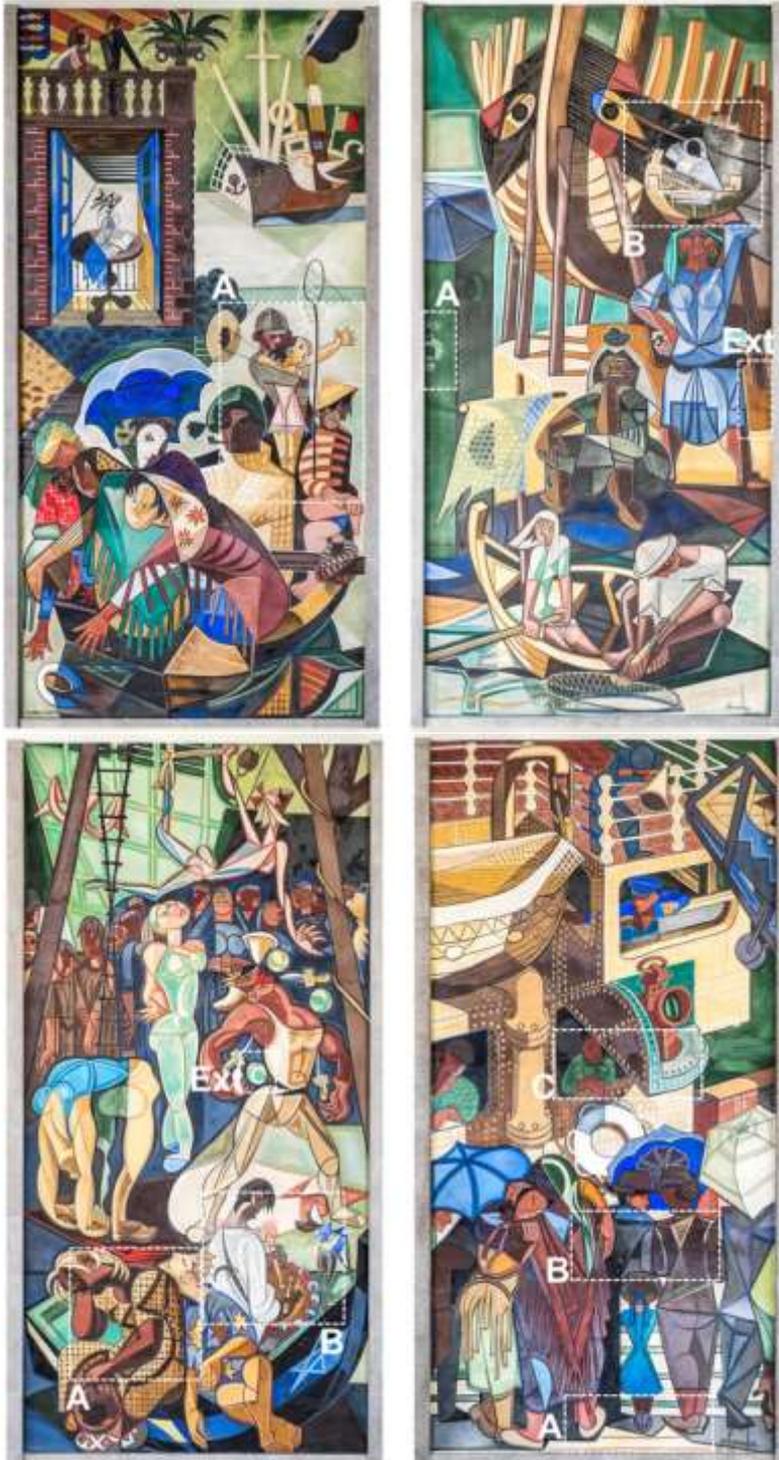
The mural paintings of the Maritime Station of Rocha do Conde de Óbidos, with dimensions of 720×380cm, consist of six murals, three on opposing sides of the room facing each other, both sets depicting riverfront scenes. The three paintings on the west wall (P1 to P3) are entitled *Sunday outing on the Tagus; Fishwives, and fishermen; jugglers and acrobats at the docks*. The other three on the east wall (P4 to P6) form a triptych commonly known as *Departure of the emigrants* [2, 4]. All are classified as frescos by art historians and have been extensively discussed considering their iconography and importance in modern art history, but no data was found concerning their materiality or painting techniques [2, 4–7]. The research undertaken focuses on the mural paintings referred to as P1, P2, P3, and P4, selected as representative of the entire set after a first visual inspection carried out in January 2021 (Fig. 1).

**Fig. 1.** From left to right, overview of the mural paintings 1, 2, 3, and 4 with approx. 720×380cm. The ten of paint layers analyzed by the analytical setup are indicated by the white squares (photos by CML-José Vicente 2013)

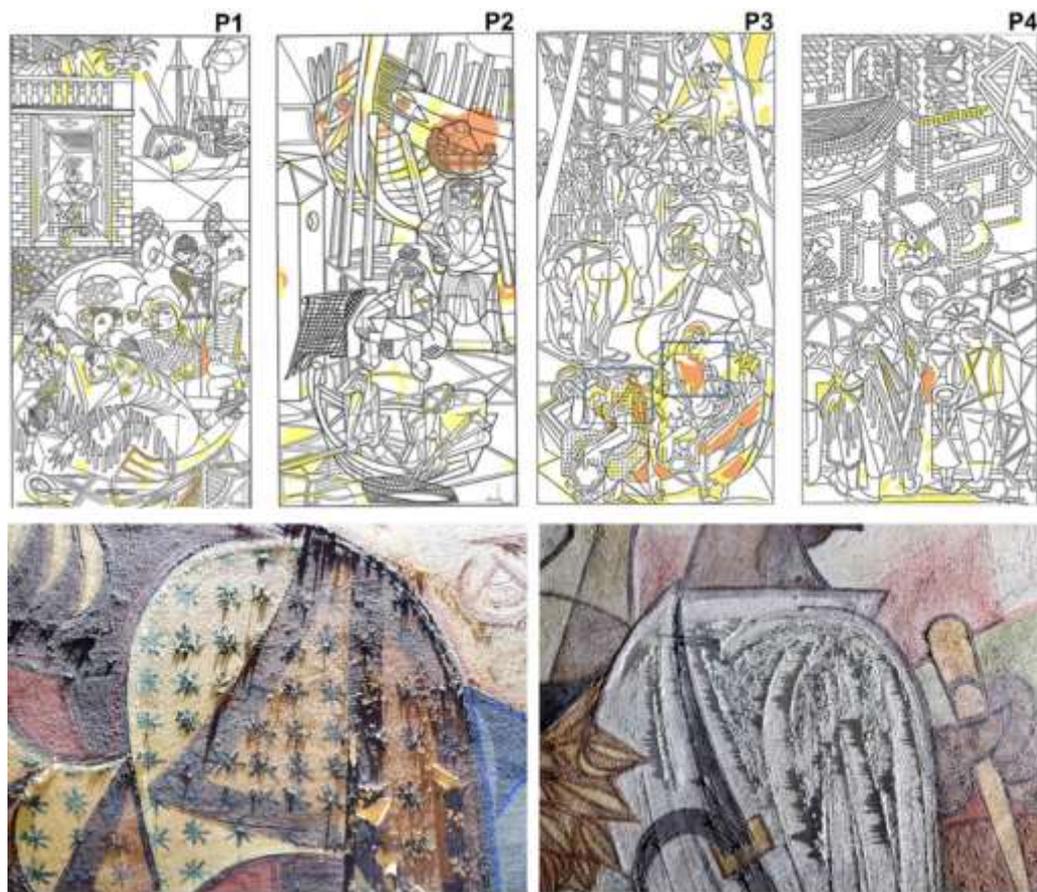
The main deterioration feature noticed in the four paintings under study by Vis and Vis-Rak is the flaking of paint layers, in several degrees of severity, which has contributed to paint

loss over the years. Powdering of paint layers was also noticed, but to a lesser extent and often associated with flaking. The colours most affected are the yellows and browns, the blacks, and the light greens in all murals. The flaking is particularly severe in P2 and 3 of the west walls, showing large areas of decay, as illustrated in figure 2. Three hypotheses were raised regarding the causes of decay: (a) the painting materials and painting techniques used by the artist; (b) the presence and activity of salts; and (c) past intervention products. The following sections address each of these hypotheses individually, although they can all be interconnected and act simultaneously.

**Fig. 2.** On the top, graphic map of deteriorated paint layers on P1, P2, P3, and P4, with the indication of the levels of decay observed in April 2022 (light to moderate in yellow and severe in orange). On the bottom, two details in Vis-Rak of paint layers on P3 with severe flaking and imminent risk of paint loss. Powdering is also observed in the same areas. (Graphic documentation by K. Rix and photos by M. Ribeiro 2022)

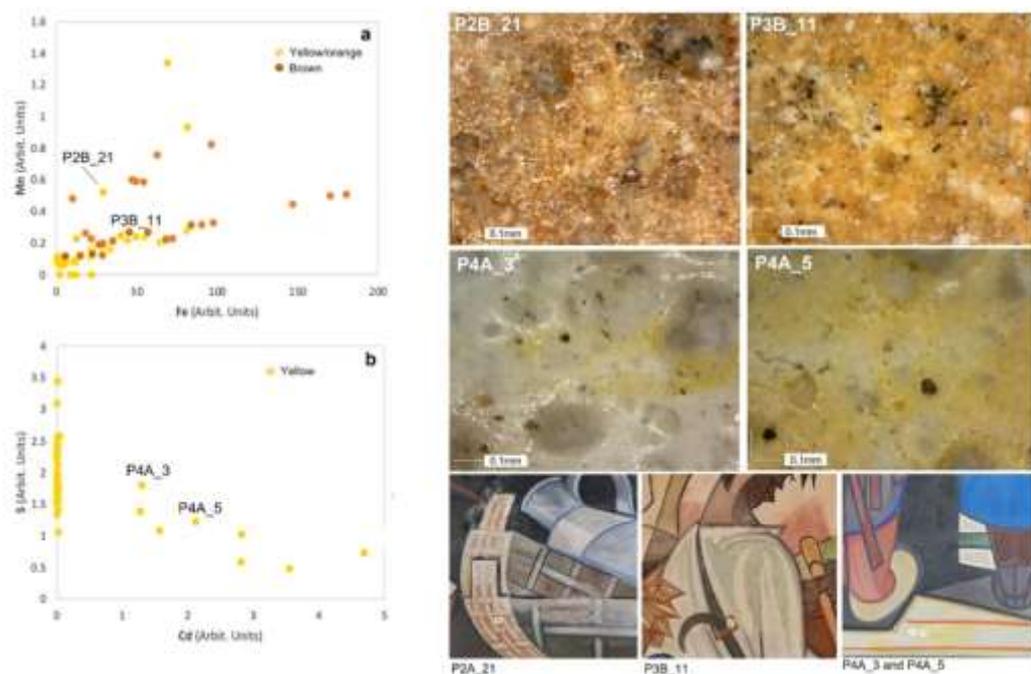
On the yellow and brown paint layers, iron (Fe) was the main chromophore found, along with smaller amounts of manganese (Mn) (Fig. 3a). The Fe and Fe-Mn-based pigments are likely

yellow ochres and brown earth pigments, with the brownish shades tending to have more manganese oxide ( $\text{MnO}_2$ ) in the composition (ex. P2B\_21 and P3B\_11 of Fig. 3a).

**Fig. 3.** On the left, an XRF Mn-Fe and S-Cd biplot; on the right, h-OM image details at 435x of yellow and brownish paint layers from P2, P3, and P4, in which the analyses P2B\_21, P3B\_11, P4A\_3, and P4A\_5 were carried out

In addition to Fe-based pigments, XRF also allowed the identification of cadmium (Cd) and sulphur (S)-based pigments in the bright yellow paint layers of P3 and P4 (Fig. 3b). These showed slight pigment powdering, and in two cases, it is suspected that they have undergone a chromatic alteration (ex. the variations found on P4A\_3 and P4A\_5 analysis and h-OM from the same paint area). Cadmium pigments are modern synthetic pigments that began to be produced on a wide scale in the mid-19<sup>th</sup> century [11]. The use of yellow cadmium pigments in the early 20<sup>th</sup> century, as opposed to earth pigments, was controversial for fresco painting since the alkaline environment could cause colour fading [11]. According to Fiedler (1986), this effect was due to the presence of cadmium oxalate and carbonate, as well as free sulphur, in a cadmium sulphide composition [11]. The use of CdS pigments in mural paintings by Almada Negreiros has already been reported, but so far, no evidence of fading has been noticed. This is the first time that this hypothesis has been raised [3, 12].

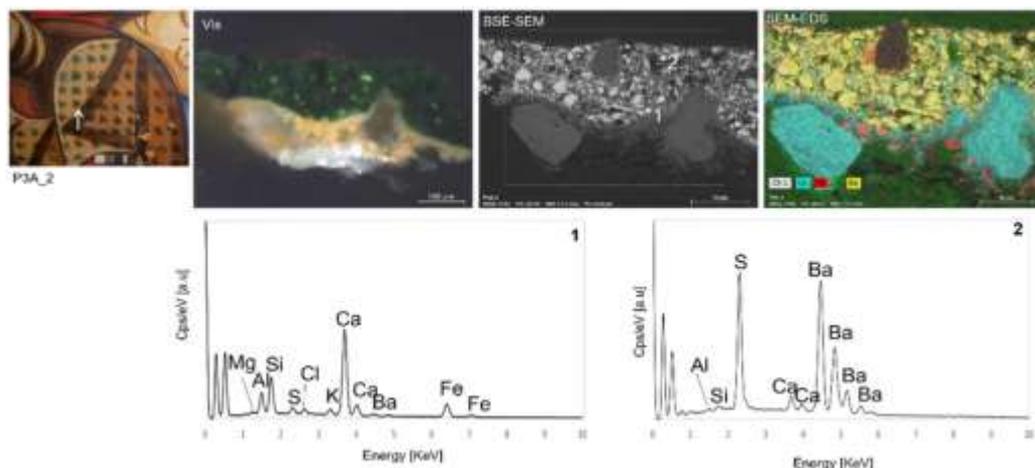
**Fig. 4.** On the top, from left to right, are the sampling location of sample P3A\_2; OM-Vis of the P3A\_2 cross section; SEM-BSE image, and the SEM-EDS elemental distribution map of calcium (blue), iron (red), carbon (green), and barium (yellow). On the bottom are the EDS spectra of a yellow particle (1) and of the green matrix (2)

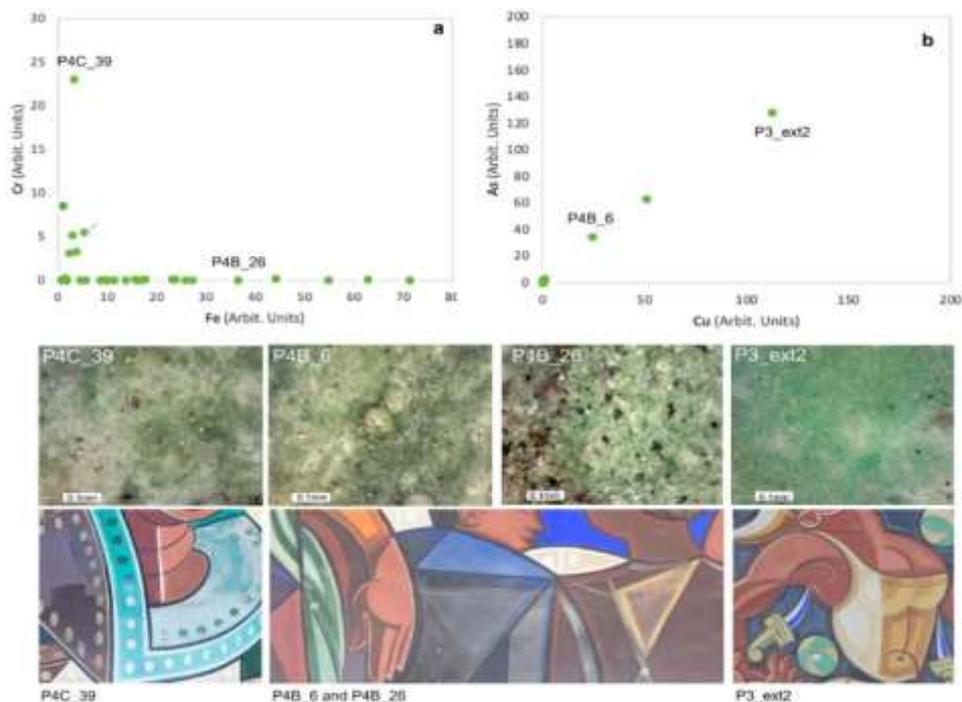
In the green paint layers analysed by h-EDRFXF, the main element identified as a chromophore is also Fe (Fig. 5a). Barium (Ba) and sulphur (S) were also detected in significant amounts in most paint layers, but their presence is most likely related to barium sulphate added as filler to the green pigments, as shown by the SEM-EDS of the coarse grains of Ba on the dark green paint layer in figure 5. The presence of barite ( $\text{BaSO}_4$ ) was also confirmed by  $\mu$ -XRD on another microsample collected from a bright green background of P2 (P2A\_2 from Table 1).

**Fig. 5.** On the top, the XRF Cr-Fe and As-Cu biplot; on the bottom, the location of the analysis carried out (white squares) and h-OM image details at 435x of green paint layers P4C\_39, P4B\_26, P4B\_6, and P3\_ext2 from P4C, B, and P3. On all the paint surfaces, not only the green as the top layer is perceived but also the underlayers of white, brown, and yellowish hues

In figure 5a, the high amount of chromium (Cr) in six green paint layers suggests the presence of another green chromophore. Cr is identified in higher amounts in bright green particles such as the ones in P1A\_2 of figure 6, and it is likely related to synthetic chromium oxide ( $Cr_2O_3$ ) or hydrated chromium oxide ( $Cr_2O_3 \cdot 2H_2O$ ) which have been available as artist pigments since the 19<sup>th</sup> century [14]. In addition to Fig. 5b, it was also found by XRF that high

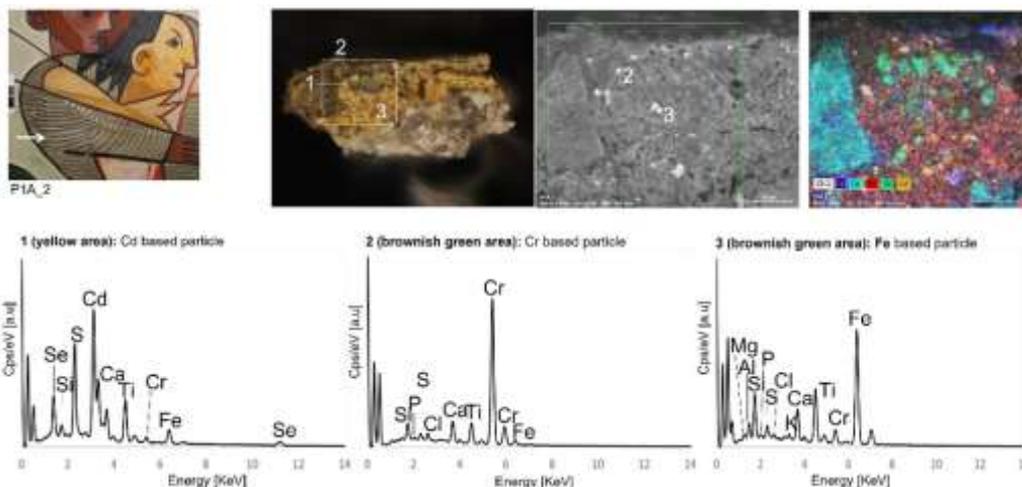
Iron is found in most paint layers with other elements in small or trace amounts, such as K, Al, Cl, Mn, Mg, and Si. The high Fe input can be related to: a) Fe-based green pigments, such as green earths [13], or potentially to Fe-organic synthetic modern pigments such as PG8, or PG1, recently identified at the Maritime station of Alcântara [3]; b) other Fe-brown, red chromophores in mixtures with the greens, or from paint underlayers, as found by SEM-EDS in the cross section of figure 6 or by h-OM in the paint surfaces of figure 4.

**Fig. 6.** On the top, sampling location of the brownish green paint layer P1A\_2; OM-VIS light of P1A 2 cross section; BSE-SEM image and SEM-EDS sulfur (dark blue), calcium (light blue), iron (red), chromium (green), Cadmium (yellow) elemental maps. On the bottom, EDS spectra of Cd, Cr and Fe based pigment particles

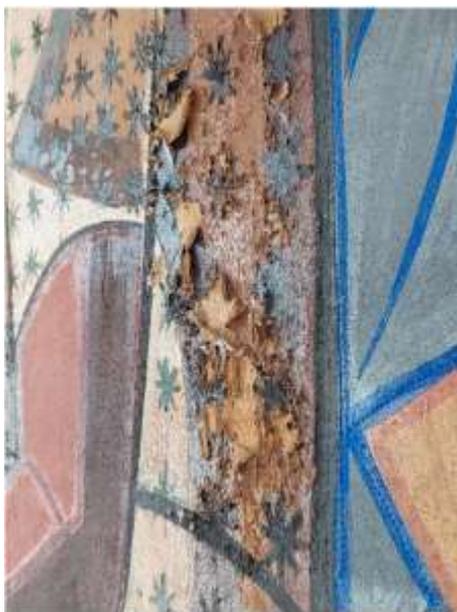
*Painting Technique.* During the on-site examination, it was noted that the most deteriorated paint layers exhibited a glossy surface, as shown in figure 7. Traditionally, mural paintings rendered in a fresco technique are matte, and all the paintings at the maritime station of Rocha do Conde de Óbidos are classified as such [1].

The gloss is clearly perceived by h-OM in areas of flaking but also in paint layers of the same color around it, in better condition. It is known that most of the paintings have been restored in the past and that adhesives were applied. Could this glossiness be related to past intervention products, or is it somewhat related to the painting technique (or to paint coatings) used originally by Almada?

**Fig. 7.** Detail of flaking paint layers with gloss on P3 (photo by M. Gil 2022. Project Almada)

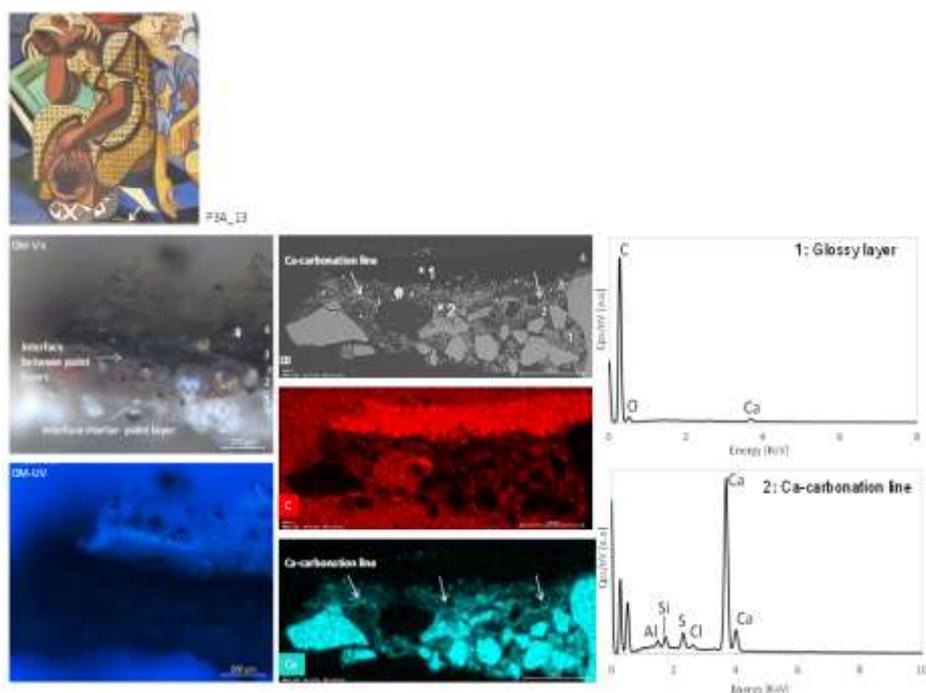
In order to understand whether the glow was restricted to the paint surface or if it was within the paint layer itself, cross sections of some of the microsamples collected from these areas were prepared and visualized by OM in the visible range (Vis) and by ultraviolet radiation (UV). One example collected from a black glossy paint layer on P3 is shown in figure 8. On the cross section obtained, four layers are perceived in the visible range. The first, a white inner layer, corresponds to the mortar used as pictorial support; the 2<sup>nd</sup> and 3<sup>rd</sup> are two overlaid paint layers of grey and black hues, respectively; and the 4<sup>th</sup> is a translucent layer on the surface (Fig. 8). This

layer, which is approximately 152 $\mu\text{m}$  thick, displays a whitish fluorescence in UV mode. This layer is confined to the surface; the two paint underlayers do not exhibit a UV response.

To ascertain the painting technique used by Almada, further analysis was carried out on this microsample by VP-SEM-EDS. By EDS, the high amount of carbon (C) and its widespread distribution on the surface confirmed the organic nature of the glossy layer, whereas the presence of calcium (Ca) and its elemental map distribution suggest a lime-based painting technique on the underneath black and grey paint layers (Fig. 8). On the SEM-BSE image, the absence of a Ca-carbonation line at the interface of the mortar and the grey paint layer reveals a fresco execution. Yet, its presence at the interface of the two paint layers may indicate that Almada has laid down the black paint when the previous one has already dried (Fig. 8). The application of additional paint layers at a later stage may imply the use of *secco* painting techniques with pigments mixed with lime (lime painting) or with an organic material. The presence of Ca in the matrix of both paint layers in figure 8 suggests that lime was a binder in both cases. However, the additional use of organic binders in this sample and in the others collected from deteriorated paint layers cannot be completely excluded and should be further explored by other analytical techniques.

**Fig.8.** On the left, the sampling location of P3A\_13; OM-Vis-UV of P3A\_13 cross section with the indication of the 4 layers found. On the middle and right, VP-SEM-EDS analysis with the location of the thin carbonation layer at the interface between layer 2 and 3

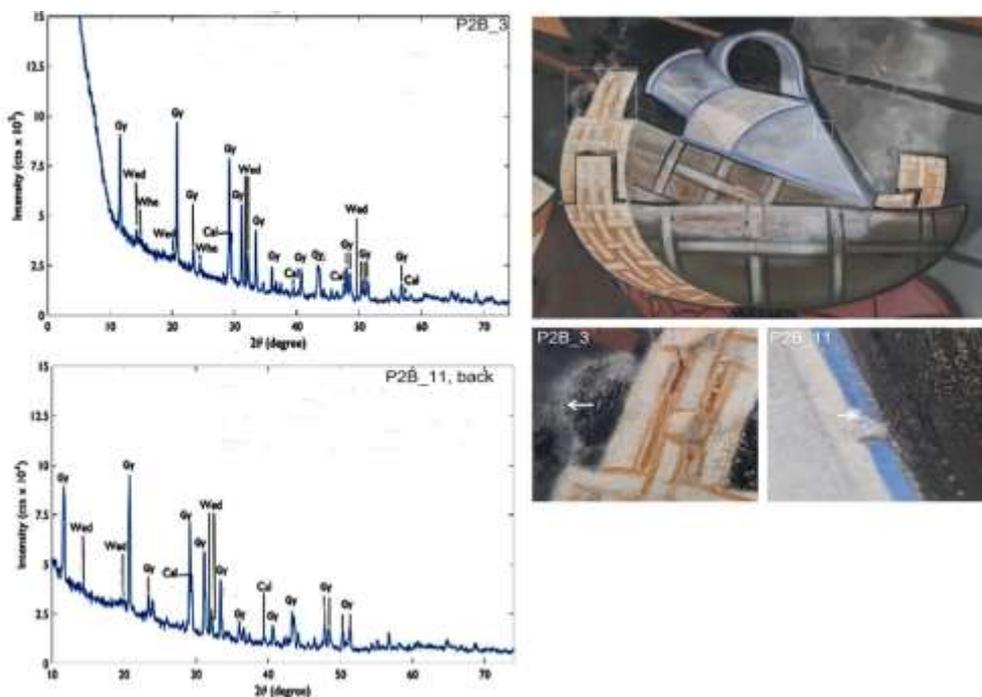
Gypsum, a hydrated calcium sulphate, was found in most of the analyses carried out (Table 1, Fig. 9). No other sulphates were identified from the list already reported in 2021 by *M. Gil et al.* [3]. The salts in the Alcântara murals include thenardite ( $\text{Na}_2\text{SO}_4$ ), syngenite ( $\text{K}_2\text{Ca}(\text{SO}_4)_2 \cdot \text{H}_2\text{O}$ ), apthitalite ( $\text{K}_3\text{Na}(\text{SO}_4)_2$ ), and anhydrite ( $\text{CaSO}_4$ ), in addition to calcite and gypsum. These salts were not identified at Rocha do Conde de Óbidos, possibly due to the amount sampled being below the limit of detection of the  $\mu$ -XRD.

**Fig. 9.** On the right, the sampling locations of microsamples P2\_B3 and P2B\_11, back collected from P2, are most affected by water infiltration. On the left, the corresponding  $\mu$ -XRD diffractograms show identified mineralogical phases (Gy – Gypsum, Cal – Calcite, Whe – Whewellite, Wed – Weddellite)

It is known that hydrated calcium sulphate is one of the main and most common salts encountered on carbonated mural paintings [16, 17]. Sulphates are usually found in soils, polluted atmospheres, and sea spray [18–22]. In a building, the formation of sulphates is typically spurred by the wet and dry acid deposition of  $\text{SO}_x$  in conjunction with water infiltration, which prompts the leaching and migration of dissolved ions into the architectural structure [21]. In this research, the presence of gypsum could be anticipated considering that both stations were a) built with the same building materials (which include reinforced cement [7]) and b) only 1.5km apart, and as such, the paintings were exposed over the years to the same weathering environment (proximity of thoroughfare and the river or sea). The activity of soluble salts, such as gypsum, is one of the main causes of flaking (and powdering) of the paint layers due to the gradually disruptive cycles of crystallisation and dissolution within a porous material.

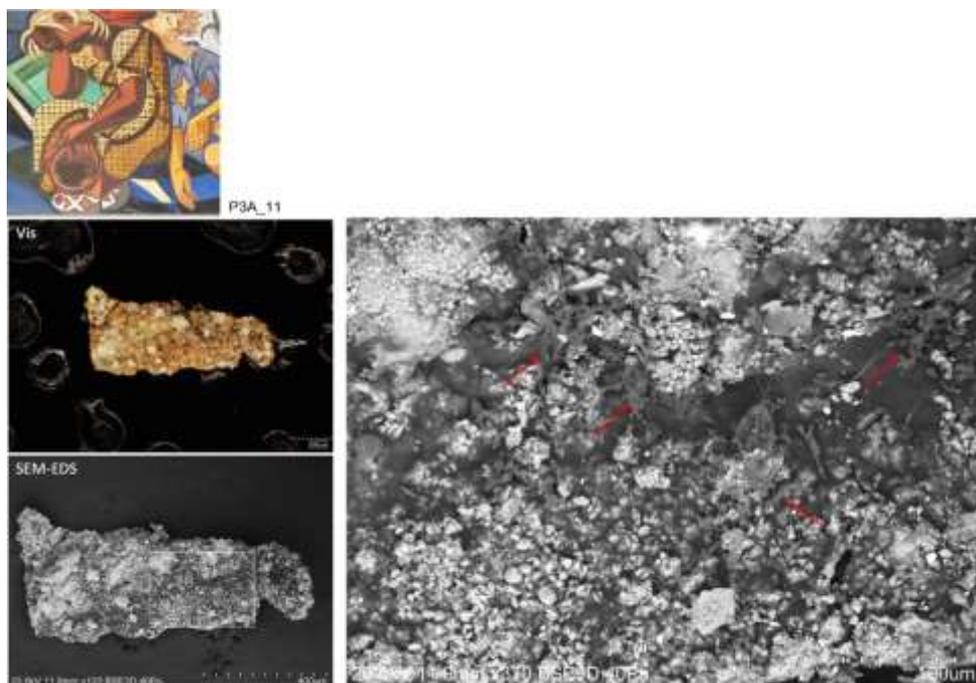
In addition to gypsum, only two other minerals have been identified by  $\mu$ -XRD that may be actively contributing to the deterioration of paint layers. These are the whewellite and weddellite calcium oxalates found on the front and back of samples P2B\_3 and P2B\_11 (Fig. 10, Table 1). The origin of these minerals in the paintings may be related to the deterioration of organic binding media, biological activity and metabolism products, or the oxidation of organic materials applied in past interventions [23]. In figure 10, the presence of bioactivity on the paint surface over the glossy carbon-based layer may suggest a combination of the last two hypotheses.

**Fig. 10.** On the left, OM-VIS (top) and SEM-BSE (below) images of sample P3A\_11 collected from a brownish paint layer on P3. On the right, detail of BSE-SEM image of the paint layer surface, indicating biological colonization over a carbon-based layer (red arrows)

Calcium oxalates are considered to be one of the most common and harmful salt contaminants, leading to powdering of the mortar and flaking of the paint layers [24]. According to *T. Rosado et al.* [24], typically microorganism activity on the surface of a mural painting, like fungi, bacteria, lichen, and algae, can serve as a biological substrate, resulting in the development of calcium oxalates [24]. The metabolism of these microorganisms produces oxalic acid ( $\text{H}_2\text{C}_2\text{O}_4$ ) that reacts with calcite on lime-based murals to form calcium oxalate ( $\text{CaC}_2\text{O}_4$ ) [23, 24]. In the deteriorated paint layers analysed that exhibit a glossy layer at the surface, the presence of microbial activity may be related to the original coatings used by Almada or to adhesives applied to past interventions. The colonisation of microorganisms is known to be supported by organic and inorganic nutrient sources, and a carbon-based layer can act as such [25].

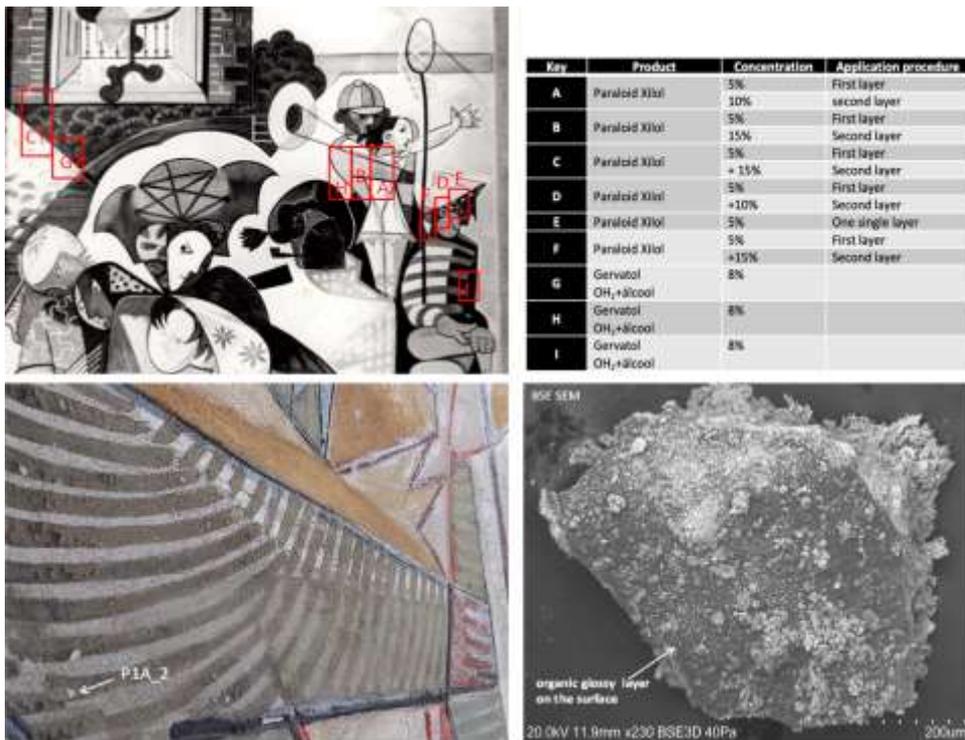
The documentation produced in 1971 and 1995 provides a small amount of context to the past treatments undertaken at Rocha do Conde de Óbidos, and which products used at that time may now be degrading and contributing to the flaking of the original paint materials [26, 27]. The report made in 1971 is particularly important since it specifies the tests made with adhesives on P1 [26] and the location of the different experiments done with Paraloid (the type is not referred to, but it is most likely B72 that was the one most used for this purpose) and Gervatol (Fig. 11). Chemically, Paraloid is an ethyl methacrylate-methyl acrylate copolymer, and Gervatol (or gelvatol) a polyvinyl alcohol. Both were tested in different concentrations diluted in xilol and in water and ethanol, respectively. Paraloid was deposited twice, reaching more than 20% in areas B, C, and F, which may be responsible for the glossy areas observed on-site in April 2022 (Figs. 8, 10 and 11). The results of these experiments are not given, nor is the final product selection, but remnants of adhesive layers are clearly identified in P1 and P2 on deteriorated paint layers.

**Fig. 11.** On top, documentation from 1971 with the indication of adhesive tests carried out on painting 1 (red squares). The letters A to I on the table correspond to the different test locations signaled. Below, on the left, is the location of the microsample collected from a previously consolidated greenish-brown paint layer. On the right, a BSE-SEM image of the surface of the microsample P1A\_2 shows a carbon-based layer on top of the paint layer

Paraloids (in particular B72) are among the most well-known acrylic resins widely used as adhesives and protective coatings in the field of cultural heritage [28, 29]. Paraloids are generally appreciated for their relative stability, reversibility, mechanical resistance, and transparency [29]. But despite their popularity, polymer materials are known to age and deteriorate due to light, heat, acid-base environments, and bioactivity [28]. Moreover, when applied in thick layers, they can produce a hydrophobic barrier that may cause further damage to paint layers affected by moisture and soluble salts. This is the case with the severe flaking paint

layers on P2, where gypsum was identified. The past conservation products applied in this area show a brittle appearance and are peeling together with the paint layer.
