EXTENDED MONITORING AS SUPPORT IN NUMERICAL MODELLING OF COMPLEX HISTORICAL TIMBER STRUCTURE

Zdzisław Mikołaj PAWLAK^{1*}, Piotr MARCINIAK²,
Ireneusz WYCZAŁEK³, Martyna ŻAK-SAWIAK¹

¹ Institute of Structural Analysis, Poznan University of Technology, 60-965 Poznań, Poland

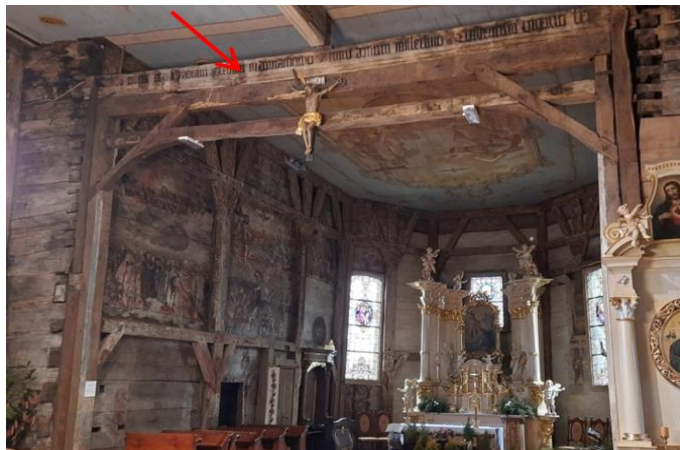
Between these walls, in the middle, there is a rood beam with a span of about 7.7m, which is supported by an additional post and beam system with angle braces (Fig. 3). A ceiling girder, which runs along the nave, rests with one end on the rood beam, in the middle of its span. The second support of the girder is a three-span beam located in the plane where the nave meets the newer, western section of the building. The three-span beam, in turn, rests on the two inner posts and at the ends on the outer walls (Fig. 4).

Fig. 3. View of the rood beam from the nave side

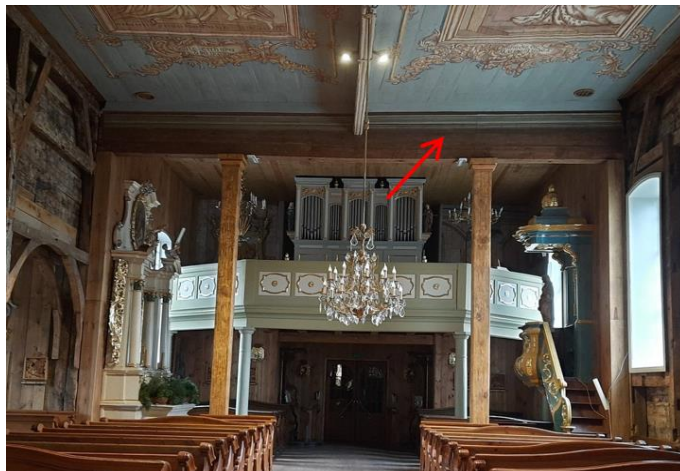
The girder, along with the entire ceiling plane, is lowering towards the west by more than 20cm. A 10.0m high king post truss rests on the side walls, but due to the longer span of the nave in relation to the chancel (Figs. 1 and 5), the inclination angle of the roof slope is slightly different, being about 64 degrees (205%).

Fig. 4. View of the three-span beam supporting the nave girder from the choir section

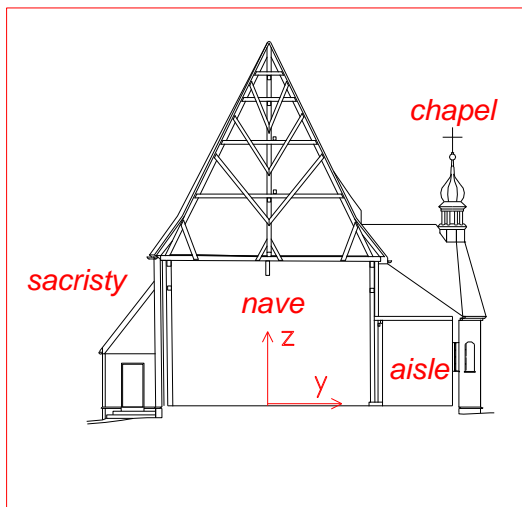
In general, the entire body of the nave tilts to the west, the entire wall panels, beams and columns, as well as the ceiling in whole are turned. The largest displacements are in the chancel, which leans evenly toward the west within a range of about 16 to 21cm. In the

transverse direction, the pillars of the north and south walls have been displaced and these walls lean towards the interior of the church. The deformation probably occurred due to degradation and lowering of the supports on the west side. Since the floor has been levelled and is now horizontal, the walls of the nave at the west end are lower by about 20 cm compared to the east end.

Fig. 5. Cross-section of the nave

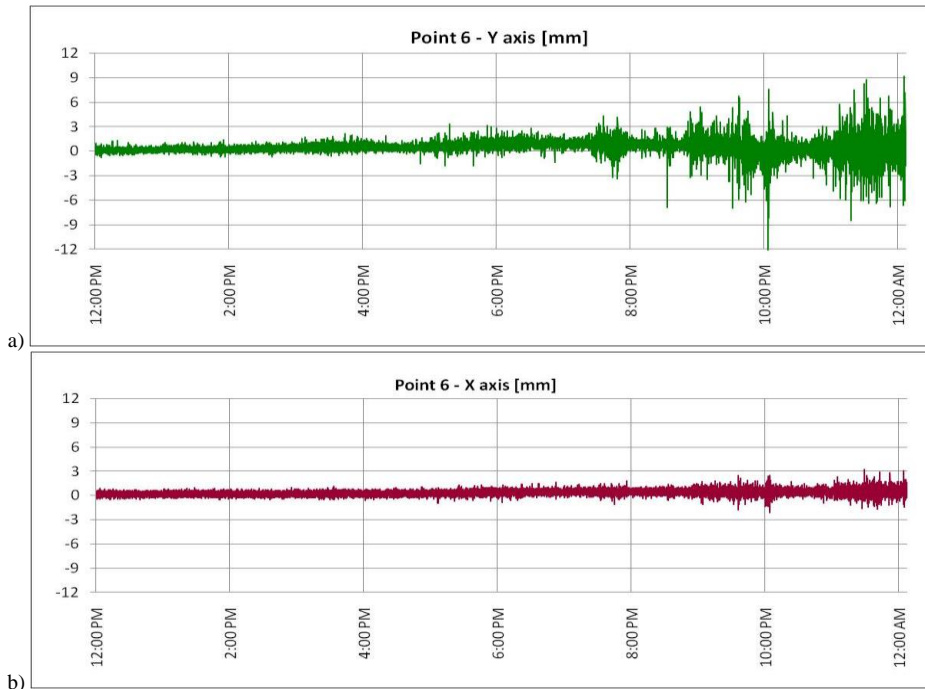
Fig. 8. Diagrams of displacements of the structure at point No. 6 on February 17, 2023 during strong winds: a) across the building, Y axis direction, b) along the building X axis direction.

The diagrams of measured deformations (Figs. 8 and 9) show a significant increase in the values of the displacement across the building (Y axis) in the evening, which, however, did not exceed the value of 12mm. The displacement oscillations were the result of load variation, the wind push was irregular and stronger wind gusts were short-lived, even impulsive. Figure 10 shows the measurements of the average wind speed, its speed during gusts and the mean direction of the measured wind. The measurements come from the weather station situated in the neighbourhood of the building.

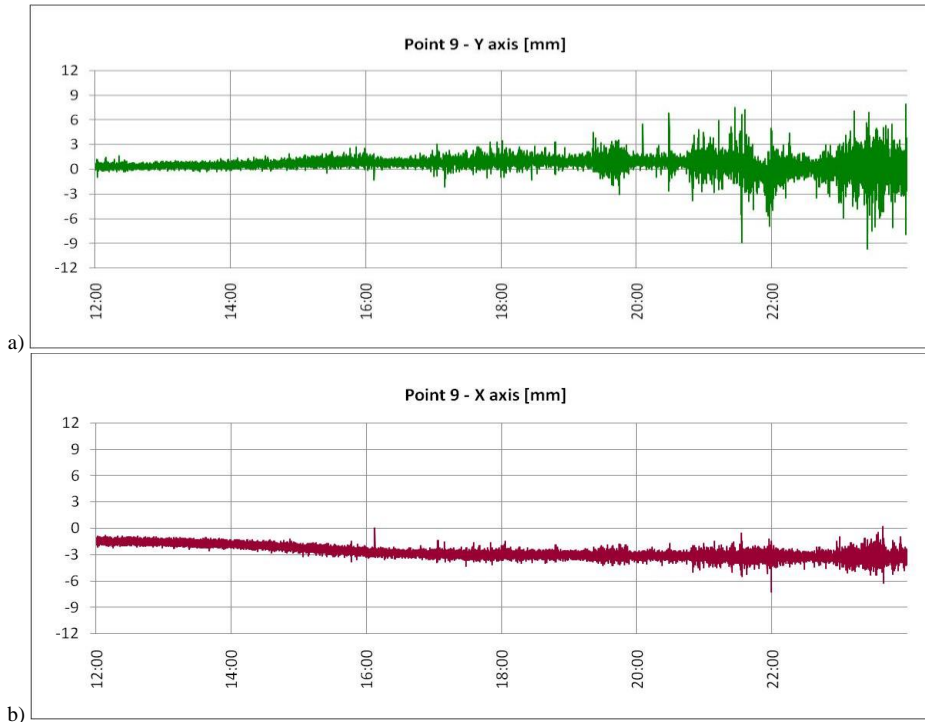
Fig. 9. Diagrams of displacements of the structure at point No. 9 on February 17, 2023 during strong winds: a) across the building, Y axis direction, b) along the building X axis direction

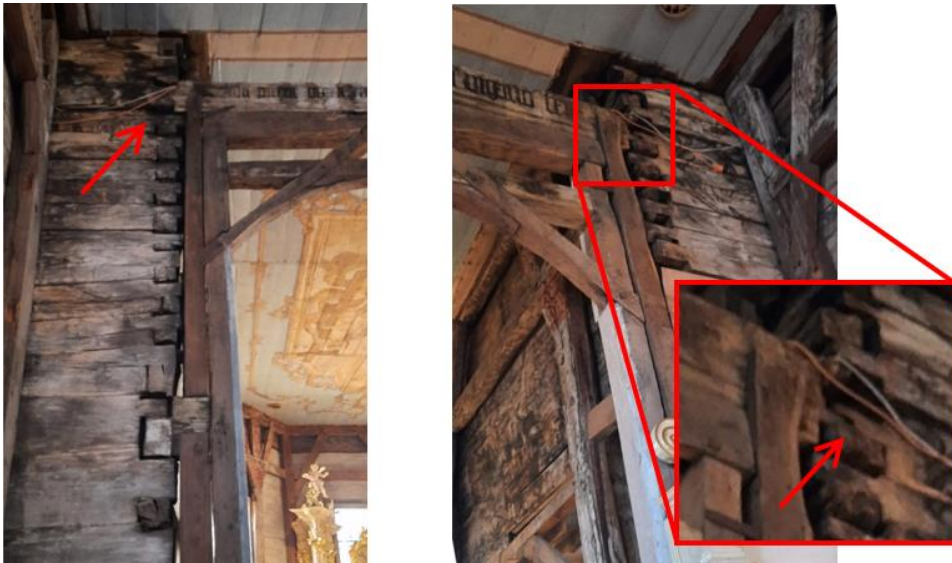
As expected, the stiffening panels have a major impact on the spatial rigidity of the post-and-beam structure. However, based on the above analysis, the authors concluded that the stiffening panels in the short sections of the walls between the nave and the chancel are the most important, as their inclusion in the calculations leads to the greatest reduction in displacements. In the actual construction, these short walls are weakened, at the junction of two perpendicular walls the logs are not well connected, gaps are visible (Fig. 19). This means that the walls are not rigidly connected to each other, the elements can displace independently and the mentioned walls do not act as stiffening panels. Furthermore, the rood beam on the right side, is broken at the notch (a narrowed area), which confirms the supposition that in this plane the structure is not properly stiffened (Fig. 19).

Fig. 19. Fragments of short log walls at the junction between the nave and chancel

Based on the performed measurements and static and dynamic analyses, the authors concluded that the displacements caused by wind are within acceptable values. It was found that if the two short walls between the chancel and nave had more rigidity in the actual structure, the displacement values would have been much smaller. The actual technical condition of these walls is poor and the recorded displacement measurements are close to the results from the numerical model, where these stiffening panels were not taken into account in the calculations. Strengthening the elements of the walls situated at the connection of the nave and the chancel could considerably improve the rigidity of the structure, reducing its deformations and thus making it more resistant to dynamic loads.

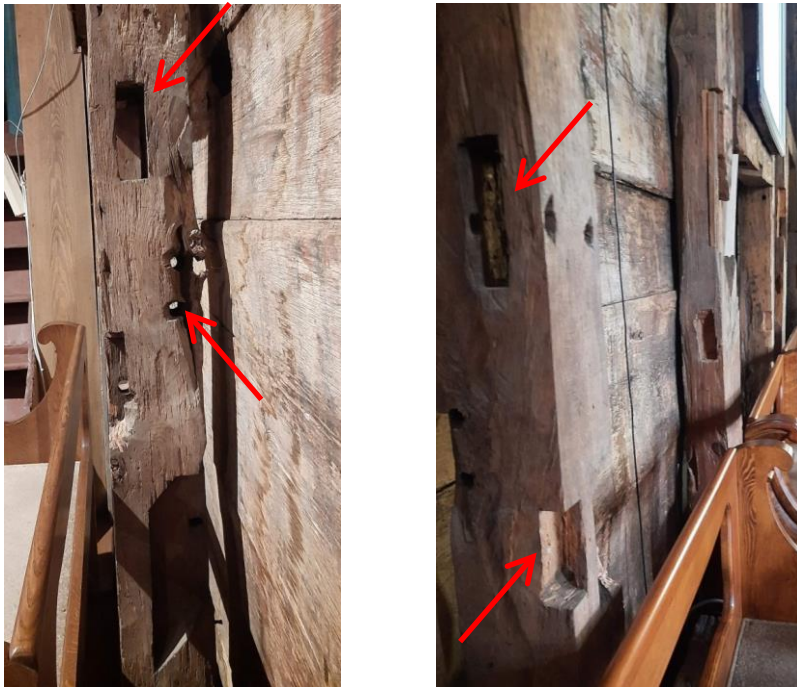
Particularly dangerous in the case of flexural elements are defects in the area of the outermost fibers of the active section, i.e. in areas of extreme normal stresses. A reduction in the cross-sectional area directly affects the load-bearing capacity of the element, but the influence of a weakened element on the stability of the entire structure requires a separate analysis.

Fig. 20. Notches and dowel holes weakening the columns in the north wall of the nave

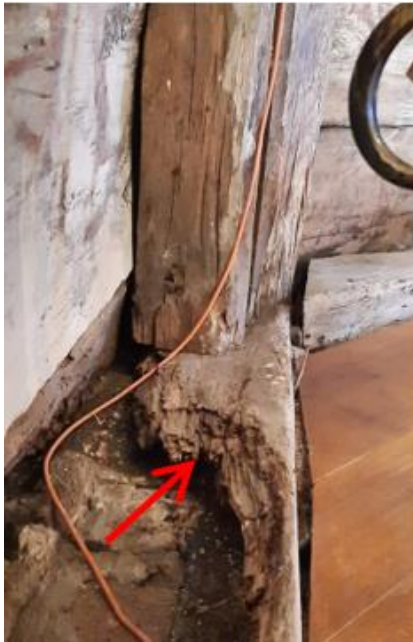
Another important factor that weakens the structure is cavities caused by the biological corrosion of wood. The greatest degradation of wooden elements occurred in the supports of the frame structure. In some places, the sill plate has completely decayed and no longer serves its purpose (Fig. 22).

The degradation of the sill plates and post supports was the likely cause of the whole construction leaning to the west and the reason for the reconstruction of the church in the early 20th century. The corroded bottom parts of some of the posts were cut off and replaced with brick plinths (Fig. 23). In addition, new sill plates were inserted along some of the walls.

Fig. 22. Degraded sill plate in the chancel

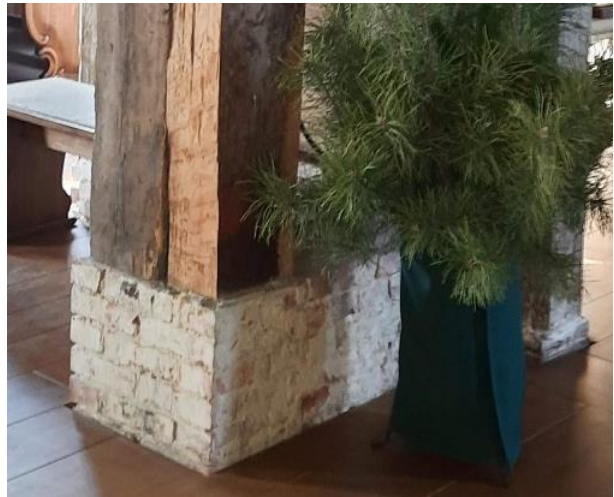
Fig. 23. A multi-branched column set on a brick plinth
