## CHARACTERISTICS OF BUILDING MATERIALS FROM THE ROOMS OF BARRACK NO. 41 AND THE GAS CHAMBER BUNKER OF THE MAJDANEK EXTERMINATION CAMP

Beata KLIMEK<sup>1,\*</sup>

<sup>1</sup> Faculty of Civil Engineering and Architecture, Lublin University of Technology,  
Department of Conservation of Built Heritage, 20-618 Lublin, Poland

**Keywords:** *Majdanek; barrack 41; gas chamber bunker; mortar and brick research*

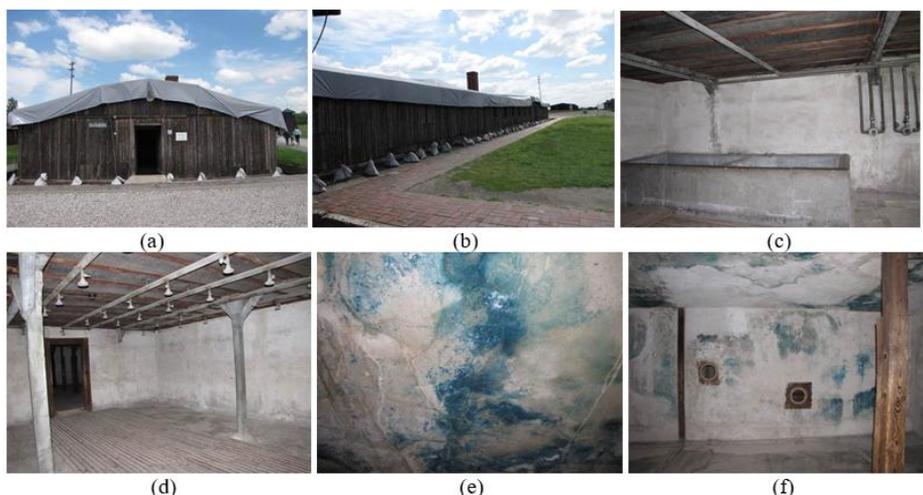
Fig. 2. Barrack No. 41 on the grounds of the former extermination camp at Majdanek a) entrance, front façade; b) the main part of the building is a barrack of the stable type; c) walls and floors of the barrack; d) the ceiling of the bathhouse covered with bituminous paper; e) Prussian blue efflorescence on the wall of the dressing room; f) in the disinfection rooms, the walls and ceilings are plastered and whitened

Prussian blue was found on the plaster in the gas chambers (Fig. 2e and Fig. 2f). This is a result of the use of Zyklon B in these rooms. Zyklon B, containing the so-called Prussian acid, together with iron compounds contained in the plastering compounds, is transformed into a dye with a characteristic blue color when exposed to a reducing atmosphere of carbon monoxide. Due to the reactivity of Prussian blue to water, blue efflorescence is also present on lime plaster (repairs according to the recommendations of the 1961 post-study documentation) [17]. In quantitative studies of ferrocyanide, it was found that the reapplied plasters contain a higher amount of it than the original plasters. The reason for this condition may be twofold. The first reason for the quantitative difference in ferrocyanide is the presence of gypsum in original plasters. Gypsum, through absorption of water particles, hydrates by increasing its volume,

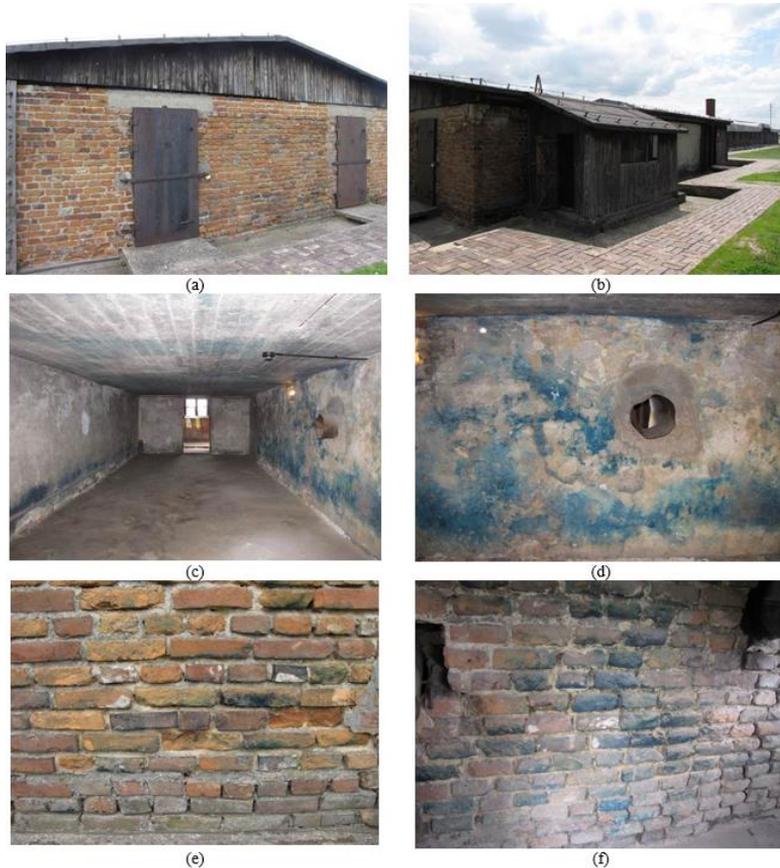
**Fig. 3.** Gas chamber bunker, on the grounds of the former extermination camp at Majdanek: a) view from the north; b) wooden extension to the furnace with a blower on the west side; c) main room of the gas chamber; d) Prussian blue efflorescence on the plaster in the chamber; e) damage to the bricks and joint of the bunker walls; f) Prussian blue efflorescence on the bricks and joint on the exterior side

Eight of the ten measurement points in the bunker chamber, the dressing room and the bathhouse were found to exceed the moisture level. Increased moisture, which persists for a long time, is the cause of significant corrosion of masonry materials—bricks and joints are severely degraded. Locally, the damage does not only affect the surface of the walls and plaster, but the degradation causes damage to the deeper structures of the bricks (Fig. 3e).

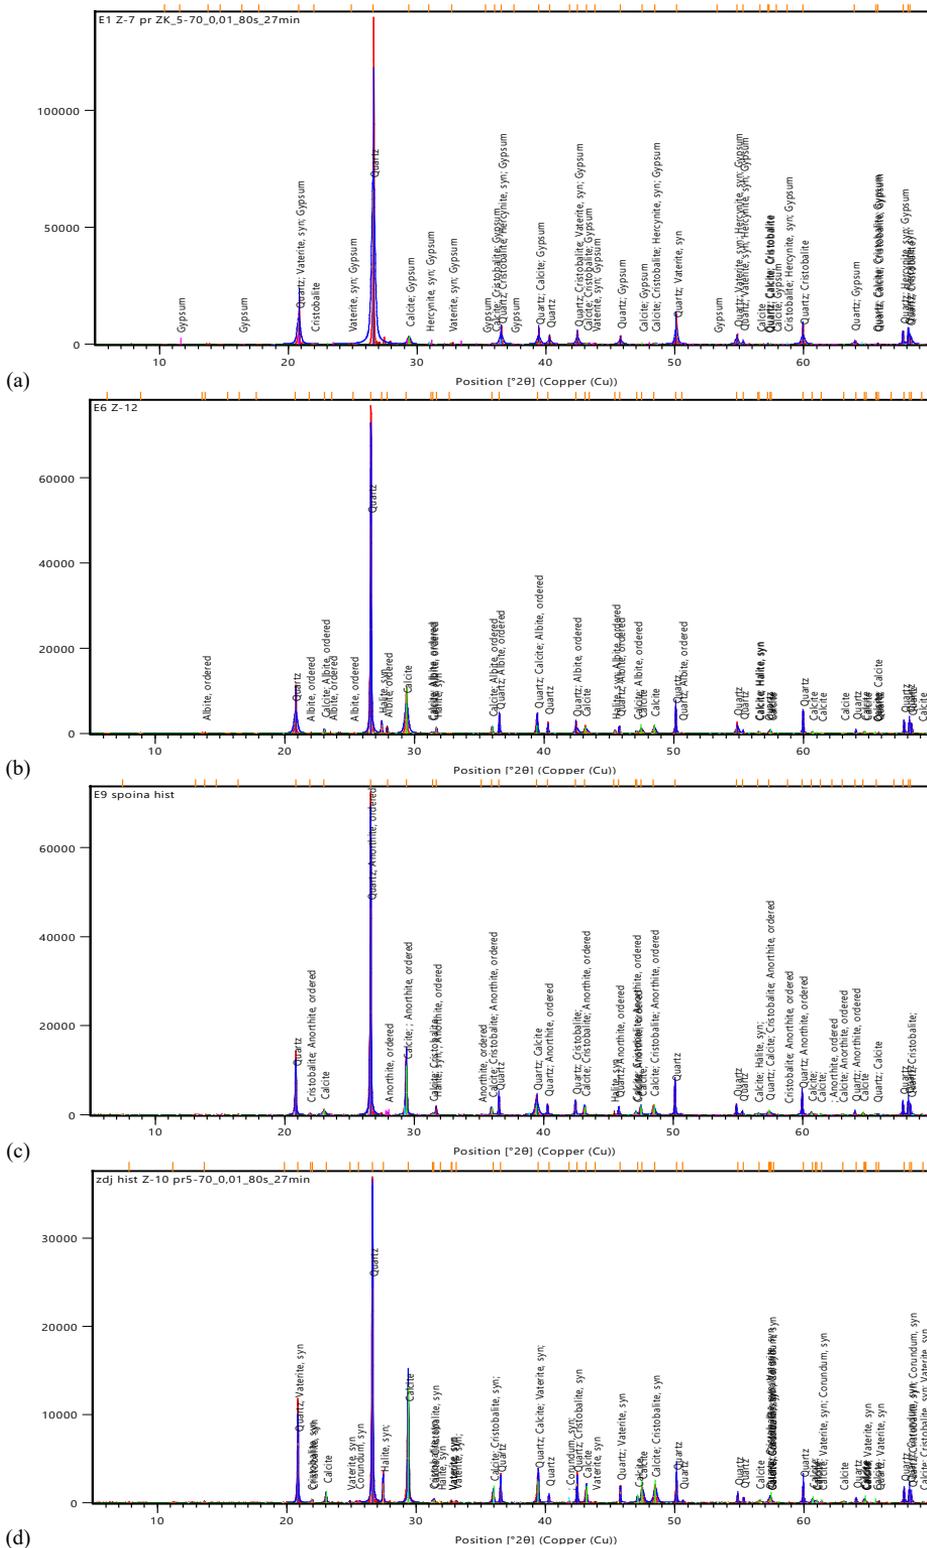
Fig. 4. XRD spectra: a) historical lime-sand plaster with gypsum (P/LG); b) secondary lime-sand plaster (P/L); c-d) lime-sand mortar (M/1A) (M/2A)

The first type of plaster (P/L) is a lime plaster with sand with a calcite content of up to 31% and quartz content of up to 63%. This plaster should be considered secondary plaster in light of the survey. It is likely that this condition is the result of the renovation of the building carried out according to the recommendations of the 1961 post-study documentation [17]. This documentation called for the corroded original plaster to be scraped off and replaced with lime sand plaster.

The second type of plaster (P/LG) is also lime plaster with a calcite content of up to 28% with sand; however, XRD analysis also showed the presence of gypsum up to 10% in the plaster mass. This type of plaster is definitely stronger, with a lower proportion of fillers up to 60%. It is presumed that the addition of gypsum was intended to reduce the porosity and absorbency of the layer by tightening it. In light of the analyses carried out, this layer of plaster was considered a proper layer. For samples of this composition, the presence of titanium white ( $\text{TiO}_2$ ) was additionally recorded.

Halite ( $\text{NaCl}$ ) salts appear in mortar and plaster analyses (Table 5 and Fig. 4).

The salt appeared in the mortars as a result of groundwater entering the masonry walls through capillary rise. The differences in salt content can be attributed to lower porosity and water absorption for the different sampling sites. SEM examination of the lime mortar samples showed high porosity and lack of cohesion between the components (Fig. 5a and Fig. 5b). This was due to the deterioration of the mortars caused by the action of moisture and crystallization of salts.

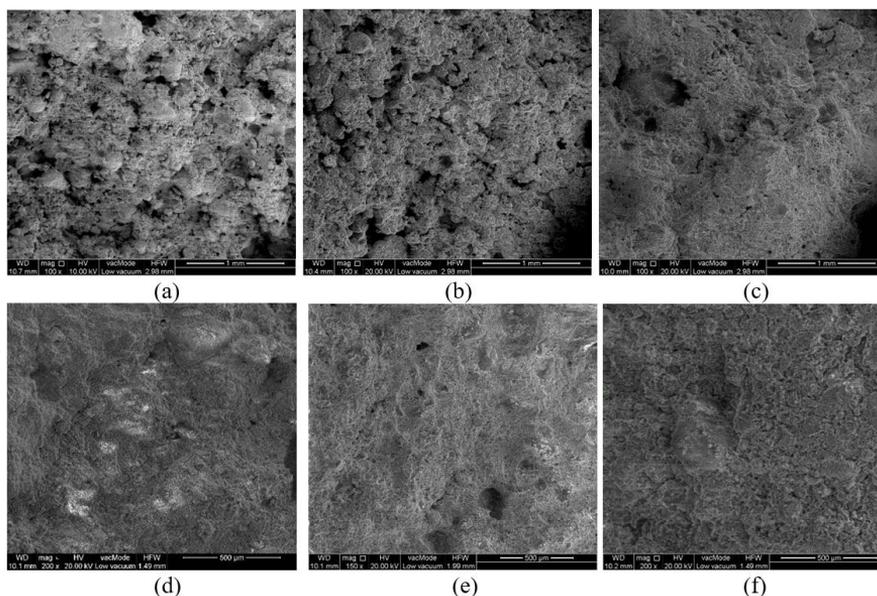
**Fig. 5.** SEM images: a) lime-sand mortar (M/3A); b) lime mortar sample (M/4A); c) lime-sand mortar (M/1A); d) lime-sand mortar (M/2A); e) lime-sand plaster with gypsum (P/LG); f) lime-sand plaster (P/L)

SEM images of the plasters show a compact microstructure. EDX analysis confirmed the XRD results that the lime plaster with gypsum (Fig. 5e) contained an increased content of SO<sub>3</sub>, up to 6.43%; CaO, up to 29.72%; C<sub>2</sub>O, up to 12.43%; SiO<sub>2</sub>, up to 23.16%; and N<sub>2</sub>O<sub>5</sub>, up to 13.23%.

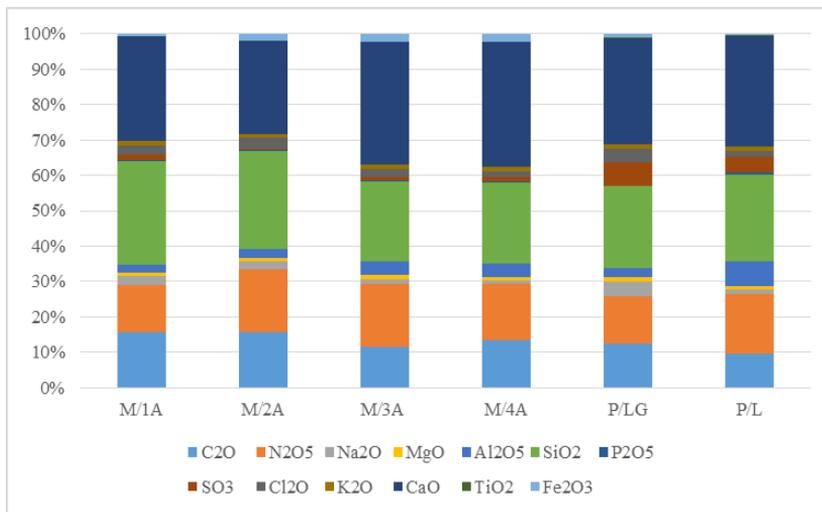
The main constituent elements of the lime mortars were Ca, C, Si and N, according to the EDS test (Table 6 and Fig. 6). The weight percentage containing the individual oxides  $\text{CaO}$ ,  $\text{C}_2\text{O}$ ,  $\text{SiO}_2$  and  $\text{N}_2\text{O}_5$  ranged from 26.49 to 35.30, 11.54-15.77, 22.60 to 29.76 and 13.53 to 17.84, respectively, in the four mortar samples tested (M/1A, M/2A, M/3A and M/4A). The remaining oxides  $\text{Na}_2\text{O}$  (1.13-2.56),  $\text{Cl}_2\text{O}$  (1.73-3.18),  $\text{SO}_3$  (0.25-1.50) and  $\text{K}_2\text{O}$  (0.98-1.45) contributed to the existence of salts.

**Fig. 6.** Weight percentage (Wt%) found for oxides in each sample: (M/1A) – lime-sand mortar; (M/2A) – lime-sand mortar; (M/3A) – lime-sand mortar (M/4A); (P/LG) – lime-sand plaster with gypsum; (P/L) – lime-sand plaster

All mortar and plaster samples showed very high N<sub>2</sub>O<sub>5</sub> contents of more than 17.84% bound by nitrates, which are a direct result of biological metabolism. They are formed as a product of processing feces and other residues produced by microorganisms.
