RENOVATION AND ADAPTATION OF A HISTORIC MODERNIST FACILITY TO CONTEMPORARY FUNCTIONAL AND UTILITY NEEDS

This article aims to present the practical aspects of the renovation of historic modernist buildings on the example of a villa from the 30s of the twentieth century, located in Częstochowa, in the historical areas of the city. The renovation process, which included both the building itself and its surroundings, was presented in the context of activities to organize historic urban fabric. The concept of adapting the building and its external space to the contemporary requirements of cultural functions was also discussed. The case study shows the effective cooperation of institutions and people involved in the conservation and renovation process, being an example of a coherent approach to the protection of architectural heritage in the changing socio-cultural reality. The legal basis for the rules of conduct in the field of protection of tangible heritage is the Act on the Protection and Care of Monuments of 2003, as amended and the Construction Law [3].

The subject of the opinion is the historical building, the so-called "General's Villa" at 30 Wyzwolenia Street in Częstochowa (

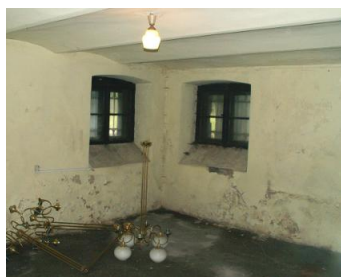
Dampness of the external walls in the ground floor strip was also found due to the capillary rising of water from the ground due to the lack of vertical and horizontal insulation (Fig. 6). The lack of insulation also caused dampness of the basement walls, rotting of plaster, mold and freezing of the walls (Figs. 7 and 8) [14].

Fig. 7. Dampness of basement walls in the southwest.
(author's photos: A. Kysiak)

The adaptation of the basement for use as utility and storage spaces necessitated the elimination of moisture and fungal infestation in the walls. To achieve this, a horizontal damp-proof course and vertical waterproofing were both designed and implemented, along with a comprehensive antifungal treatment of the basement walls.

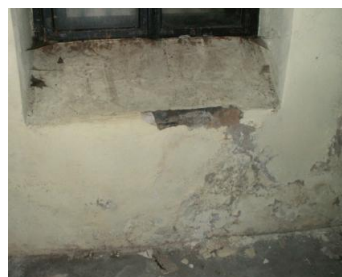
Fig. 8. Rot and fungus walls in the basement (author's
photos: A. Kysiak)

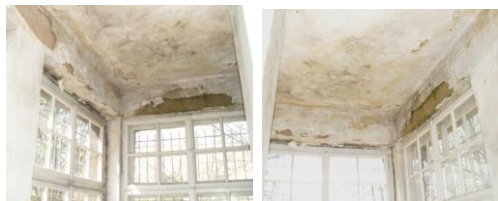
However, the terrace and the walls of the veranda on the ground floor of the building require a major renovation. As a result of the leaky surface of the terrace and damage to the downpipe within the veranda, dampness, detachment of plaster and mold on the veranda walls occurred (Fig. 10).

Fig. 10. Dampness, rotting plaster and brick, mold infestation of the walls in the veranda on the ground floor (author's photos: A. Kysiak)

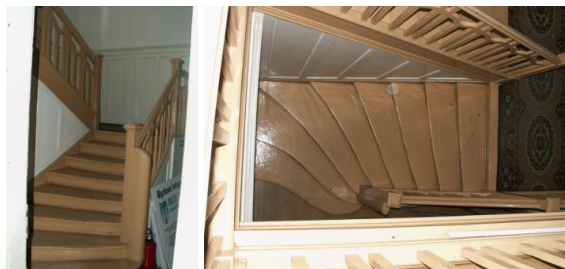
The central staircase leading from the ground floor to the first floor has the form of wooden two-flight broken stairs with a landing (Fig. 14). They can therefore be used as the main escape stairs in a public building. No visible bends or curvatures were found on the stairs. Outbreaks of biological wood pests have been noticed in a few places. There are some small gaps in the platforms. The stairs were properly maintained; their technical condition was considered satisfactory.

Fig. 13. Wooden stairs in the central
(author's photos: A. Kysiak)

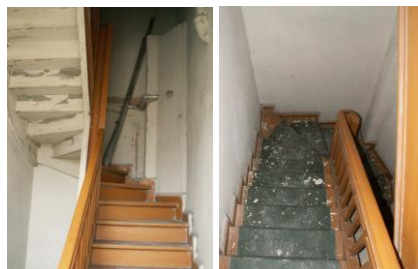
The utility (winding) stairs from the courtyard side (western staircase), leading to the

attic, are narrow and do not meet the current technical conditions. The wooden structure of the stairs is in average technical condition. It is necessary to strengthen them and replace the treads and balustrades (Fig. 15). The technical condition of the roof truss structure was considered to be of medium condition. Slight roof bends and leak points were found. Impregnation and insecticidal renovation are required, as well as strengthening of the roof structure, along with gutters, downpipes and flashings of cornices, chimneys and walls.

Fig. 14. View of the stairs in
the west staircase (author's photos: A. Kysiak)

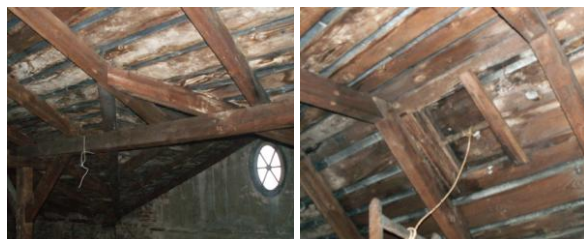
Fig. 15. Technical condition of the roof truss elements (author's
photos: A. Kysiak)

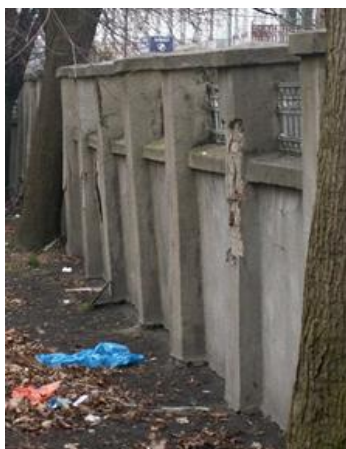
The technical condition of the brick fence made of 2.3 m high brick is bad (Figs. 18 and 19). As a part of the planned renovation, the fence was dismantled and reconstructed in its original form with the use of dismantled and preserved decorative metal elements.

Fig. 18. Deflection fences from the street side of Focha
(author's photos: A. Kysiak)

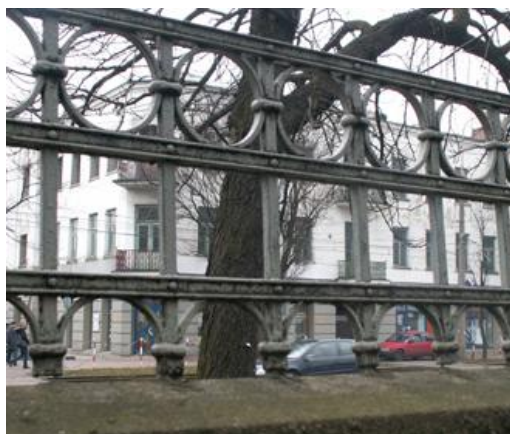
Fig. 19. Decorative fencing metal fencing panels
(author's photos: A. Kysiak)

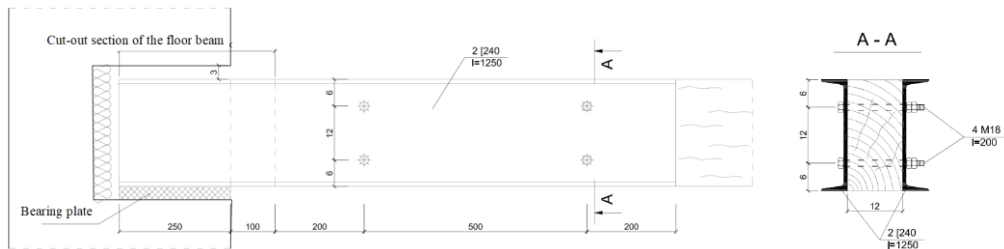
Fig. 23. Method of strengthening the ceiling beam above the ground floor

An exploratory opening in the floor above the first floor revealed that the joists did not meet the required load-bearing capacity for a technological load of 2.8kN/m², typical for office and storage spaces. Reinforcement was carried out by attaching 18×4cm overlay boards, nailed with 5×150mm nails spaced at 10cm intervals (three rows).

An assessment was also made regarding the biological degradation of the timber, including moisture content and fungal infestation. Upon exposing the beams, it was found that the ends of the joists embedded 25cm into the wall niches exhibited signs of biological corrosion. The damaged portions of the beams were cut out and replaced with C-sections of the same height as the timber beams. These were fastened to both sides of the remaining wooden section using bolts (Figs. 23 and 24) [18].

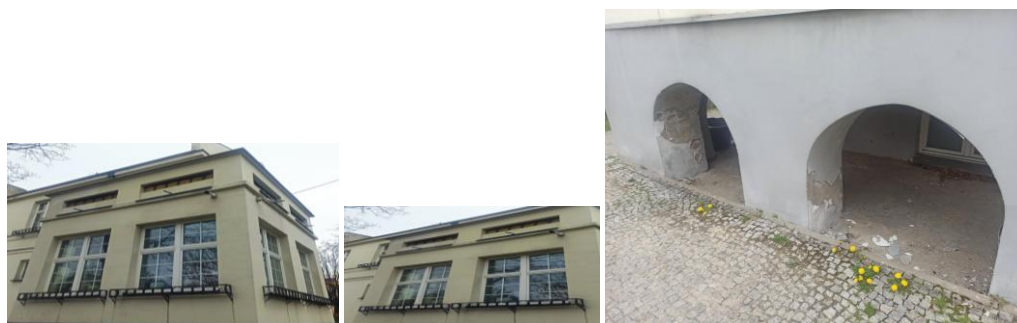
Fig. 29. Building elevation after renovation – visible original, restored window joinery and refurbished original flower grilles beneath the windows (author's photos: N.Solkiewicz-Kos, M.Tubielewicz-Michalczuk)

The renovation of the window and door joinery included the removal of old paint layers, degreasing, filling of wood cracks and losses and realignment of the sashes to the frames (Fig. 29). The renovation also included the property's fence. The perimeter wall and the decorative metal grille were restored (Fig. 30).

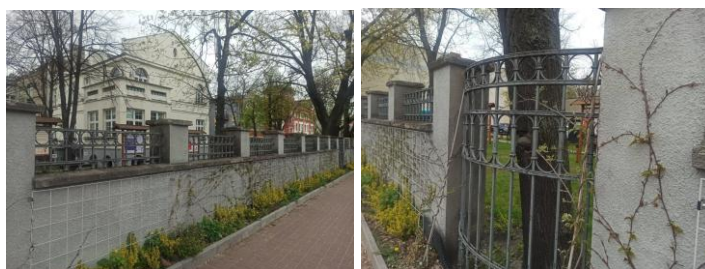
Fig. 30. Property fence after renovation – visible restored fence wall as well as the original, refurbished decorative metal grille (author's photos: N.Solkiewicz-Kos, M.Tubielewicz-Michalczuk)
