SEISMIC EVALUATION AND RETROFIT PROPOSALS FOR A REINFORCED CONCRETE BUILDING IN CULTURAL HERITAGE AREA

Abstract

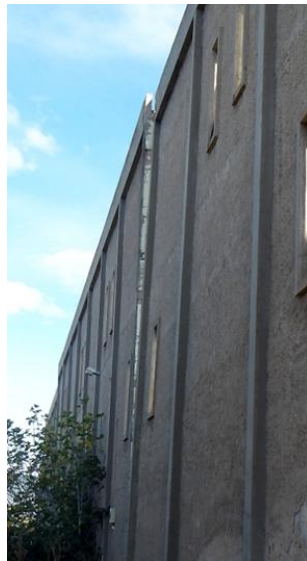
Fig. 8. Photograph of the leaning wall

Over the years the building has deteriorated mainly due to environmental factors, as it has been exposed without any paint or roof for protection. In addition, a part of the structure between the joints is leaning outside (Fig. 8). The last sections of this article present the building's damages and provide recommendations for their repair.

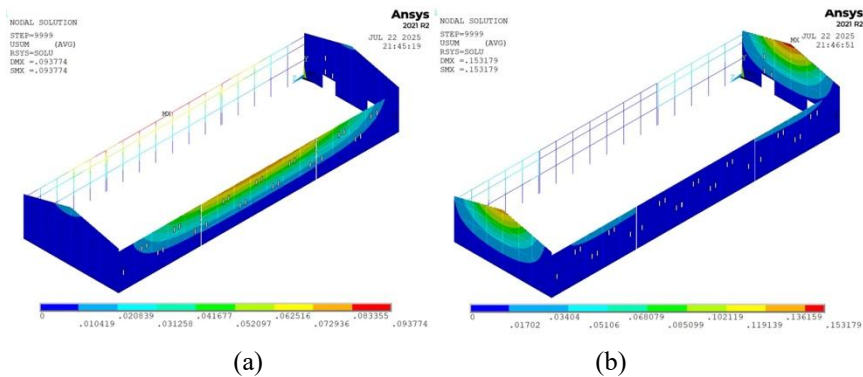
Fig. 13. Maximum displacements (in m) developed in the structure by earthquake excitation in (a) the X-direction and (b) in the Z-direction

The seismic behavior of the building was examined using response spectrum analysis. Based on Eurocode 8 [16] and the building's location, the design spectrum shown in figure 12 was used for the seismic analysis. The structure was subjected to the earthquake load (in the form of a response spectrum) in both the X and Z horizontal directions. The results are presented as contour plots of the maximum displacements (in m) and maximum principal stresses (in Pa), using the SRSS method. Figures 13 and 14 present the maximum displacements and principal stresses, respectively, when the structure was subjected to earthquake loading in the X-direction (parallel to the building's short side) and the Z-direction. Under X-direction loading, the highest displacements occurred at the top of the middle wall and the frame perpendicular to the earthquake direction (Fig. 13a), while the maximum principal stresses appeared at the bottom of the same middle wall (Fig. 14a). Under Z-direction loading, the highest displacements occurred at the top of the walls perpendicular to the earthquake direction (Fig. 13b), while the maximum

principal stresses appeared at the bottom of the same walls where the maximum displacements occurred (Fig. 14b).

According to the analysis, the most vulnerable parts of the structure are the upper middle sections of the concrete walls parallel to the X-direction (the short side of the building) and the central wall and frame parallel to the Z-direction (the long side of the building).

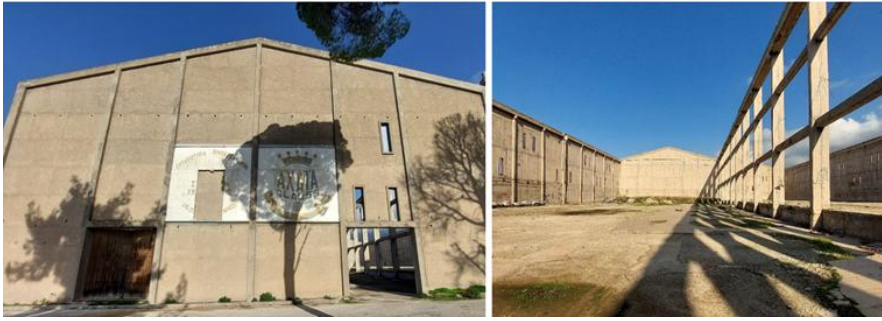
Damage assessment is primarily focused on identifying and recording deterioration across the structural elements of the building. Over time, the building has undergone significant deterioration due to prolonged exposure to environmental conditions, as it has remained unprotected without surface coatings or a roof covering (Fig. 24).

Fig. 24. Front and interior views of the building under study

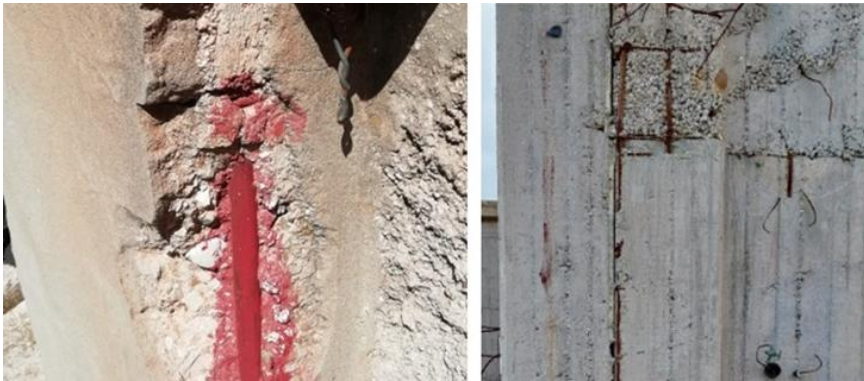
The observed damages included cracking, delamination, localized failure, section loss, spalling, and reinforcement corrosion (Figures 25-26). In a few columns, the shear reinforcement had failed along with the concrete cover, exposing the longitudinal reinforcement to carry the compressive force of the column without any support, resulting in local buckling (Fig. 27).

Fig. 25. Spalling and corrosion damage on the building's columns and walls

Most of the damages can be repaired by using common strengthening techniques according to the guidelines presented in the Greek codes (KAN.EPE.) and in EN 1504—European Standards for Concrete Repair. These techniques include the removal of damaged concrete surrounding the corroded reinforcement followed by mechanical cleaning of the steel (e.g., sandblasting) to eliminate rust and corrosion residues. The cleaned reinforcement must be treated with anti-corrosion coatings.

Concrete repair involves the application of repair mortars, typically cement-based or polymer-modified, which must demonstrate adequate adhesion and durability against environmental exposure. Application methods may include manual trowelling or injection techniques, particularly in cases of deeper damage. Finally, surface sealing materials must be applied to prevent moisture and chloride ingress. Protective coatings or waterproofing membranes are recommended to ensure the long-term durability of the repair.

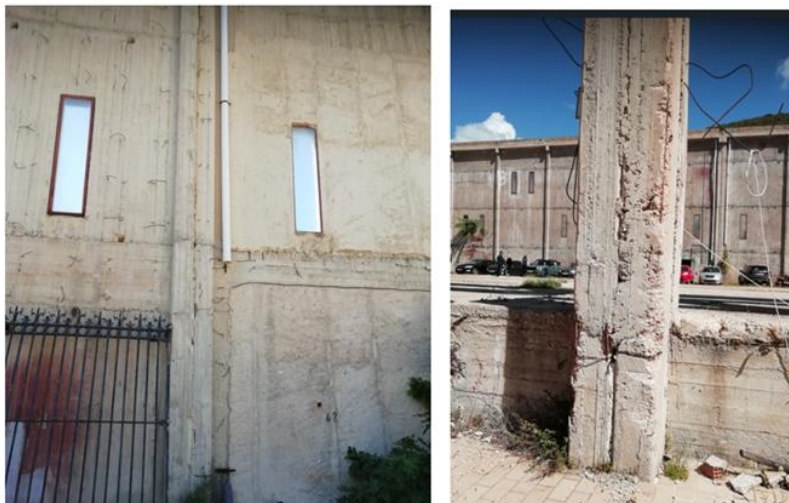
Fig. 26. Deterioration of the concrete cover and exposure of steel reinforcement at the joints

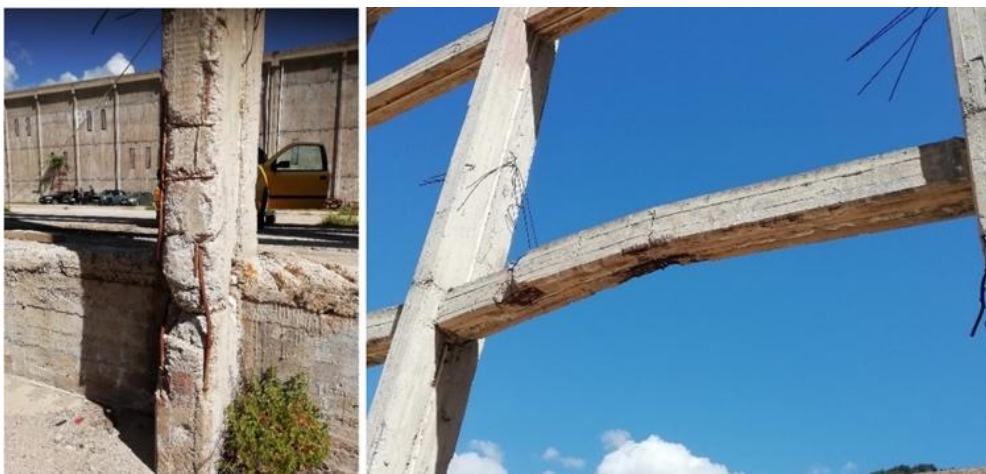
Fig. 27. Localized concrete failure, corrosion and failure of shear reinforcement, and buckling of longitudinal reinforcement

The columns with buckled longitudinal reinforcement require removal of the deteriorated concrete and cutting and removal of the buckled portion of the steel reinforcement. New steel bars will be welded to the remaining reinforcement, with new stirrups added, followed by encasement and casting of new concrete in the repaired section.

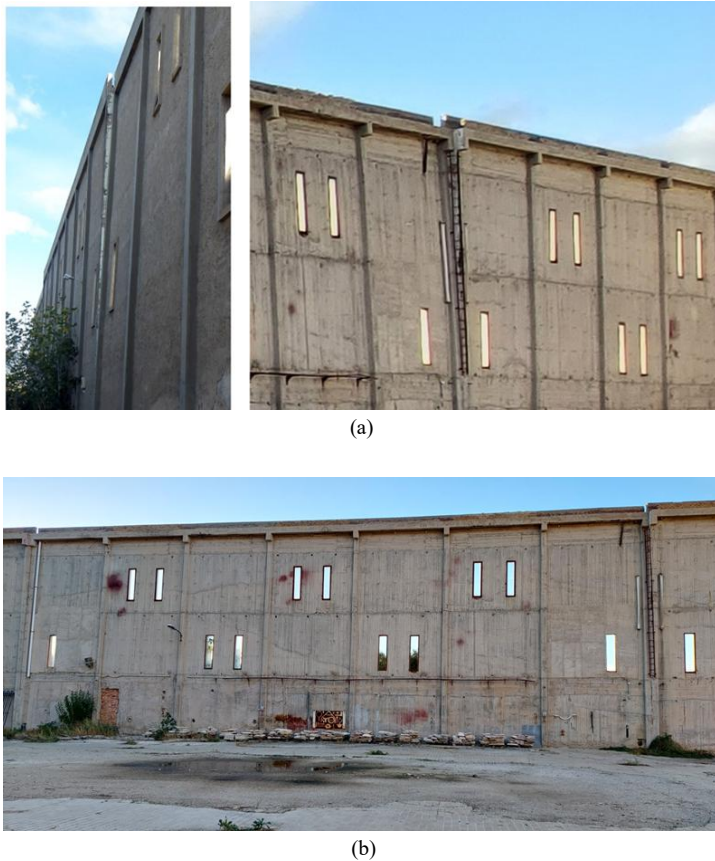
One of the problems that exists in the building under study is the leaning wall on its longer side. This was attended by adding steel members inside the structure, connecting the leaning part with its adjacent section, which remains in a normal position, to prevent further leaning (Figs. 8 and 28).

The causes that led to the leaning of the wall need to be identified before attempting to restore it to its up-right position. The strength of the soil should be assessed to ensure that there are no weak areas that could lead to settlement or rotation of the footing. A visual inspection of the ground does not reveal any obvious issues with the soil. It can be concluded that, since the wall was not connected to the rest of the structure (prior to the addition of the steel members), it was vulnerable to seismic excitations acting perpendicular to its plane.

Fig. 28. The leaning wall and the corrective measures implemented

To restore the wall to its upright position, compensation grouting can be employed. This technique involves injecting a mixture of sand, water, and cement into the ground at specific locations to counteract any settlement that the leaning wall may have experienced. Depending on the wall's response to the interventions, hydraulic jacks may also be required to assist in realigning it.
