## THE RECONSTRUCTION AND RESTORATION OF THE FORMER JEWISH HOSPITAL IN KROPYVNYTSKYI

*The article analyzes the experience of reconstructing and restoring one of the former buildings of the Jewish hospital in the city of Kropyvnytskyi. This object is an architectural monument, built in 1910–1914 in the eclectic style with elements of modernism, in interiors with motifs of the traditional "Jewish" style. It is significant that, during its existence, the hospital was used for its intended purpose; however, some buildings were rebuilt and lost part of their original decor. As of the beginning of the restoration work, building No. 2 had signs of disrepair. The article highlights the history of the object, its style characteristics, and characteristics of the original structural roofs and materials. The stages and content of the restoration project are described.*

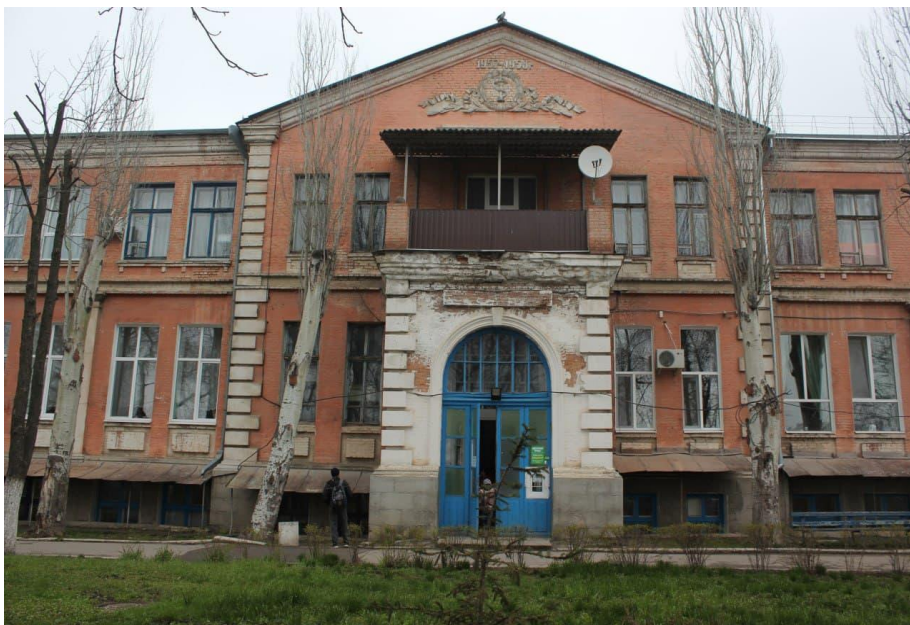
**Fig. 1.** The main facade of the medical building No. 2 (state before restoration).

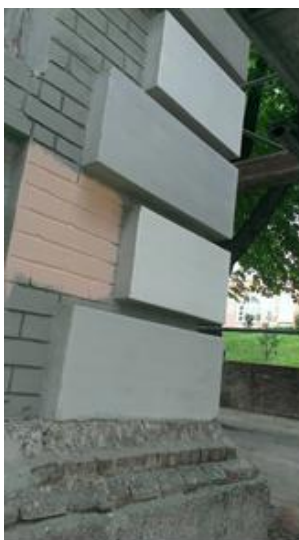
**Fig. 3.** Fragment of the plinth.

The inspection revealed the following: the plane of the base of the main entrance portal is plastered, which does not correspond to the original appearance; the plaster has local areas of peeling and destruction of the plaster layer, with paint washing out; there are cracks with displacement of stones in brick and granite masonry with a length of more than 8 rows of masonry; the lower and corner parts of the base are clogged with moss; the brickwork of the courtyard facades has hairline cracks and cracks with an opening size of up to 3 mm, crossing the masonry to a height of more than 8 rows; there is washing out and weathering of the mortar from the masonry; there are local areas of brick destruction and mechanical damage to the brick; the coating of the masonry planes of the pits has damage to the layer of plaster and ceramic tiles and destruction of the brick; the canopies above the pits have damage from corrosion of metal sheets, cracking of asbestos-cement sheets, and improper fit to the enclosing structures of the building.

Comprehensive repair and restoration work of light wells with effective waterproofing of the retaining walls of the wells: to increase waterproofing, perform facing of the external surfaces of the brickwork (or monolithic concrete casting) of the light wells with granite-hewn unpolished granite slabs. The color of the granite is close to the color of the original blocks that are used to face the base of the main facade.

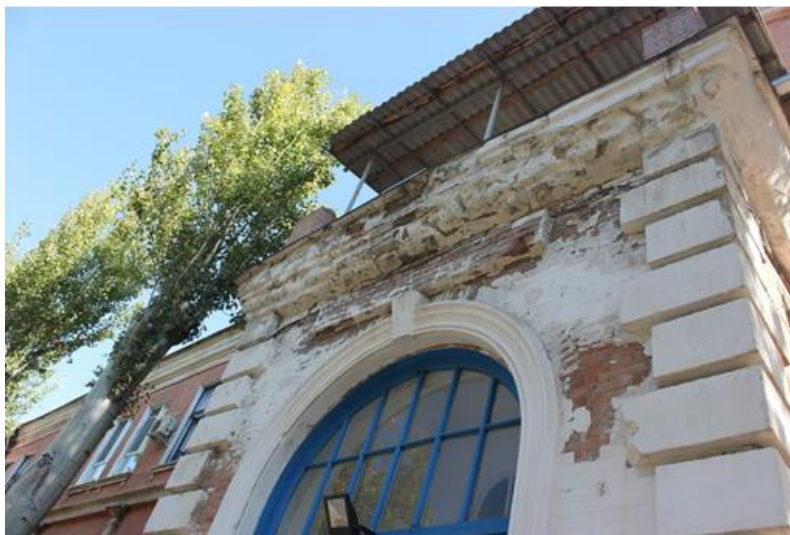
Fig. 4. Fragment of the external walls.

The inspection revealed oblique hairline cracks and cracks with an opening size of up to 3 mm on the plane of the main facade, which cross more than 8 rows of brickwork, and cracks in brick lintels above window and door openings. Paint washout; cracks with displacement of stones in brick and granite masonry with a length of more than 8 rows of masonry; traces of waterlogging – especially in the corner parts of the building with moss growth and within the crown cornice and the adjacency of the covering of portals and canopies over light wells; washing out and weathering of mortar from the masonry; local places of destruction of bricks; mechanical damage to bricks; the paint is peeling and washing out; cracking and damage to the plaster layer; the crown cornice has vertical and horizontal cracks; there are places of damage to the bricks; metal elements are affected by corrosion; a window opening is bricked up in an unaesthetic way and with a violation of the architectural appearance of the building.

It was planned to strengthen the granite masonry of the basement part of the building (northwestern and southwestern facades) and the brick masonry of the lintels above the windows where cracks appeared. To design the reinforcement of the structures according to the constructive solution of the design organization, but in such a way that does not change the aesthetic and architectural appearance of the facades and interiors.

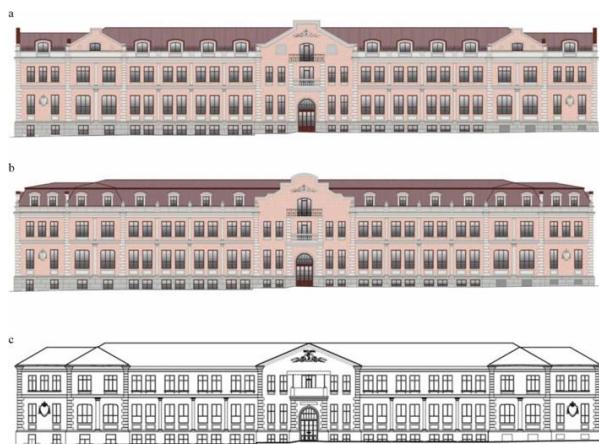
**Fig. 5.** Variants of facade reconstruction. Author M. Omelyanenko: a – 1<sup>st</sup> variant; b – 2<sup>nd</sup> variant; c – facade before reconstruction

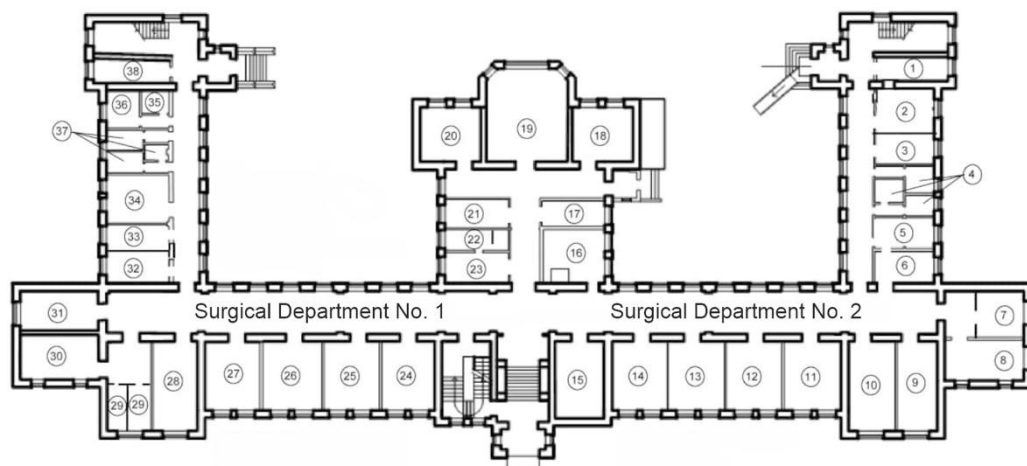
**Fig. 6.** Plan of the building after reconstruction. Author M. Omelianenko: 1 – head of surgical department No. 2; 2, 15 – resident rooms; 3, 16 – procedure rooms; 4 – toilets and shower room; 5, 38 – cafeteria; 6, 34 – dining rooms; 7 – dressing room; 8, 31 – manipulation rooms; 9-14, 24-33 – postoperative wards; 18 – anesthesia room; 19, 20 – operating room; 21 – sterilization room; 22 – doctors’ changing room with shower; 23 – preoperative room; 35 – pantry; 36 – shower room with bath; 37 – toilets
