STRUCTURAL DAMAGE ASSESSMENT OF HISTORIC TRADITIONAL MASONRY BUILDINGS: A CASE STUDY

Mohamed Mostafa ABDELMEGEED^{*1}, Efstratios BADOGIANNIS², Gerasimos KOTSOVOS³, Emanuel VOUGIOUKAS²

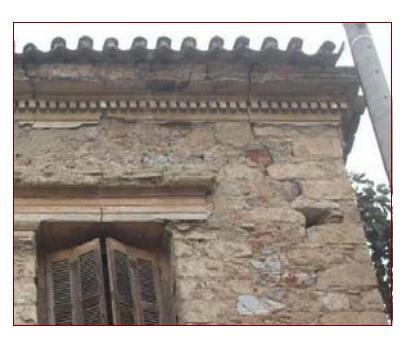
More specifically, Fig. 8 shows the vertical splitting that occurred near or at the joint of intersecting walls, whereas the lack of bracing tying together the individual trusses of the roof at their support in the wall recesses allowed excessive out-of-plane displacement under horizontal actions, which led to near vertical cracking at the top edge (crowning) of the wall (see Fig. 9). In-plane horizontal actions appear to be the cause of the inclined cracking shown in Figs 10 and 11. Such cracking often initiates at the corners of openings (windows and doors) due to the stress concentrations developing at such locations (see Fig. 11).

Fig. 9. Vertical cracking at to edge (crowning) of the façade of the building

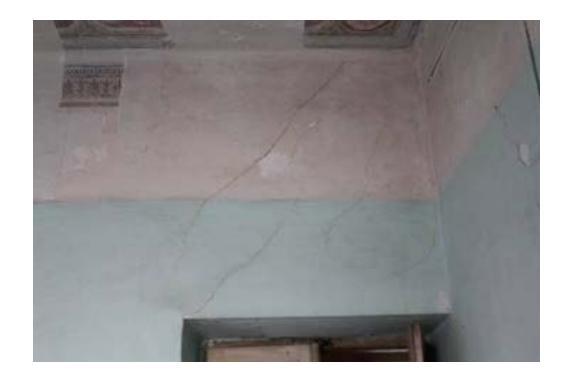
Fig. 10. Inclined splitting of masonry wall

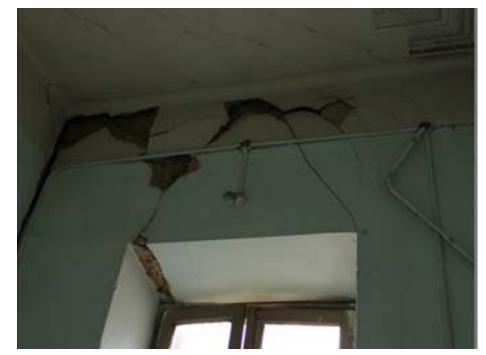
Fig. 11. Cracking at openings' corners

However, as discussed in the preceding section, in spite of the above modifications, the development of tensile stresses larger than the tensile strength of concrete cannot be prevented in localized regions of the walls. In such locations cracking may be minimized, or even prevented, if the tensile strength of the masonry is improved. The latter can be achieved through grouting that will also restore the continuity of the masonry which was disrupted by the

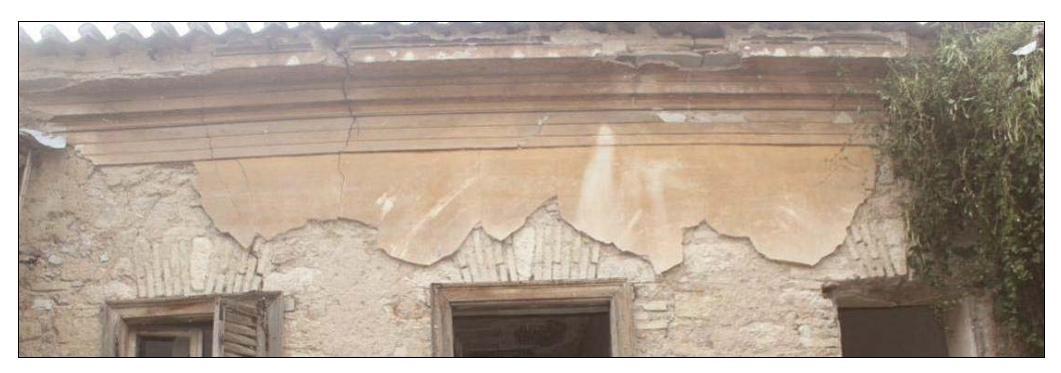
It is also important to note that the loss of the plastering of many of the walls (see, for example, Fig. 12) revealed fragmentation (bleeding) of the mortar used to bind together the stones of the masonry. This is considered to weaken considerably the structural system not only in terms of strength, but also in terms durability, since it reduces the stability of the walls in future seismic excitations.

Fig. 12. Loss of plaster revealing mortar fragmentation (bleeding)

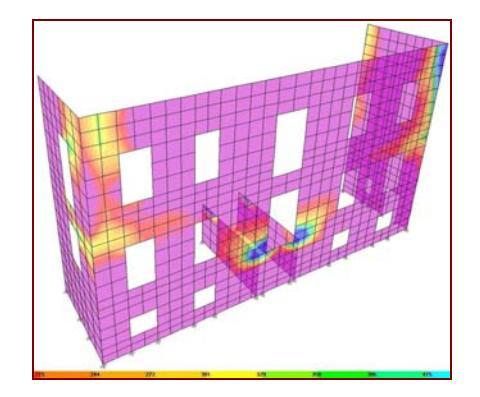
Fig. 13. Tensile stresses (in kN/m²) exceeding the tensile strength of masonry developing at the wall crowning under seismic action in the y-direction (orthogonally to Aktaiou Street)

From Figs 13 to 16, it can be seen that the most critical cracking develops when the horizontal load acts in the y-direction. Fig. 13 shows that the most critical locations of the cracking are expected to be on either of the side regions of the top edge of wall 1 (façade in Aktaiou Street); in fact, at the right-hand side region cracking is predicted to occur at the joint of wall 1 with wall 3. Cracking is also predicted to occur at the bottom corners of the main entrance in Aktaiou Street. Cracking similar to that of wall 1 is predicted to be suffered by walls 5 and 6 (walls parallel to wall 1, see Fig. 3). As for the case of wall 1, they are predicted to occur on either side of the top edge of the walls, as well as at the bottom corners of the doors (see Fig. 14).

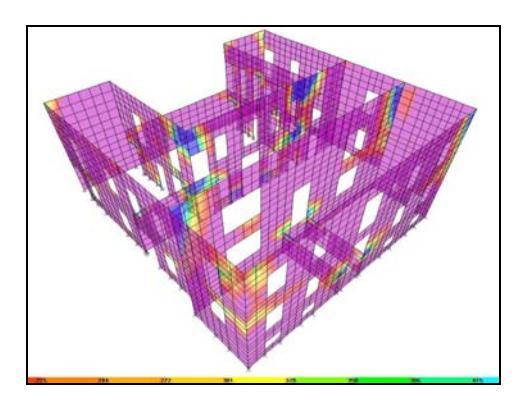
Fig. 14. Tensile stresses (in kN/m²) exceeding the tensile strength of masonry developing in the region of the wall intersections under seismic action in the y-direction (orthogonally to Aktaiou Street)

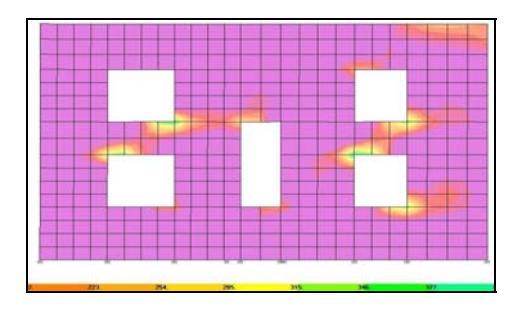
Fig. 15. Tensile stresses (in kN/m²) exceeding the tensile strength of masonry developing in the region of the openings of a typical internal wall in the x- direction (i.e. parallel to Aktaiou Street)

Under seismic excitation in the x-direction, the internal walls are found likely to suffer cracking in the region of the diametrically opposite corners of door and windows; in fact Fig. 15 shows that the largest tensile stresses develop at such locations of the door and windows to the backyard of the building enclosed by walls 6, 4, 7 and 8. Moreover, Fig. 16 shows that seismic excitation orthogonal to walls 1, 5 and 6 causes out-of-plane displacement of the walls in the form of bending of their top edge (due to insufficient roof diaphragm) and, therefore, tensile stresses at mid-length which are likely to cause flexural cracking.

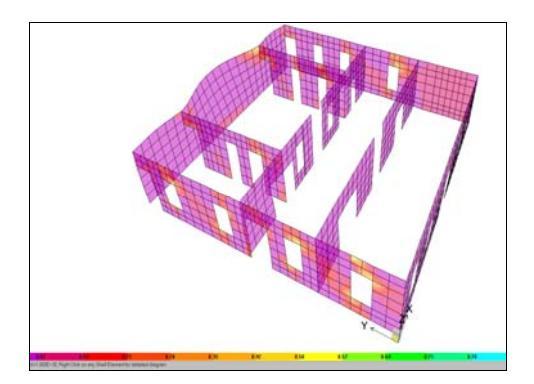
Fig. 17. Deformed shape and distribution of principal tensile stresses (in MPa) exceeding the tensile strength of the masonry of the walls of the first floor of the building under seismic excitation in the y-direction

From Figs 17 to 20, it can be seen that allowing for diaphragmatic action at the levels of the floors and roof leads to a significant reduction of not only the values of the principal tensile stresses developing in the masonry walls, but also of the locations at which these values are larger than the tensile strength of masonry. In fact, diaphragmatic action is found to reduce the out-of-plane displacements of the walls to such an extent that cracking as a result of such displacement seems unlikely. Moreover, since allowing for diaphragm action also causes conditions of bracing at the levels of the floors and roof, the values of the tensile stresses developing at these locations due to the lack of bracing (see Figs 13 to 16) reduce well below the tensile strength of masonry.

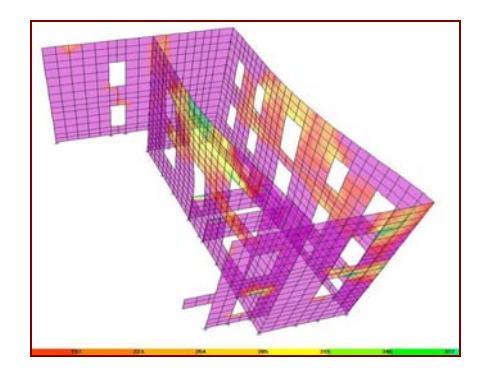
Fig. 16. Deformed shape and related tensile stresses exceeding the tensile strength of masonry (in kN/mm²) under the combined action of the service load and seismic excitation in the y-direction (orthogonally to Aktaiou Street)

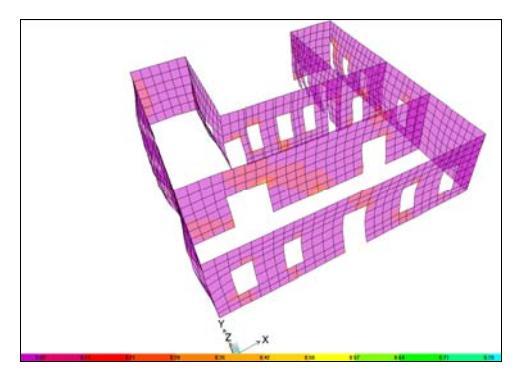
Fig. 18. Deformed shape and distribution of principal tensile stresses (in MPa) exceeding the tensile strength of the masonry of the walls of the first floor of the building under seismic excitation in the x-direction (ACC3)

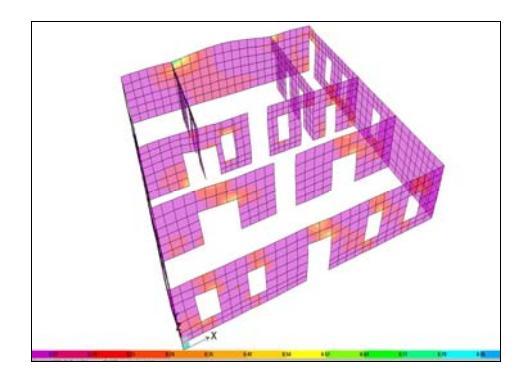
Fig. 19. Deformed shape and distribution of principal tensile stresses (in MPa) exceeding the tensile strength of the masonry of the walls of the basement of the building under seismic excitation in the y-direction (ACC5)

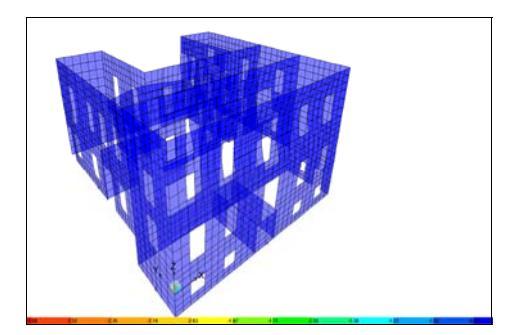
Fig. 21. Deformed shape and distribution of principal compressive stresses (in MPA) exceeding the compressive strength of the masonry walls of the building under seismic excitation in the x-direction (ACC3)

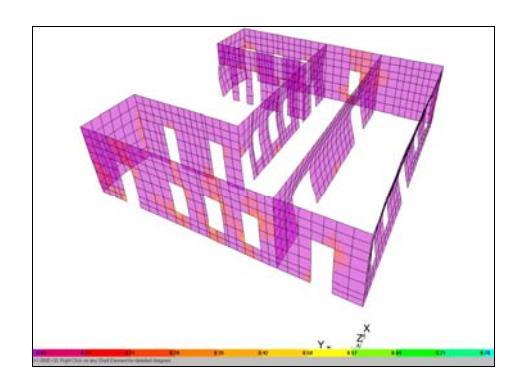
Fig. 20. Deformed shape and distribution of principal tensile stresses (in MPa) exceeding the tensile strength of the masonry of the walls of the basement of the building under seismic excitation in the x-direction (ACC3)

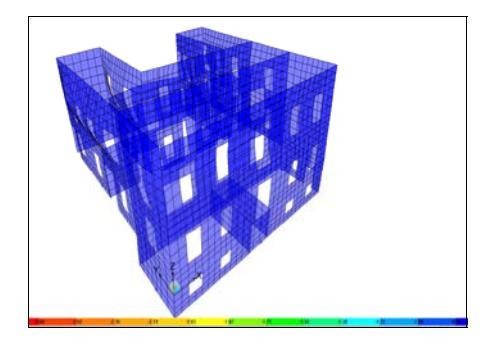
Fig. 22. Deformed shape and distribution of principal compressive stresses (in MPA) exceeding the compressive strength of the masonry walls of the building under seismic excitation in the y-direction (ACC5)
