CHARACTERIZATION OF QARH'S WALL PLASTERS, AL-ULLA, SAUDI ARABIA. A CASE STUDY

Mohsen M. SALEH *

Abstract

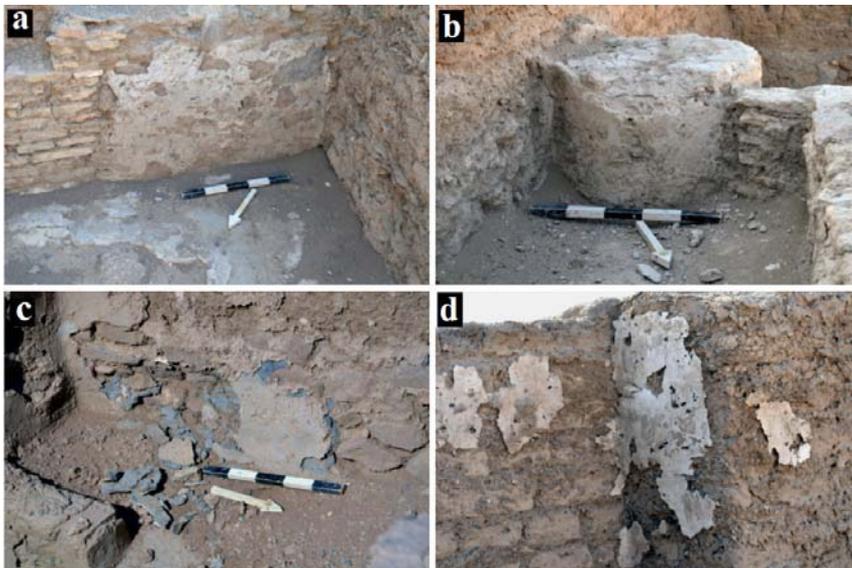
Fig. 2. Different kinds of wall plaster at the Qarh archaeological site.

Many plaster layers (Fig. 2) were found at the Qarh archaeological site. Those plasters used to cover the lower parts and the interior room walls of the units from our field observations; some reports mentioned the following:

- Wall plaster thickness ranges between 1.5cm and 2.5cm in most areas, and up to 3.8cm in some areas. The variety of the wall plasters thickness resulted from the unevenness of the mud-brick surfaces under those plaster layers. On the other hand, this caused the interior surface of the plaster to be uneven.

- Wall plaster was used to plaster architectural elements, such as columns and pillars built of burnt brick.
- The wall plaster consists mostly of more than one layer, but in a few cases it consists of a single layer. The multiple layers of the wall plaster can be observed on the uneven mud brick wall, so the builder added more than one layer to get a flat surface.

- An insulating layer (gray to black in color) was observed between the wall plaster and the mud brick wall. It was observed only in the places where water was used, such as bathrooms, kitchens, water basins and water tanks, which may indicate relationship between this gray layer and waterproofing the mud brick wall.

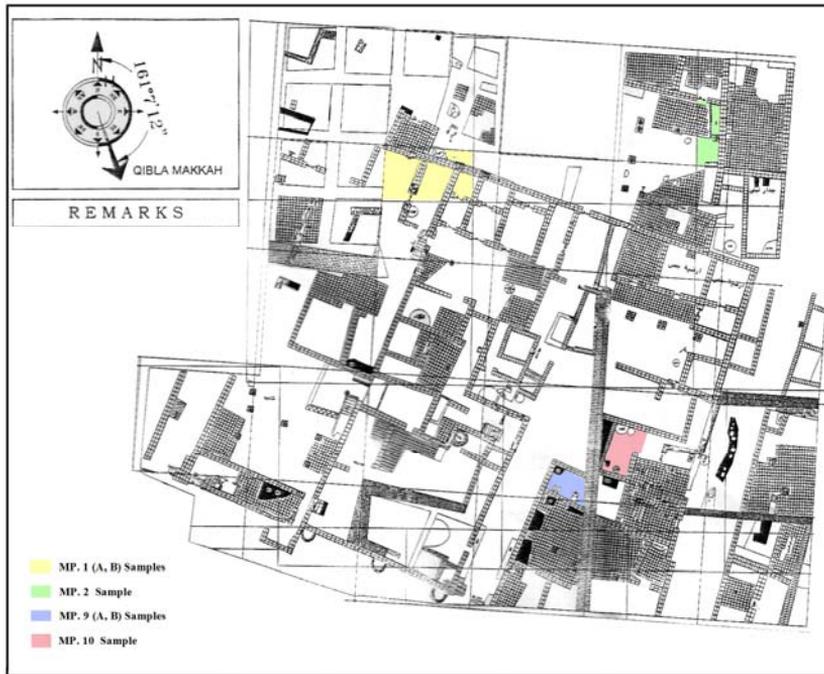
Fig. 3. The places where the wall plasters samples were taken from.

To analyze the different kinds of wall plasters, many samples were collected, representing the different kinds of wall plasters, as shown in Table 1 and Figure 3.

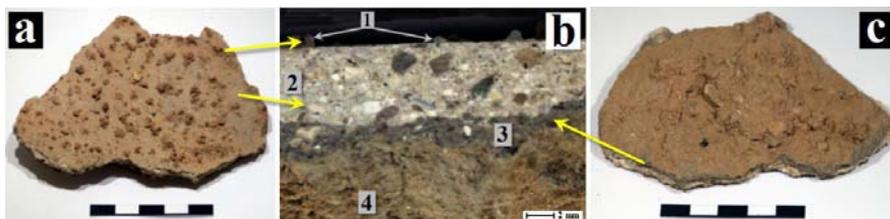
Fig. 4. Sample MP1 (a) salt crystals on the surface, (b) cross section shows: salt crystals (1), white layer (2), grayish layer (3), mud brick remains (4), (c) lower layer of mud brick remains.

Sample MP. 1 reveals the presence of salt crystals on the surface. It consists of three layers: the lower layer is remains of mud brick, the intermediate layer has grayish components and the top layer has white components (Fig. 4).

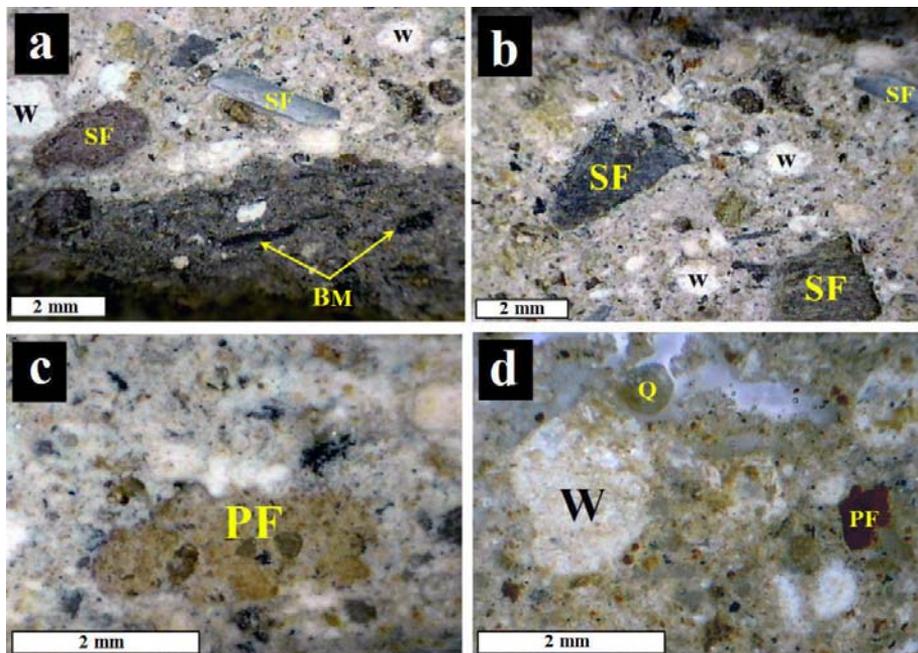
Fig. 5. (a) The white upper layer consisting of white background, stone fragments "SF" and white clusters "W". The intermediate grayish layer showing grayish background containing burnt material remains "BM" and an amount of white clusters. (b), different shapes, sizes and colors of stone fragments. (c) archaeological pottery remains "PF", (d), quartz "Q" and white "W" clusters.

By examining the cross and the thin section of the white and gray layers, the following components were revealed: a white layer (the upper layer) consisting of a mixture of white background, sand, stone fragments (SF) pottery fragments (PF), and white clusters (W) that are different in color, shape and size (Fig. 5). We may assume that the cementing material was a white material, while sand, rock and pottery fragments were fillers.

The gray layer (the intermediate layer) consists of a grayish background, burnt ash mixed with sand, and traces of burnt organic materials (BO) (Fig. 5).

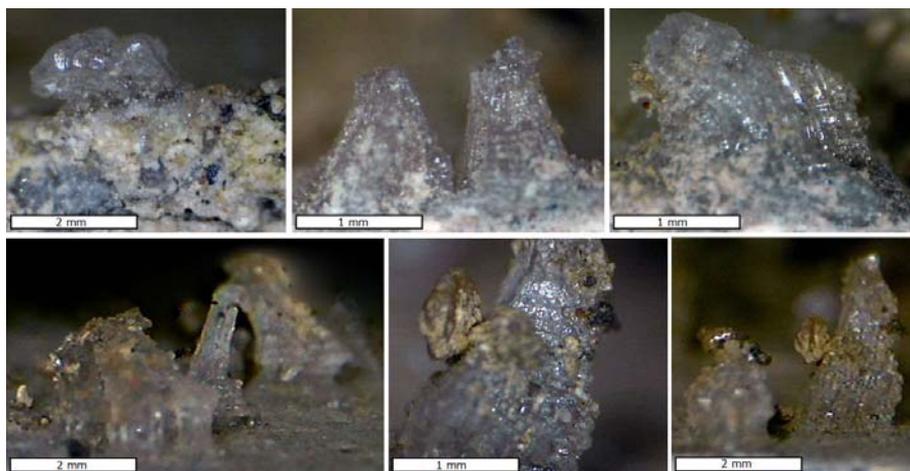
Fig. 6. Various forms of crystalline salts on the sample MP.1a surface.

The salt crystals on the surface of the white upper plaster layer crystallized in various forms (Fig. 6). They are pure and transparent, which indicates a crystallization in suitable conditions and the existence of an internal source of saline water [15, 16].

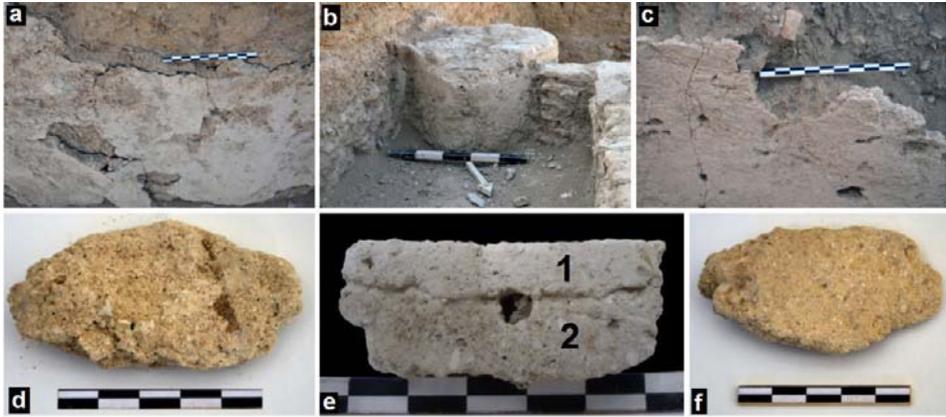
Fig. 7. Images of the cracked plaster layers(a, b and c), the lower surface of the sample MP.2. (d), cross section of sample MP.2 showing the two layers (e) and the upper surface of the sample MP.2 (f)

Sample MP.2 used to plaster the walls and the column at square 20 C. The plaster layers have many cracks causing the separation and falling down of the plaster. Its thickness is up to 3.2cm and it consists of two layers (Fig. 7).

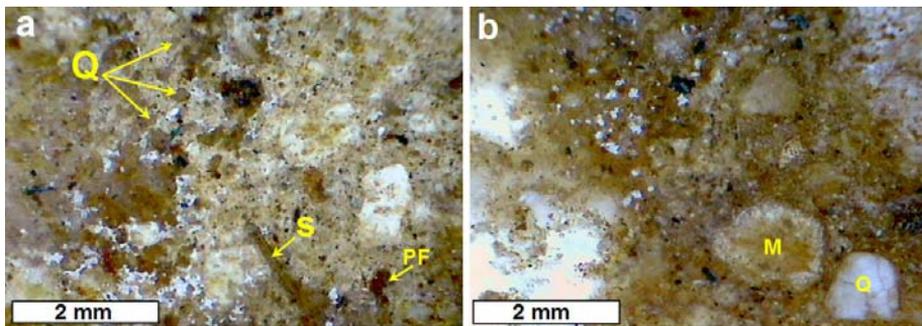
Fig. 8. MP.2 sample consisting of a mixture of white background, a large amount of fine sand with rounded edges "Q", a small amount of pottery fragments "PF", straw "S", and white clusters "M".

The detected results of the optical microscope analysis for sample MP.2 showed that it consists of a mixture of white background, an amount of fine sand with rounded edges "Q", a small amount of pottery fragments "PF", straw "S", and white clusters "M" (Fig. 8).

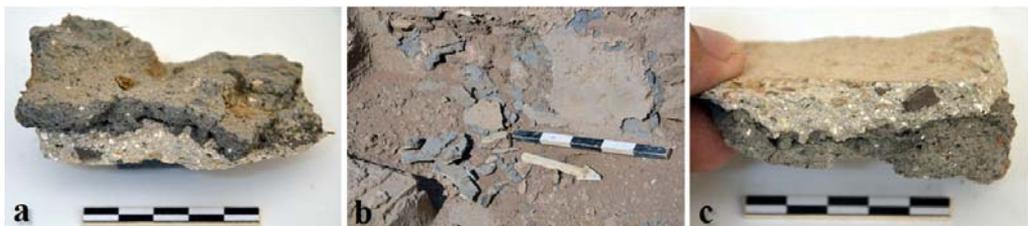
Fig. 9. MP.2 sample showing the two layers (the white layer and the grayish layer): a and c - cross section, b - the area where MP.9 sample was taken from.

Sample MP.9 taken from the plaster was used on the walls and the floor in the bathroom at Sq. 23 B. The grayish layer was used as a contact layer between the mud brick wall and the outer, white plaster layer. The foundations of the bathroom were built from sandstone, which was more resistant to moisture than mud-brick (Fig. 9).

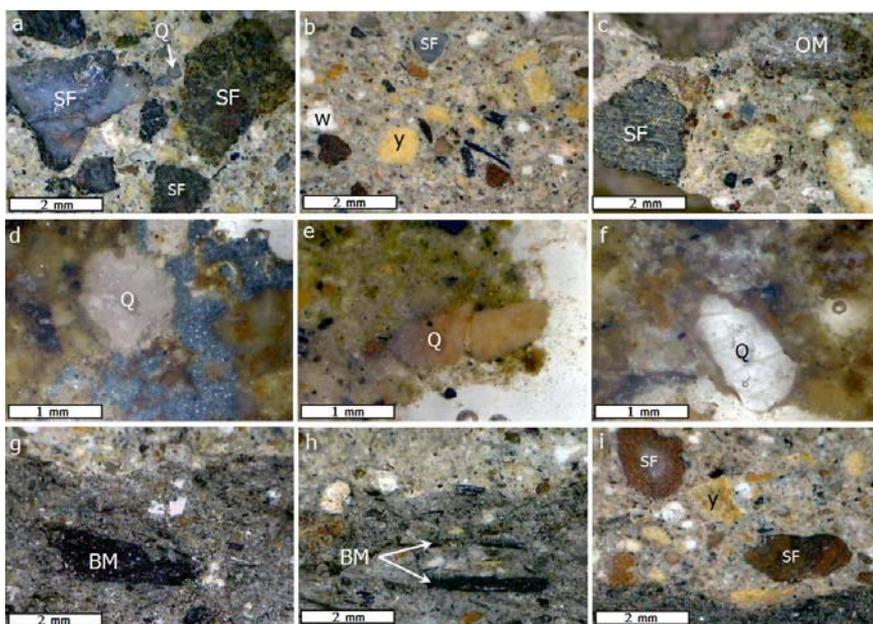
Fig. 10. Images of sample MP.9a (a, b, c, d, e, f and i) and MP.9b (g, h and i).

By examining the cross sections and the thin sections of sample MP.9 under the optical microscope observations we detected that sample MP.9 consists of two layers: the first layer MP.9a is a mixture of white background, fine sand with sharp edges "Q", stone fragments "SF", yellow and white clusters, as well as re-used parts of old mortar (OM), as mentioned by Miriello and others [18]. It may indicate that the components of sample MP.9 were of a white cementing material and fillers of sand, stones fragments and remains of old mortar (Fig. 10). The second layer, gray in color MP.9b consists of a grayish cementing background that contains remains of burnt material "BM" (Fig. 10g, h and i).

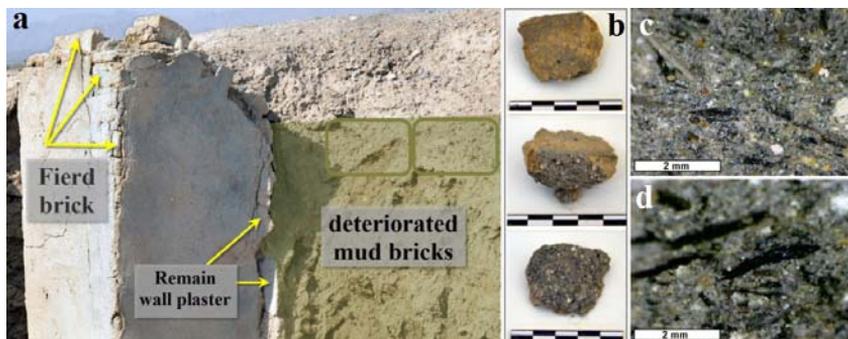
Fig. 11. The stable plaster layer on the burnt pillar, and the remains of plaster on the mud brick wall (a) and the composition of the sample MP.10 (b, c, d)

Sample MP 10 was taken from the plaster used on the mud brick wall and a burnt brick pillar at Sq. 23 C. Field observations revealed that the plaster was stable on the burnt brick pillar but completely destroyed on the mud brick wall. The results of the optical microscope analysis show that sample MP.10 consists of grayish cementing background, containing remains of burnt material "BM". This sample is different from the other samples, as it has only one gray layer used on a mud brick wall and a firebrick pillar (Fig. 11).

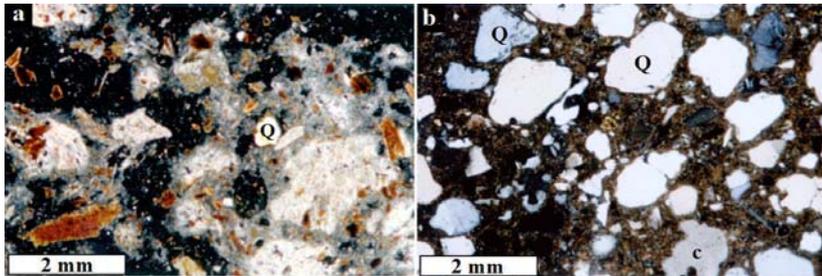
Fig. 12. Microphotographs of Qarh plaster under crossed polars (a) and Quartz in sample MP.1a and in sample MP.1b (b)

From the results of the polarized microscope investigation, a difference between the two layers MP.1a and MP.1b was detected. Sample MP.1a consists of different shapes and sizes of quartz "Q" and stone fragments "SF" in a gypsum background. Sample MP.1b consists of different shapes and sizes of quartz (sand) "Q" in a background of clay, iron oxides and traces of burnt organic materials (Fig. 12). These results comply with the results of other investigations, carried out on similar samples [19, 20].

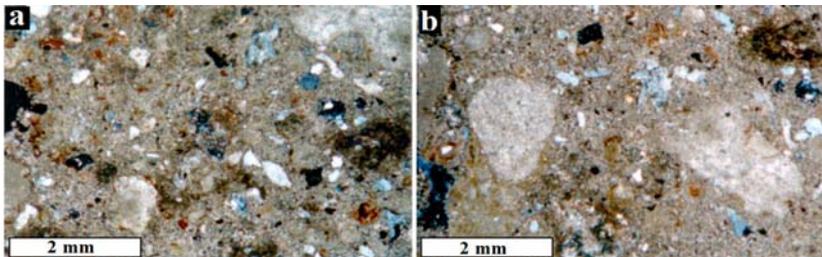
Fig. 13. Microphotographs of sample MP.2 showing the mixture of gypsum, sand and charcoal fragments under crossed polars.

The PM result of Sample MP.2 has revealed that it consists of a mixture of a gypsum background with various phases of gypsum nodule, a little amount of quartz (sand) and charcoal fragments. This composition, where the filler was not enough, explains why this sample is weaker than the other samples (Fig. 13).

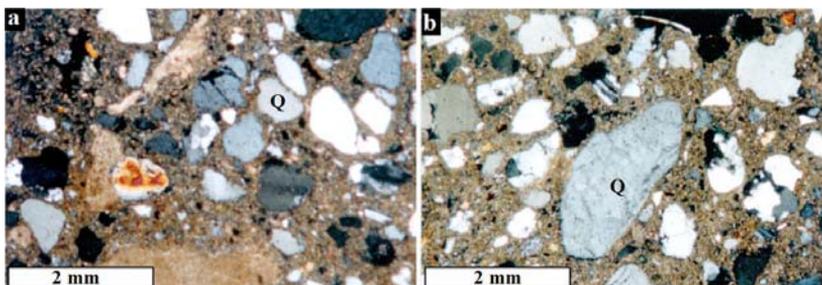
Fig. 14. Microphotographs of white upper layer in sample MP.9a (a), the gray lower layer in sample MP.9b (b) under crossed polars.

Sample MP.9 (including MP.9a) representing the white upper layer and MP.9b representing the gray lower layer. The Polarized Microscope results show that MP.9a consists of quartz (Q) in different shapes and sizes in a calcareous background, lime lumps and stone fragments. Sample MP.9b consists of a mixture of calcite and quartz as well as traces of burnt organic materials (Fig. 14).

We may deduce that the white matter (gypsum) was replaced by calcite (lime). The lime plaster was used to coat the ancient bathrooms that usually used water more than the other units in the ancient homes, as lime plaster is more resistant to water than gypsum plaster [21]. Thus, we assume that the builders knew that information and therefore replaced gypsum plaster with lime plaster. In addition to moisture isolation that layer consists of gray ash, lime and sand.

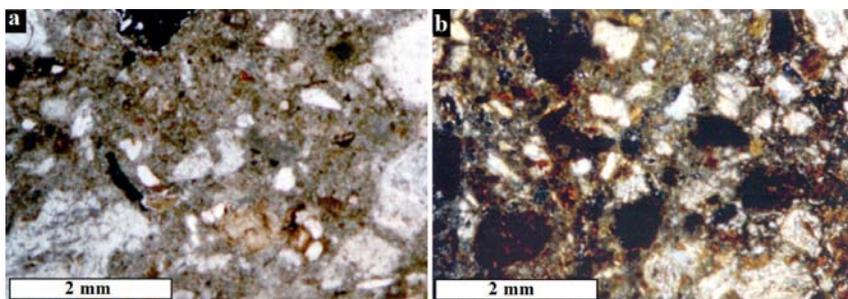
Fig. 15. Microphotographs of sample MP.10 under crossed polars.

The polarized microscope investigation of sample MP.10 revealed that it consists of a mixture of gray background of manual kilns ash, gypsum, calcite and quartz, as filler. This sample was different from the other samples, as it is gray color and consists of a mixture of calcite, gypsum and quartz, used for plastering the firebrick pillar (Fig. 15).

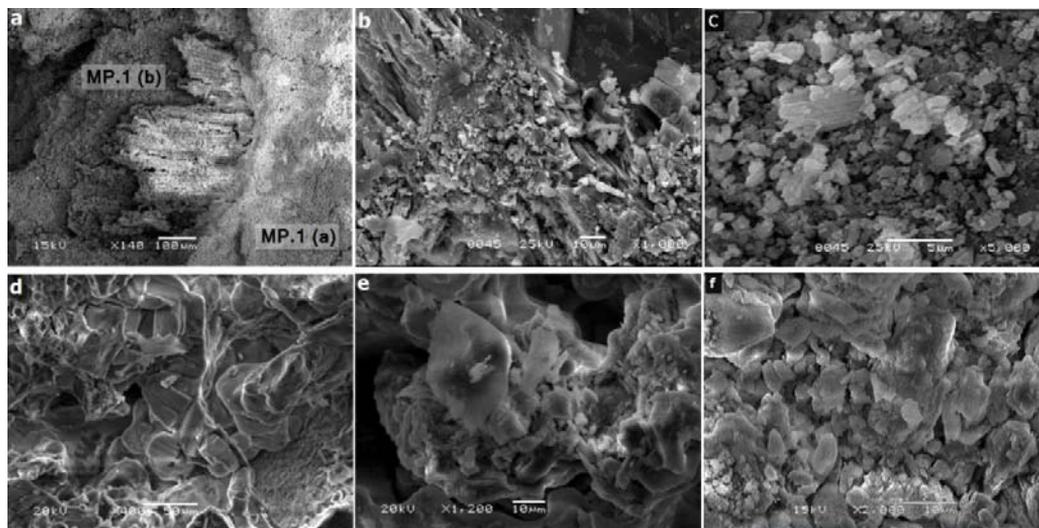
Fig. 16. SEM images: a - the difference between the texture of sample MP.1a and MP.1b, b - the surface deterioration of the sample MP.1b, c - halite crystals in the background of bassanite and sand, d - the white upper surface of the sample MP. 9a containing halite crystals, sand and lime, e - gray under layer of the sample MP.9 b, f - the damaged of bassanite and calcite components in sample MP.10.

Results of the scanning electron microscope investigations showed that the surface of sample MP.1a and b was fragmented and damaged (Fig. 16a and b). Sample MP.2 shows halite crystals in a background of gypsum (Fig. 16c), sample MP.9a and b shows the deterioration of the surface that contains halite crystals, sand and lime (Fig. 16d and e) and sample MP.10 shows the deformation of calcite and bassanite grains (Fig. 16f).

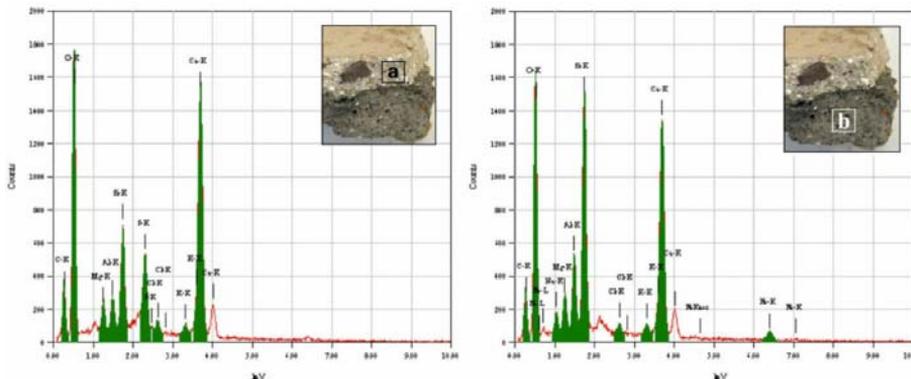
Fig. 17. EDS spectrum of MP. 9 (a and b) samples.

The results of the EDS analysis carried out on the sample MP.9a and b are shown in Table 2 and Fig. 17.

Sample	C	O	Mg	Al	Si	S	Cl	K	Ca	Fe	Na
MP.9 (a)	9.54	22.31	1.98	2.59	7.85	7.34	1.74	2.04	44.61	-	-
MP.9 (b)	7.88	19.70	2.16	5.54	19.02	-	1.07	1.97	37.34	3.78	1.45

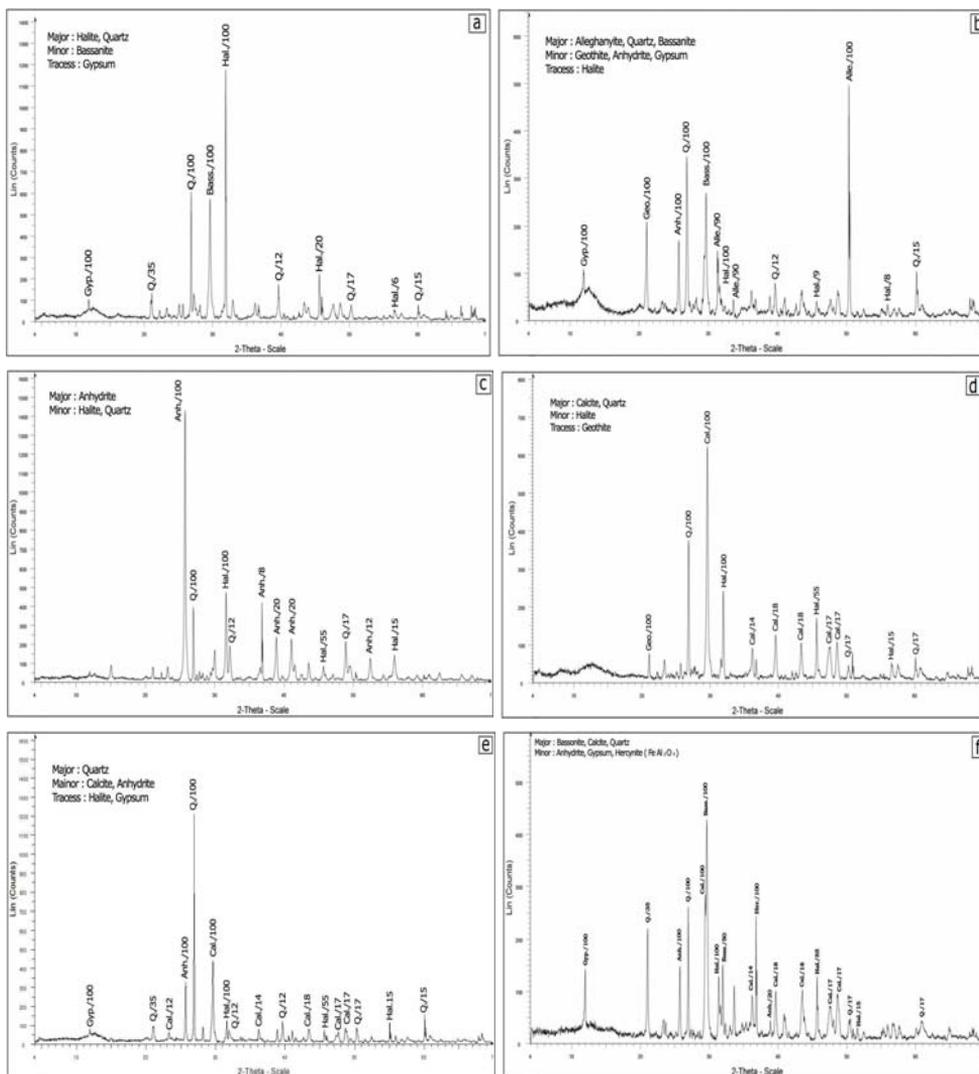
Fig. 17. X-ray spectrums of the identified minerals from the studied plasters samples, Sample MP.1(a and b), Sample MP.2(c), Sample MP.9(d and e), and Sample MP.10(f).

The results of the XRD analysis for the studied samples are shown in Table 3, and Fig. 17(a, b, c, d, e, f) [25, 26].

The XRD results confirmed the investigation results obtained by optical microscopy, polarized microscopy and SEM-EDS. From those results, we deduced that the main materials used in the different kinds of Qarh wall plasters were:

- Gypsum (Bassanite $2\text{CaSO}_4 \cdot \text{H}_2\text{O}$, Anhydrite CaSO_4)
- Lime (Calcite CaCO_3)
- Sand (Quartz SiO_2)
- Qsromel (the ash resulted after burning firewood and other materials in manual kilns), (Alleghanyite $\text{Mn}_3\text{Si}_2\text{O}_8(\text{OH},\text{F})_2$, Hercynite FeAl_2O_4)

Halite (NaCl) was detected in samples; MP.1a and b, MP.2 and MP.9a and b, as a salt contamination rather than as a plaster component. Its existence is a result of its transferring from under ground water in the soil through water capillarity.
