## EVALUATION OF COLORIMETRIC CHANGES IN THE ITAQUERA GRANITE OF THE RAMOS DE AZEVEDO MONUMENT, SÃO PAULO, BRAZIL

**Keywords:** *Itaquera Granite; Color; CIE L\*a\*b\*; Spectrophotometer; Biplot analysis.*

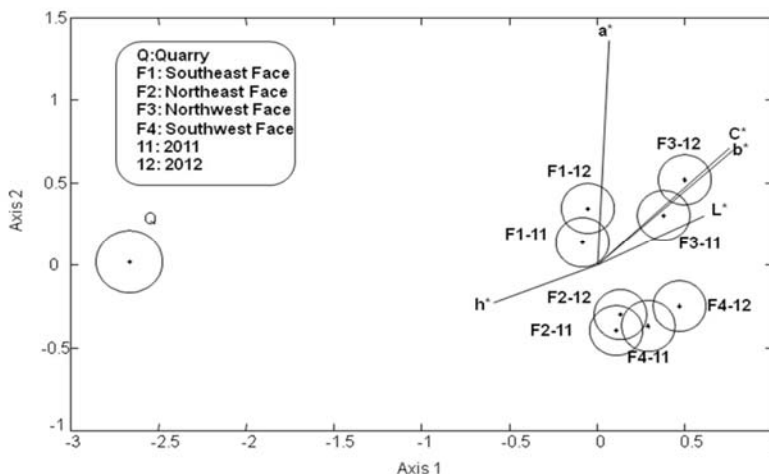
**Fig. 3.** Graphical representation of the color of unaltered granite for the different faces of the monument in the years 2011 and 2012.

The chromatic parameters obtained in this work are presented below. Figure 3 shows the statistical color analysis for the different faces of the monument in the years 2011 and 2012.

The  $L^*$  parameter increased, so there was a lightening of the granite in the monument compared to the sample from the quarry. The finish of the monument is bush-hammered, whereas the measurements for the fresh sample were performed on a fracture surface. This difference in finish may be the cause of the lightening of the  $L^*$  parameter for the monument. During the period of analysis, there was a certain constancy in the cleaning of the monument, which would also contribute to a higher  $L^*$  value. In addition, the sandblasting done in 1999 might also have contributed to the higher  $L^*$  value for the monument.

No major difference was observed in the measurement of the parameter  $a^*$  between the monument and the sample from the quarry.

The parameter  $b^*$  is greater on all faces and for both years, with a notable yellowing of the granite in the monument compared to the fresh sample. Face 3 is the one with the greatest yellowing.

After two years of studying the Monument to Ramos de Azevedo, a small change was observed in  $b^*$ , while  $L^*$  and  $a^*$  remained very close to the original values, resulting in more yellowish hues in the stone, as we can see in Figures 3 and 6. Considering each face separately, there are no discrepancies in the colorimetric parameters, indicating that solar irradiation, wind and rainfall have homogeneous effects across the monument.
