THE CLEANING OF THE ISIS TEMPLE'S MURAL PAINTINGS IN UPPER EGYPT USING ZINC OXIDE NANOPARTICLES AND NON-IONIC DETERGENT

Abstract

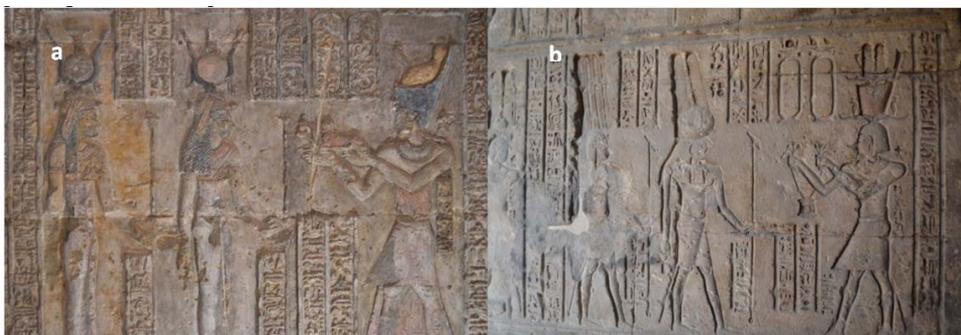
Fig.1. Mural painting at the Isis Monastery at Deir Chelouit **a-** raised relief; **b-**sunken relief in the internal wall of Isis temple with some pigments on whitewash.

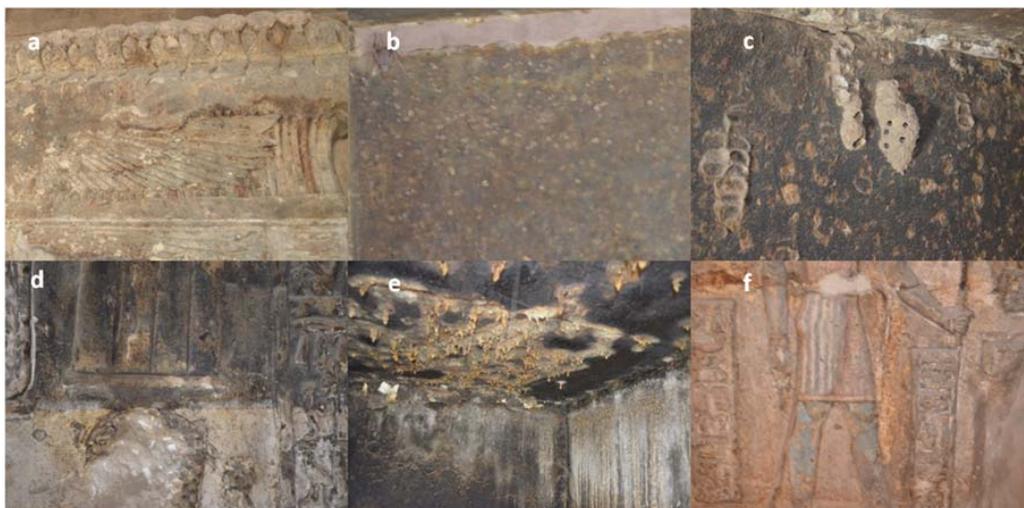
Fig. 2. Conservation state of the Isis Monastery, showing the high degree of decay of the sandstone: discoloration of the surface, bats dropping, concentrated layer from dust, wax and birds, bee nests, spider web nests, soot, oil soot layer and losses of pigments.

Visual examination inside the Isis temple revealed that all the surfaces of reliefs present visible discoloration, generally grey/black, but occasionally brown, orange, red or green in appearance (fig. 2a) due to the prolonged action of microorganisms. The atmospheric conditions of the Isis tomb have favored the growth of microorganism, in particular where higher humidity values were present. Among the macroorganisms, bats had a critical importance in the mural paintings deterioration of Isis temple. They had more destructive tools than other macroorganisms through their excretions. These excretions which contain guano, blood and urine (Fig. 2b) cause not only aesthetic damages but also physicochemical changes of the substrate that lead to irreversible loss of valuable historical stone surfaces [4]. Concentrated layer from birds dropping, bees' nests and spider web nests were noticed clearly (Fig. 2c). Also, the wall is completely covered with concentrated layer from soot and patches of waxes (Fig. 2d), resulting from burnt candles by visitors in Coptic era which caused irreversible disfigurements, changing and reducing the surface permeability. The extensive observations of the zones with ground moisture and stone shows crumbling, scaling, and the most salt efflorescences appearances (Fig. 2e). Analyses showed that chlorides and gypsum are locally concentrated and accumulated. The presence of salts had led to the detachment and flaking of the paint layer (Fig. 2f). The aim of this research is to evaluate new analytical strategies using Nano micelles assembled with ZnO nanoP and dispersed in non-ionic detergent as cleaning agent and to compare to Ethomeen C_25 (Polyoxyethylene15), Vulpex (potassium methyl cyclohexy, (Triton X-114) Polyethylene Glycol Octylphenyl Ethers used here in removal of wax, soot and blood of bats (bats dropping) from the surface of wall painting in Isis temple at Luxor.

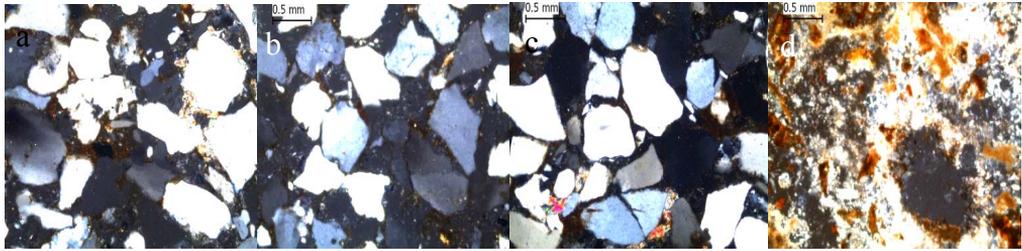
Fig. 3. Petrography micrograph of sandstone samples; **a-** subrounded and wavy extinction of quartz grains resulted of deterioration aspects and ferrous oxide, **b-** concave convex boundaries, dark and altered of quartz grains coated with clay minerals; **c-** angular grains of quartz and altered feldspar **d-** phosphate, Iron coating and staining.

Texture: The quartz crystals are angular to sub-rounded in shape. They are surrounded by feldspars (partially altered to sericite); wavy extinction and concave convex of quartz were observed. Iron coating, staining and phosphate grains were also observed (fig. 3a-d).

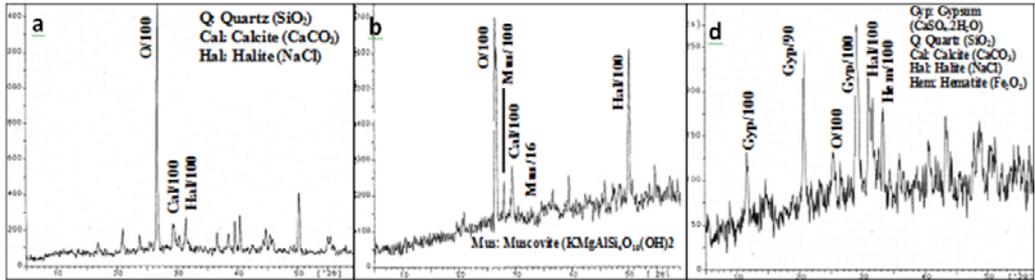
Fig. 4. XRD patterns of mural painting at Isis temple; **a-** Sandstone samples; **b-** salt sample; **c-** plaster samples.

XRD (Fig. 4) results indicate that the most abundant element in the sandstone samples is quartz (65.40%); white feldspars, (10.25%), calcite (5.10%), clay minerals (5% montmorillonite) appear in smaller amounts. Also XRD analysis showed NaCl concentration levels of 2% whereas samples from the lower parts from the temple ranged from 5.44 to 6.12%; these ratios indicate that an amount of NaCl has accumulated in certain areas of the building. So, salt crystallization is a direct cause of damage.

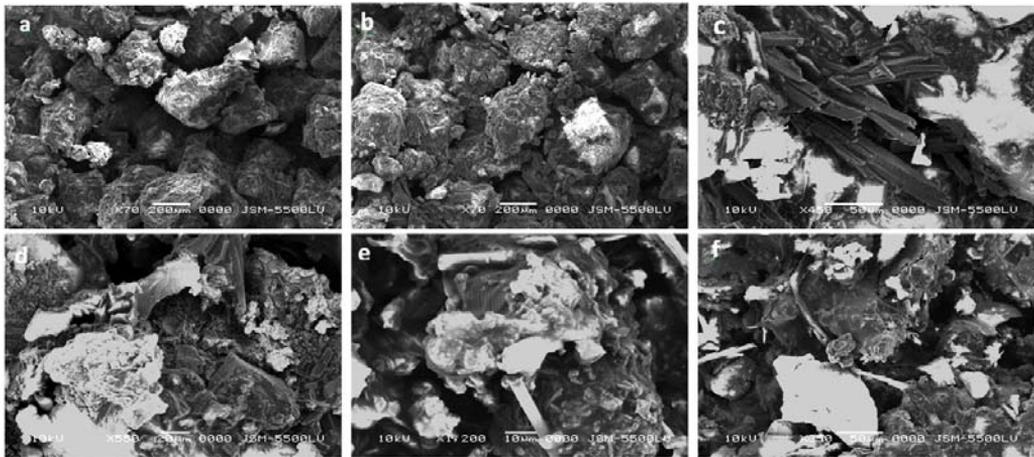
Fig. 5. SEM photomicrographs of the sandstone samples; **a-** deformation of subangular quartz grains; **b-** micro exfoliation; **c-** sodium chloride crystals; **d-** crystal of gypsum; **e-** shell and shell fragments; **f-** Extensive penetrations of fungal hyphae.

SEM: It is possible to observe variable sizes of angular and sub-rounded particles of quartz grains (fig. 5a). SEM photomicrograph shows that even quartz, which is one of the most durable minerals, showed susceptibility to mechanical deformation, it showed micro exfoliation, micro pitting appears clearly and dissolution of cements occurs of the sandstone which leads to an increasing in porosity and loss of cohesion of the stone and the disintegration of crystals is seen clearly (fig. 5b). The scanning examine also shows the presence of sodium chloride crystals in some phases of crystal and traces of crystalline salts mixed with crypto-salts accumulated in the pores (Fig. 5c). Also, the SEM photomicrograph showed crystals of gypsum (Fig. 5d). The observations revealed significant presence of shells and shell fragments (Fig. 5e). SEM micrographs showed the biodeteriorated stone surface beneath the microbiota (Fig. 5f). Extensive penetrations of fungal hyphae inside the stone were clearly established in some samples. Fungi are capable through a range of etching and chelating processes, to bore and burrow their way into mineral surfaces producing distinctive boreholes pits and channels.

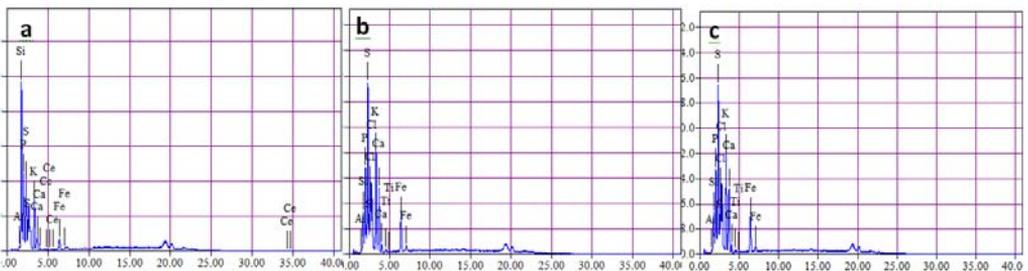
Fig. 6. EDX pattern of sandstone samples from Isis temple at Luxor.

EDX microanalysis of various sandstone samples listed in (Fig.6 & Table 1) showed that, the samples essentially consist of silicon (Si) (11.70 - 35.63%), Calcium (Ca) (5.52 - 38.69%), Potassium (K) (4.35 - 30.58%), alumina (0.84 - 4.44%) sodium (Na) (3.20%) and sulfates (4.56-19.18%). Considering these results, it can be concluded that, the main building materials used in the temple is sandstone containing Si as the major cemented by calcite. The high amount of potassium (K) and Aluminum (Al) is attributed to feldspar content of the rock. A high concentration of sulfate (S) ions may be attributed to the crystallization of gypsum salts. The high concentration of sodium can perhaps be attributed to sodic or plagioclase feldspar or the high concentration of chlorine (Cl) (6.68 - 8.47%) and sodium (Na) (3.20%) can be attributed to the crystallization of halite salt. Iron (Fe) was identified in darker brown samples which is present as cement. In addition, the chemical analyses of sandstone samples from Isis temple reveal interesting points. Phosphate (P) elements are generally found in the all samples. The P content varies widely. It was generally a minor constituent (5.26 - 6.23%) but in exceptional sample it represents a major component (10.69 - 20.60%). It occurs mainly as phosphatic shell dirties and probably to a lesser extent as detrital apatite and probably also replaces silicon in silicate minerals [12]. Titanium (Ti) appeared to be correlated with the content of alumina. High manganese (2.00%) was noted in some samples which attributed to shale or phyllite. The presence of magnesium (Mg) with high concentration, suggests a somewhat dolomitic carbonate in the cement.

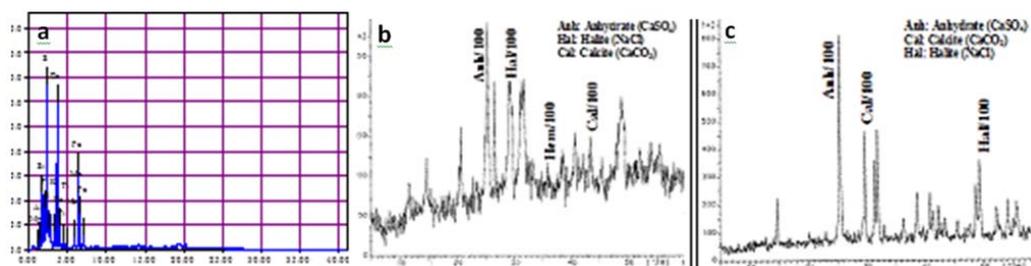
Fig. 7. Analysis results of plaster samples, a- EDX pattern of plaster; b- external plaster sample; c- XRD pattern of internal plaster.

The sample obtained from the degraded plaster from the temple of Isis under stereomicroscope shows a non-homogeneous surface layer and the grains are covered with thick layer of dirt, small fissures and smoke in outer surface of gypsum grains. EDX analysis reveals that the plaster sample taken from external relief contains Ca, S and K as the main elements with the contribution of Si, Fe, P, Cl and Na in small percentages (Fig. 7a). XRD patterns of the thin plaster (Fig.7b and c) indicated that it was mainly consists Gypsum ($\text{CaSO}_4 \cdot 2\text{H}_2\text{O}$), Anhydrite CaSO_4 (Transformation of gypsum $\text{CaSO}_4 \cdot 2\text{H}_2\text{O}$ to Anhydrite CaSO_4 by thermal weathering), Calcite CaCO_3 , Quartz SiO_2 and a small amount of Halite NaCl . Calcite originates from limestone powder, quartz from aggregates and Halite from salts.

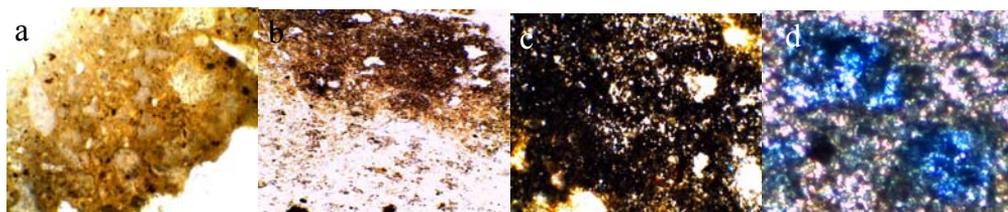
Fig. 8. LOM photomicrograph of paint layer: a- yellow pigment, b- brown pigment, c- red pigment, d- blue pigment (X40).

Yellow pigment: On careful observation under the stereomicroscope, the yellow pigment appeared to have different shades of yellow that can be described qualitatively as bright-yellow and orange-yellow. The examination showed the particles are polygonal in shape and coarse morphology of the surface (Fig. 8a). These large particle sizes suggest the

Brown pigment: The brown pigment appears to be homogeneous with regard to color and indeed only one shade of reddish-brown was observed. The observation revealed a net of micro-cracks at the surface of the color (Fig. 8b). In the EDX analyses of the brown pigment an important amount of Iron (60.54%) was observed (Fig. 9b). Brown color may be produced by iron oxide.

Red pigment: The image of the red paint sample showed an uneven thin layer which tends to be dark red (Fig. 8c). In the SEM-EDS analyses of the red pigment sample, Fe, S, Ca and Si were detected as major elements and As, Al, K, and Ti, as minor elements (Fig. 9c). The presence of iron was confirmed by using SEM-EDX on samples taken from red colored areas. There was a clear evidence of hydroxides (mainly hematite) that colored the pictorial film to vary degrees.

Blue pigment: According to LOM indications, the blue pigment has irregular particle shapes, coarse grain and uneven thin layer. It is composed by small black inclusions of whitewash (Fig. 8d). The sample of blue pigment from Isis temple in this study was composed primarily of calcium (Ca), sulphur (S), silicon (Si), with copper (Cu), iron (Fe), aluminum (Al), magnesium (Mg), titanium (Ti) and tin (Sn), present in different concentrations. The present analysis and the SEM-EDX information (Fig. 9d) confirms that Cu and Ca are correlated within cuprorivaite (Egyptian blue) domains identified based on their Cu. The presence of Mg, Ti and Sn, suggests an ultrabasic geochemical origin of the copper ore. The observation of aluminum (Al) in the paint layer can be explained as impurity found in the iron compounds. Egyptian blue was manufactured by heating silica sand, copper alloy filings or ores and potash or Natron, and was commonly found in artefacts from the 4th Dynasty onwards [14].

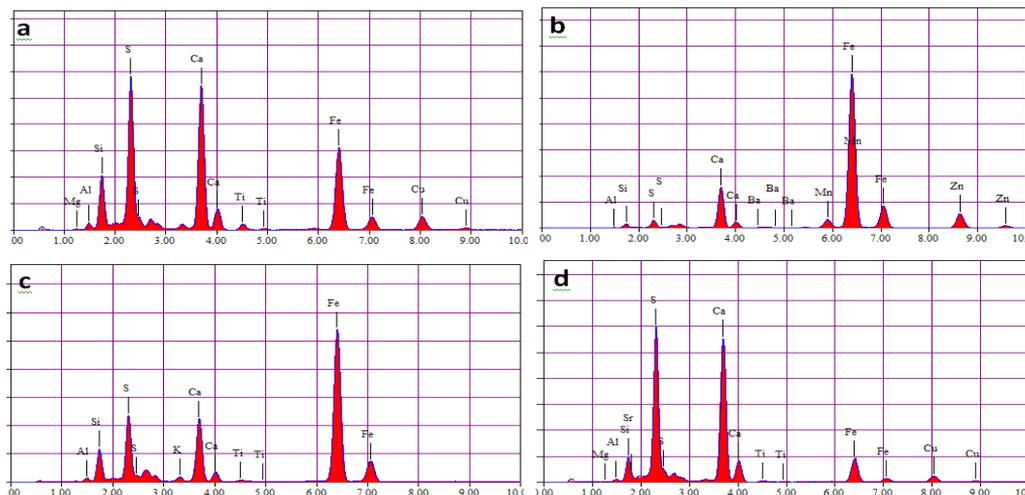
Fig. 9. EDX pattern of pigment samples; a- yellow pigment; b- brown pigment; c- red pigment; d- blue pigment

pigment was grounded after production. Also, subtle color differences may also be seen among the particles. Some of the particles appear red-yellow, while others are more intensely red. The elemental composition analysis of the yellow pigment indicates that it is mainly composed of Fe, Ca, S, Si, Al and As (Fig. 9a). The presence of Iron may be responsible for yellow pigment, Ca and S may be from ground layer. The less amounts of arsenic (As) and Cu may attribute to heavy metals in sandstone. The observation of aluminum in the paint layer can be explained as impurity found in the iron compounds. The most common yellow pigment in ancient and prehistoric Egyptian art is goethite, iron (III) oxhydroxide, commonly known as yellow ochre [13].

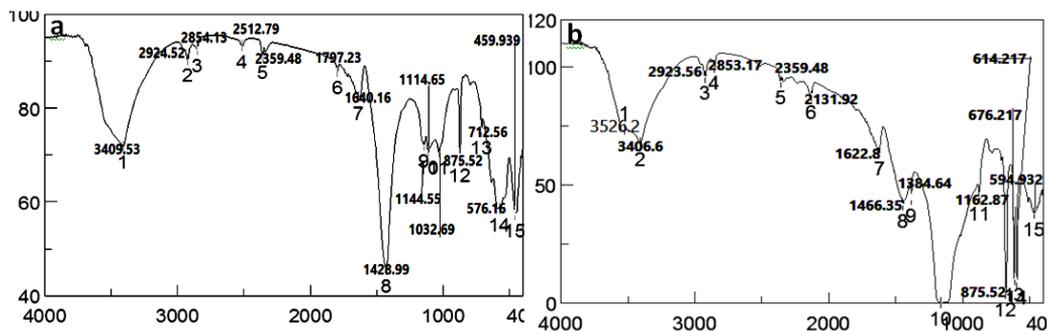
Fig. 10. FTIR spectra for the paint layer samples, a- Blue pigment; b- brown pigment.

Fourier transform infrared (FTIR) spectrometry was employed with the aim of establishing the possible existence of an organic medium that acts as a binder in the paintings studied. FTIR analysis was carried out by scraping samples from the areas that were expected to be rich in binder material, that is, the pictorial film areas from red and blue pigment. The results of FTIR analysis of the samples listed in (Table 2, Fig.10) showed that, this high percentage is reflected in an important band in the IR spectrum, caused by the carbonate bands like stretching vibration of CO_3^{2-} (1430cm^{-1}). This strong band could be overlapping others in the $1300\text{--}1600\text{cm}^{-1}$ range and the bending vibration for calcium carbonate occurs at 875cm^{-1} . FTIR spectra revealed the presence of gypsum ($\text{CaSO}_4 \cdot 2\text{H}_2\text{O}$) due to the anti-symmetric and symmetric O-H stretching, 1144cm^{-1} due to asymmetric S-O stretching and 600 and 700cm^{-1} due to S-O bending. This indicates that the ground layer at Isis temple was made by mixture of calcium carbonate and gypsum. The organic binders show spectral features in the whole middle infrared spectral range. Animal glue is hydrolyzed collagen and therefore shows typical protein vibrations like the so called amide I (1620 , 1640cm^{-1} , mainly C=O stretching) [15] and amide II ($3400\text{--}3200\text{cm}^{-1}$ CH stretching and $2900\text{--}2800\text{cm}^{-1}$, NH stretching) band. The FT-IR spectrum of the binding media was similar with the stander animal glue [6].

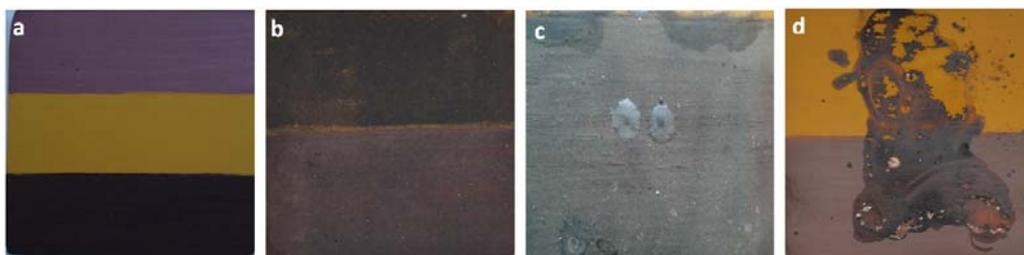
Fig. 11. Wall painting models before and after adding the deterioration aspects: a,b- models before adding; c- soot, dirt and wax; d- bats blood.

A typical wall painting, belonging to the classic tradition in Pharaonic Egypt, consists of sandstone used as a support and roughly three layers (Fig. 11a and b) whose main structural component is gypsum, calcium carbonate, and sand with ratio 2:1:0.5. The inner layer, which is laid on the wall, is called arriccio. Moving towards the surface, the intonaco layer is found, consisting of a plaster that often contains an equal amount of gypsum and calcium carbonate with little fine sand. The third and outer one is the paint layer, which is a thin film (50 μ m thick) made by a mixture of common pigments and animal glue as organic binders (which used in Isis temple) in the so-called tempera technique which is applied on the dried intonaco by using organic binder. On the other hand three kind of the most common pigment, brown (Hematite Fe₂O₃ + carbon black), red (Hematite), yellow (goethite FeOOH) and black (carbon black C) were used in the Egyptian wall painting. After the models preparation, an artificial and concentrated layer of the most common deterioration, dirt, which was obtained from the accumulated dust on the outer surface of the temple mixed with water supplemented with glue to increase cohesion with the model surface, bats blood obtained from dead bats, soot obtained from metal surface which has been exposed to soot rising from the burning of organic materials, scraped and mixed with oil and then put on the surface of the model using the brush and wax obtained from candles were added on the experimental models surfaces (Fig. 11c and d).

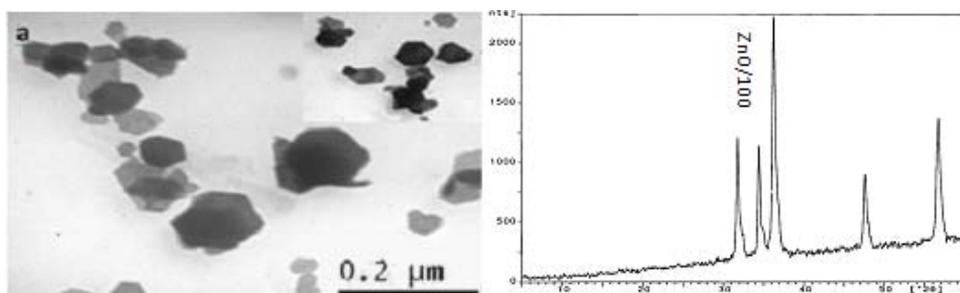
Fig. 12. TEM image (with size about 150-210nm) and XRD patterns of the prepared zinc oxide nanoparticles.

In order to analyze morphology and particles dimension, the preparations ZnO nanoP were characterized by X-ray diffraction (XRD) and profile analysis, by transmission electron microscopy (TEM) JEOL JSM 6400 with an acceleration voltage of 100kV.

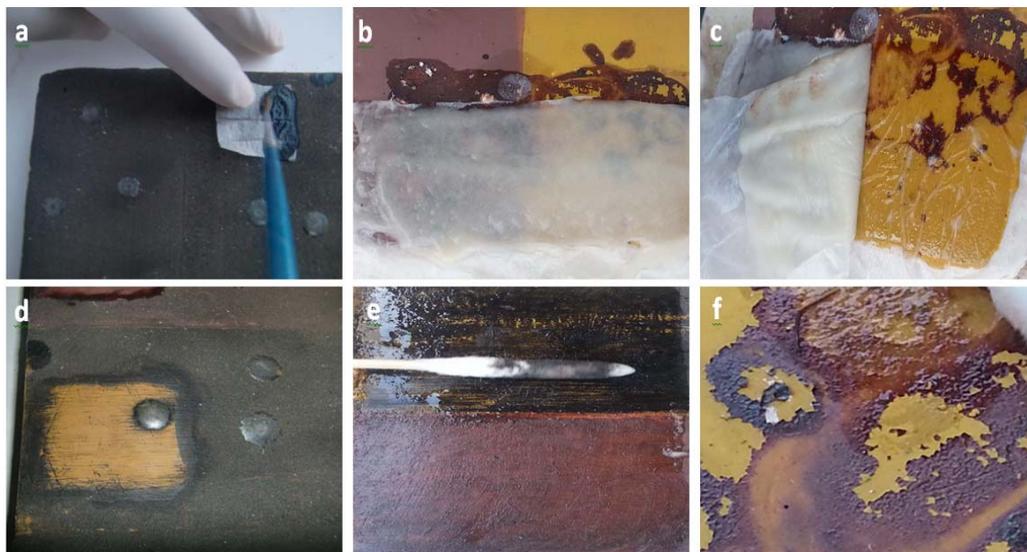
Fig. 13. Results of application of NPs for removal the deterioration aspects from the surface of mural painting; **a-** cotton swab technique; **b-** ZnO + Nonionic detergent in carbojel, **c-** removing of the poultice and the remaining materials; **d-** good affects for soot and dirties and none affects wax and blood; **e-** excellent affects for wax and blood batches; **f-** discoloration and removing pigments by composite (5).

- Composite (4) gave very good results for soot, dirt and good results of wax (Fig. 13e).
- Composite (5) was very effective in cleaning the models but had a discoloration effect and removed pigments (Fig. 13f).

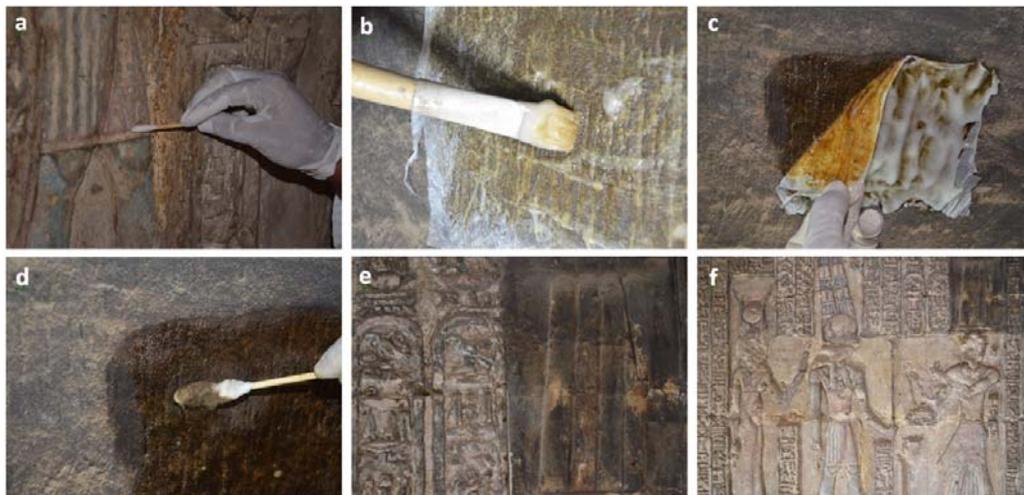
Fig. 14. Application of ZnO NPs on mural painting in the temple of Isis: **a**-cleaning by ZnO NPs with soaked in a swab; **b**- The wet pulp is manually distributed over the Japanese paper layer; **c**- Composite (3); **d**- removing of poultice; **e**- removing of remaining materials with cotton swab embedded with distilled water; **f**- the results of mechanical and chemical cleaning.

- From fig.14e it can be observed that the soot layer and blood batches crust of sample were successfully removed from the surface upon treatment with the composite 3.

The surface of mural painting in Isis contains several disfiguring overlapping stains as blood batches, wax, soot and dirt. The cross section and optical microscope examination images shows, the soot impregnated into porous and covering the grains of the sandstone and plaster. For that reason, the use of nanoparticle solution (NPs) mixing with nonionic detergent was required. Results of the experimental study suggested that the ZnO NPs dispersed in Ethomeen C25 5% mixed with Vulpex (K₅P₃O₁₀) (potassium methyl cyclohexyl (1:1) was the best composite for removing the deterioration aspects. The cleaning of the surfaces is an irreversible process; therefore, the methodology chosen to remove batches must allow full control of all steps in order to ensure the complete solubilization/swelling and removal of the undesired materials while avoiding their penetration within the painting pores, so that the physiochemical properties of the mural are fully re-established [20]. Treatment tests using these materials were undertaken at three different sites: the wall painting outside the temple, (which are affected by blood patches and remains of nests); the wall painting inside the temple (which are affected by soot, remain of waxes and blood patches) and finally for removal of oil-soot made by vandals to deface at Coptic era. The simple preparatory work to test the sensitiveness of pigments and binding media present in the painting stability of the painting was carried out on top using small amounts of the microemulsions on small areas with soaked in a swab, checking for possible negative effects. Composite (3) solution was applied using the two techniques (soaked in a swab or Arbocel compress poultice). The application consists in the following procedures: Composite (3) was mixed with Arbocel and applied over a thin sheet of Japanese paper, whose role is to avoid the adhesion of the poultice to the partially solubilized coatings. The contact time for each application was two hours and the temperature was 28°C. Finally, the poultice was removed and the remaining materials were removed with a gentle mechanical action and then cleaned many times with cotton swab embedded with distilled water to remove any residual surfactant (Fig. 14).

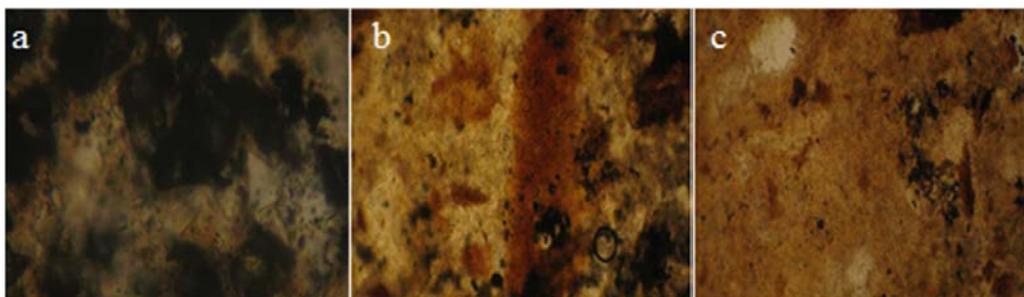
Fig. 15a, b, c. Optical microscopy results of application of ZnO nanoparticles dispersed in Ethomeen C25 5% mixed with Vulpex for removal blood and soot batches from sample from Isis wall painting, **a**- before application, **b**- during cleaning. **c**- After cleaning

Micro-samples were taken with scalpel from the painting surfaces before and after cleaning, and analyzed by LOM. The purpose of this was to determine the efficacy of the cleaning agents used. LOM confirmed the efficacy of ZnO NPs dispersed in Ethomeen C25 5% mixed with Vulpex (K₅P₃O₁₀) in cleaning. LOM micrograph shows the layer of deterioration aspects were completely removed (Fig.15). Also the FT-IR spectra, reported in (Fig. 16), show that no etching damages or changing was introduced on the wall painting substrata after the cleaning. FTIR results confirmed the stability of the pigments before and after cleaning of different kind of organic patches. A FTIR comparative study for the untreated samples (a) and treated sample with ZnO NPs assembled with the Vulpex was conducted. FTIR spectral assignment, there are typical frequencies of the two sample.

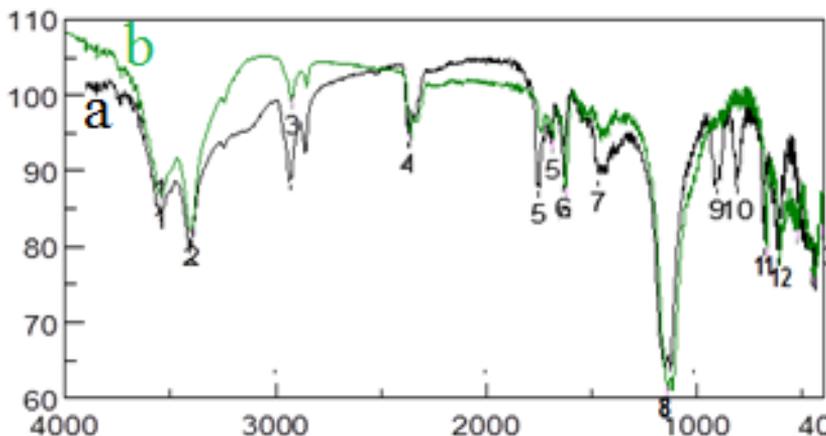
Fig. 16. FTIR patterns of untreated samples (a) and treated sample with ZnO NPs assembled with the Vulpex (b)
