## SUSTAINABILITY OF ARCHITECTONIC CONSERVATION YARDS IN ENVIRONMENTAL PROTECTED AREAS: THE CASE OF THE ZÉNOBITO TOWER IN CAPRAIA ISLAND

*The issues addressed in the restoration project for Zénobito's Tower, in Capraia Island, are a stimulus for a broader debate on sustainability of architectural preservation interventions in delicate environmental contexts inside protected areas. As a matter of fact the preservation intervention on the tower and the absolute preservation of the environmental context impose a severity rarely practiced, even in restoration. The tower is three and half hours walking distance from the village, in a wilderness area where in some periods even walking is forbidden, due to protection of nesting birds. The sea in front of it is a marine protected reserve, with severe limits on access by boat. The authors set the goals of the projects for restoration of this heritage as material conservation of the tower; minimal intervention; reversibility or retractability; usage of eco-friendly materials. All this led to a serious reflection and a careful evaluation of every factor that may have an impact on the environment. This paper includes a theoretical discussion,

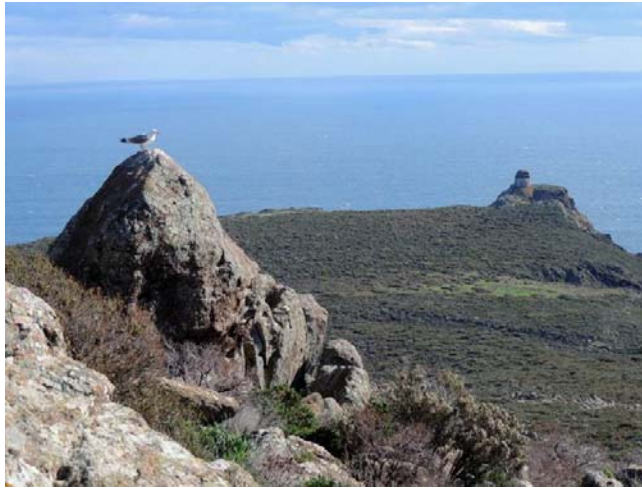
**Fig. 1.** The southern tip of Capraia Island with the Zénobito tower

The tower is located in an unspoiled natural area, three and a half hours walking distance from village, with no roads (Fig. 1). In some periods of the year even the simple passage of people on the footpath is forbidden to protect the nesting birds. The sea under the tower is a marine reserve, with strict limits to vessels transit. The tower is now abandoned, conservation

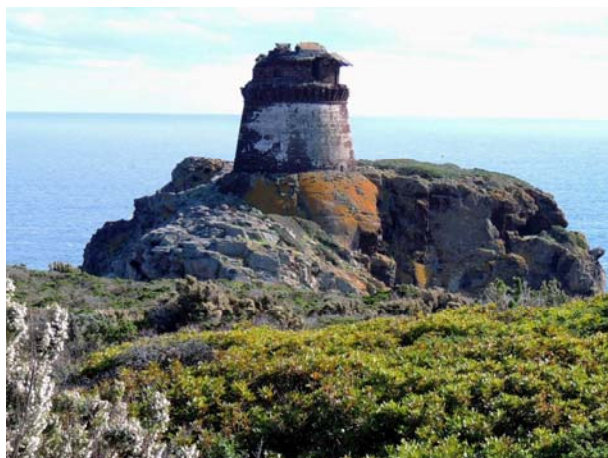
Currently the tower, which has no static problems, shows important remains of the plaster coating, still characterized by good adhesion to the wall (Fig. 2).

**Fig. 2.** The shape of the tower with the plastered conical base and the overlying cylindrical body with the corbels that supported a gallery

The plaster over the masonry is missing in large parts of the tower, the action line is to keep it unmodified, because the masonry under it seems to be at “quasi-equilibrium”.

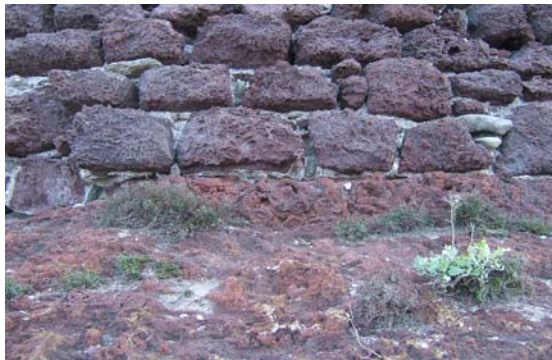
This was achieved in a structure based on two walls, an outer and an inner one, linked by a core element. The outer wall is composed of blocks of volcanic rock, roughly shaped and put in place with a rich mortar, made necessary by the irregularities of the same blocks (Fig. 3).

**Fig. 3.** The masonry made of volcanic rock blocks roughly shaped and put in place with an abundant mortar, made necessary by the irregularities of the same blocks

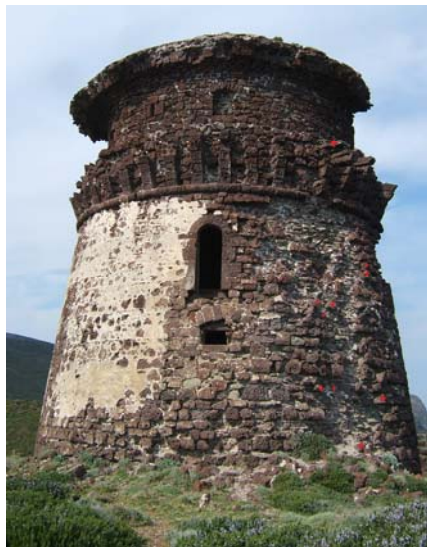
This masonry still shows good cohesion, even if the mortar joints are deeply eroded. Only on the southeast face, a well-defined portion of the external wall fell, uncovering the wall core structure (Fig. 4). Therefore the major preservation problems are in this area and in the upper part of the cylindrical body where the corbels that supported the gallery (no longer present) are deeply eroded and in some cases missing at all. These areas definitely need a restoration that allows stopping the progress of decay mainly due to marine-salts crystallization with the consequent fall of stone elements, but this must be a localized, "non-invasive" minimal intervention. In this regard, from great nineteenth century masters of restoration to recent claims of some contemporary restoration theorists, a common line of thought states that an area that displays and maintains the *patina* of time proves to be a very interesting element, worthy of being kept and maintained [4-11]. Moreover, when an architectural surface is in a state of "quasi-equilibrium", i.e. then the degradation progress is negligible, the non-intervention is preferable [12, 13]. All these concepts have been considered in this project (F.F.).

**Fig. 4.** In the conical base, left side of the image, remains of the covering plaster still with good adhesion of the masonry, are visible; on the right side it is evident the zone where a portion of the external wall fell, uncovering the wall core structure. With red asterisks are marked the stone blocks that in 2010 were still on site and that in the 2013 survey fell down.

Another debate issue is *whether to reconstruct the masonry or not*. The conspicuous lack of material in the south-east masonry, which has been mentioned above, should be carefully analysed in the phase that anticipates the construction yard itself. Today, as a matter of fact, it is not yet clear whether it is simply deterioration or it comes from human activity, for example a cannon shot. This must be understood.

In case of artificial origin the lack should be described in stratigraphic analysis, but it should not be filled again, because the lack itself is an historical document; intervention should be restricted to safety issues, i.e. avoiding falls of materials and injuries to people below.

The main reason in favour of a reconstruction of the missed masonry is the risk of further decay of the structure in absence of such a reconstruction. In case the current state has not an artificial origin, but it is the result of a natural decay, all these pros and cons of an intervention should be evaluated, after an initial study that investigates why the lack has such a narrow extension, the relation to changes in materials or microclimate, for example wind prevailing direction.

If the intervention will be decided, this would be easy to read and distinguish from original parts. New mortar, for example, should distinguish itself from original one; this would be easily obtained because in Italy it is illegal to use marine sand to make mortar, as they did in these times. The hidden masonry wall inside should be photographed before being hidden again, and photos should be exhibited in a museum, for example in the second tower near the village.
