PRESERVATION AND RESTORATION OF THE WADI SURA CAVES IN THE FRAMEWORK OF THE “GILF KEBIR NATIONAL PARK”, EGYPT

In 2010 the Italian-Egyptian Environmental Cooperation launched a safeguarding project for the preservation of the caves with prehistoric rock art located in the Gilf Kebir plateau in southwestern Egypt. The project was part of the cooperation program developed to establish the Egyptian Gilf Kebir National Park (GKNP) protected area. Given their bad state of preservation, the Italian conservation project focused on the Caves of Swimmers and Archers, located along the Wadi Sura. Although only very few studies of this kind have been carried out in the Saharan region, our work in the Gilf Kebir can be considered a pilot study, the results of which should be evaluated in the long term. Results obtained to date and reported in this paper provide analytical petrographic studies of the bedrock, a complete photographic and geodetic survey of the two sites, data from climate monitoring, along with a preliminary consolidation of some of the most at-risk areas of the two caves. Finally, laboratory experimentation led us to select the most suitable materials for the consolidation of t

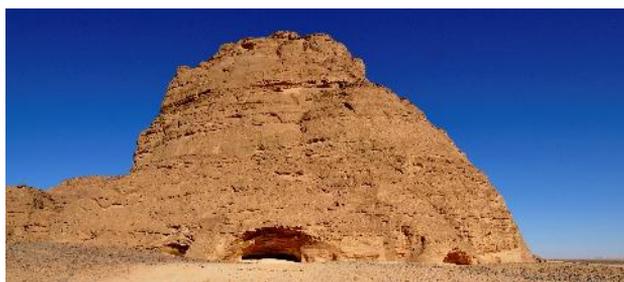
Fig. 2. Cave of Swimmers (center) and Cave of Archers (right).

The conservation work described in this paper focused on the two caves we have known for the longest time, the Cave of Swimmers and Cave of Archers, which given their bad state of preservation, required the most urgent intervention. The first one opens up into a Paleozoic sandstone hill, directly at the bottom of the Wadi Sura; the entrance is large, ranging between 15 and 18 meters wide, and a c. 9-meter height. The cave's chamber is c. 8m deep, with a bedrock floor covered by a thin sand deposit. The smaller Cave of the Archers is located just 40m to the south of the Cave of Swimmers. Its entrance is 10m wide and 5m tall, with a west/southwest orientation (Fig. 2).

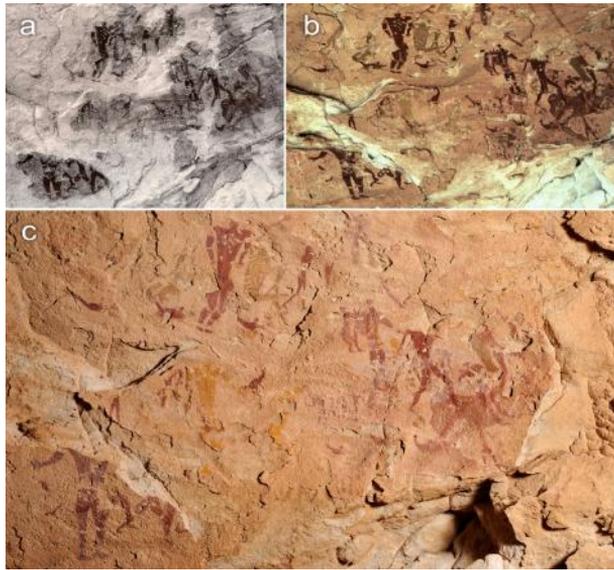
Fig. 3. Cave of Swimmers. Comparisons of the photos of the same area of painted wall showing the severe, but extremely slow degradation process which affected the cave: a. photo published in *Libysche Felsbilder* [6]; b. photo taken by G. Negro in 1983; c. photo taken by C. de la Fuente in 2010.

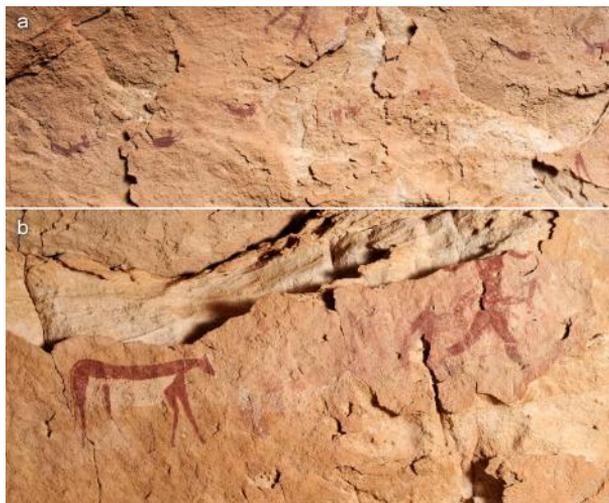
Fig. 4. Cave of Swimmers. Painted wall: a. the swimmers; b. two figures of domestic cattle and human figures.

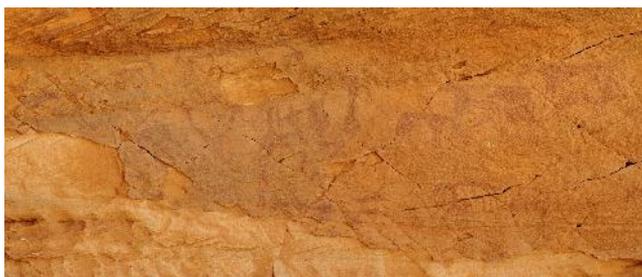
In the Cave of Archers, only a small portion of the original paintings is currently visible and covers an area longer than 2m. A number of long-limbed figures holding bows can be seen in the depicted scenes. Various bovine figures, at the opposite end of the wall, emphasize the greater presence of herder groups than that of hunters, which one would assume from the depicted bows (Fig. 5).

Fig. 5. Cave of Archers. The painted wall of the cave showing figures of domestic cattle and archers.

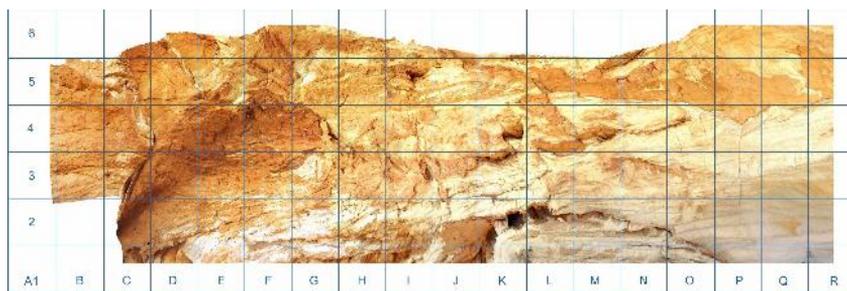
The aim of the geodetic survey was to reconstruct both caves in 3D. Collected data have been used to build high-resolution 3D models of both caves (A. Sonnessa, SurveyLab, Sapienza University of Rome spin-off). Surveying activities were performed using a topographical *Riegl Z210i* laser scanner. The purpose of the survey was also to collect data concerning the conservation conditions of the rock paintings. Several scans were obtained to reconstruct the exact topography of the cavities; 25 scans were produced for the Cave of Swimmers and seven for the Cave of Archers, with an average spatial resolution of about 5×5mm (c. 40,000 pts/m²) for each scan. Purpose-built targets were used to link the scans together. A straightened section of the painted wall of the Cave of Swimmers has been processed and overlaid with a 50×50cm grid in order to facilitate the location and recording of each of the figures (Fig. 6).

Fig. 6. Cave of Swimmers. Straightened section of the painted wall of the cave, with a 50×50cm grid.

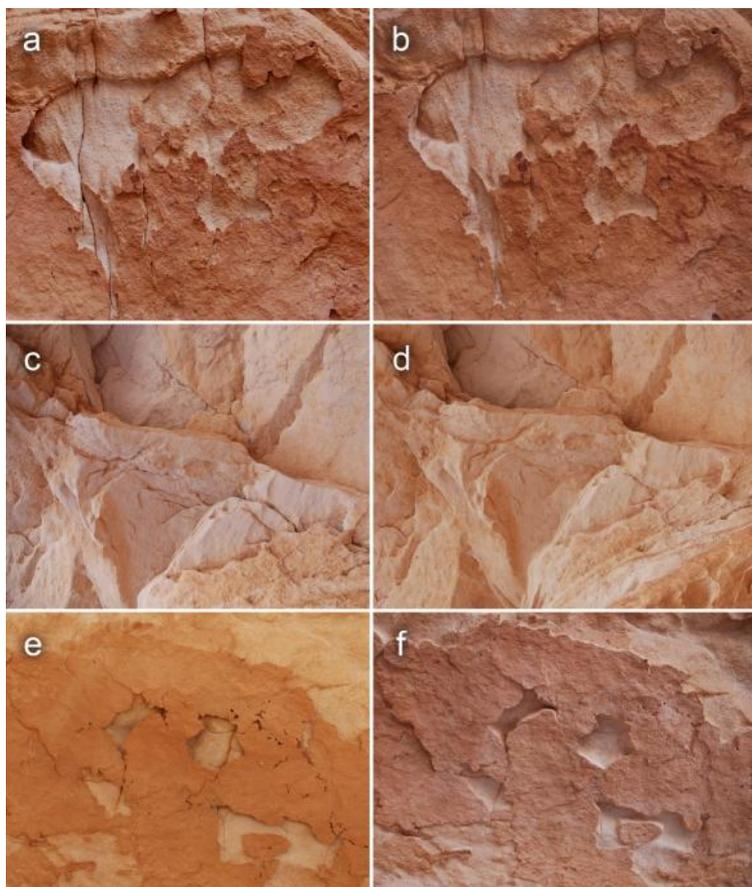
Three c. 50cm² areas from inside the Cave of Swimmers have been chosen to be restored. They show different conservation problems:

- Area 1 is characterized by deep cracks and thin and superficial fractures, lacunae in the iron crust, detached stone layers and wide gaps underneath the crust. There are also figures painted in red ocher (Fig. 7a);
- Area 2 is characterized by a deep and extended hollow below the surface crust. It is extremely thin and only anchored in a few points. There are no painted figures (Fig. 7c);
- Area 3 is located at the top center of the northern half. It has lost its crust, and for this reason, the area is characterized by strong decohesion. A severe phenomenon of sandstone layer detachment is present (Fig. 7e).

Fig. 7. Cave of Swimmers. The three intervention areas: a. Area 1 prior to restoration; b. Area 1 after restoration; c. Area 2 prior to restoration; d. Area 2 after restoration; e. Area 3 prior to restoration; f. Area 3 after restoration.

Figures 20 a-f show Areas 1, 3 and 2, respectively before and after the conservation work. This has not affected surface cleaning nor any pictorial reintegration. Only a small amount of dusting was carried out to remove dust and sand. It was decided that the tone of the recent fracture surfaces should not be darkened even though doing so would have been more visually-appealing to visitors as these fractures are useful indicators of weathering development and thus provide important information to our conservation efforts.

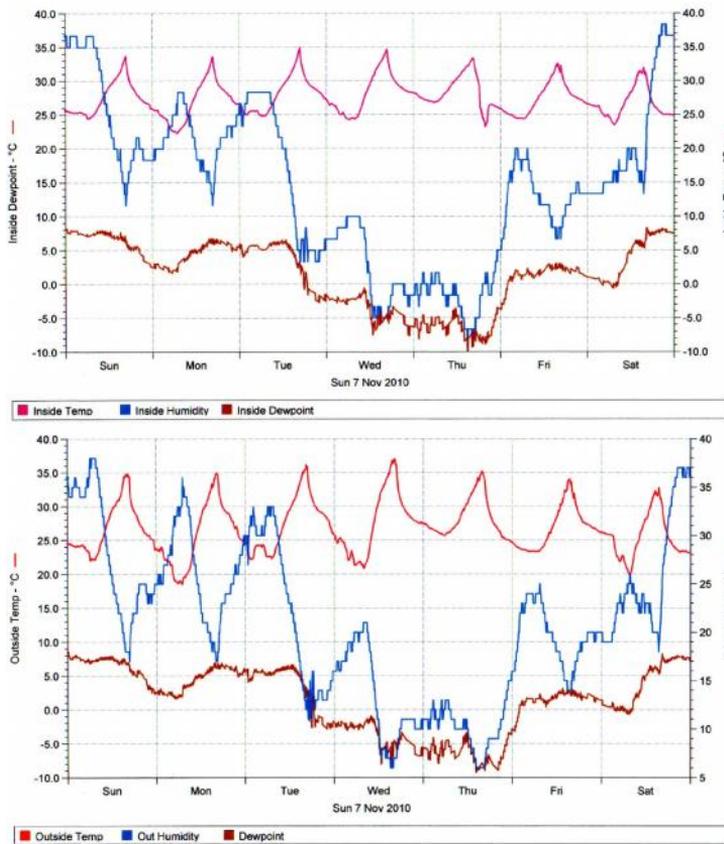
A *Davis Vantage VUE* meteorological station was positioned in the Cave of Swimmers to record data on air temperature and relative humidity as well as wind direction and intensity inside and outside the site. The station recorded data 24h a day for the whole duration of the fieldwork. Moreover an *EL-USB series* data logger was positioned inside the Cave of Archers in order to record data on air temperature and relative humidity.

Fig. 8. Cave of Swimmers. Climatic monitoring inside and outside the cave (temperature; humidity; dew point; atmospheric pressure) recorded with a *Davis Vantage VUE* meteorological station.

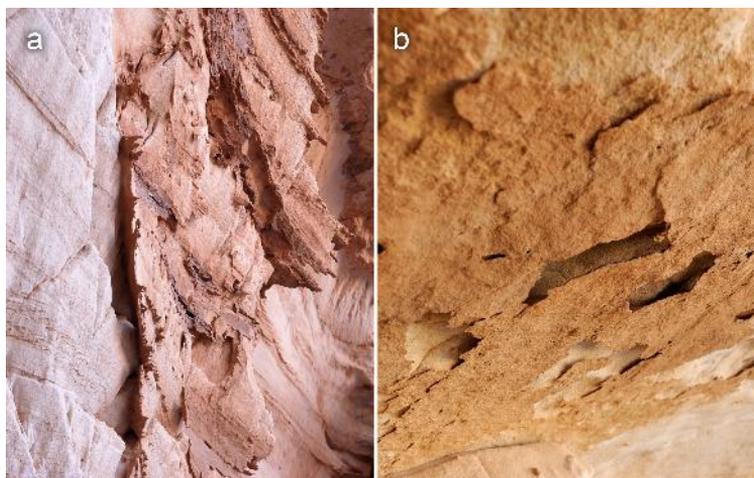
The most visible and widespread phenomenon is exfoliation (or sheeting), identified both on the surface, in the form of thin raised flakes, and in deeper portions, with the detachment of thick layers of rock (Fig. 9a). The sheeting is connected to changes in temperature that cause cycles of expansion and contraction of the material, resulting in a strong mechanic stress [25]. The sandstone surface subjected to solar radiation reached high temperatures (up to 52.5°C in the Cave of the Archers, with an air temperature of 30°C). Information on sun radiation collected by means of the photo radiometer yielded values reaching up to 1,076.2W/m². In particular, the expansion of outer layers during the day because of the heat and solar radiation, and their sudden contraction due to the drop in the external temperature during the night, cause traction forces leading to the detachment of layers. The quicker the changes, the easier the exfoliation phenomenon takes place [26, 27]. The whole process is further accelerated on the surface layer by the presence of the crust, which, being darker in color and iron-enriched, warms faster than the underlying rock. Other exogenous causes of sandstone degradation include the dry thermoclastic phenomena which, acting very slowly, occur over an extended period of time. We can say that some exfoliation was already present on the rock surface when pigments were applied to the surface. Finally, we must also consider the sandstone decohesion, which affects the entire bedrock but is more accentuated towards the outside, except in some portions where the crust is preserved.

Fig. 9. Cave of Swimmers. Mechanisms of sandstone degradation: a. fractures and detachments of the surficial crust which expose the sandstone underneath to wind erosion and ablation; b. deeper erosion creating large gaps; the surficial crust is almost completely detached from the sandstone underneath.

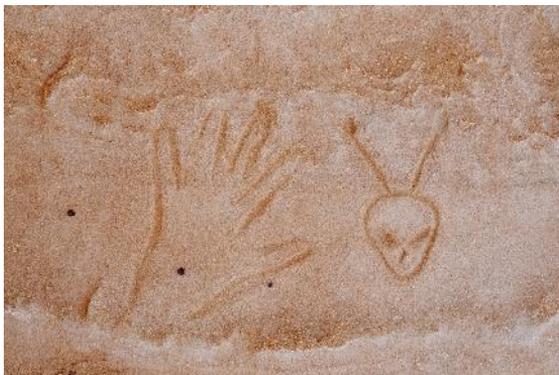
As a final comment and concern for the preservation of the Wadi Sura rock art repertoire, the impact of visiting tourists should also be considered [28]. Although at present tourism in Egypt and Libya has declined, due to political unrest, overall tourism in Gilf Kebir has grown in recent years, with the consequent intensification of vandalism. The lower southern area of the Cave of Swimmers has been extensively vandalized by modern graffiti and engravings (Fig. 10).

Fig. 10. Cave of Swimmers. Area of the cave’s wall recently vandalized by visitors (between March and November 2010).

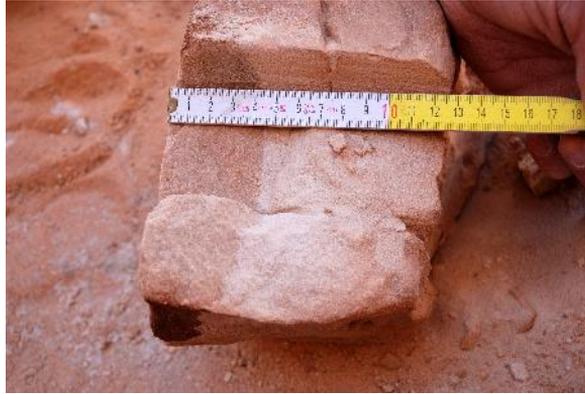
Fig. 11. Area around the Cave of Swimmers. Application of ethyl silicate tested on a sandstone sample.

Sandstone consolidation: The application test of ethyl silicate, both in white spirit (Rhodorsil RC 70, Phase - Proind Ltd.) and in ethyl alcohol (Silester AR, Kremer Pigmente GmbH & Co.), showed the latter to be more suitable because of the higher penetration capacity of its solvent, empirically tested on some rock samples (Fig. 11).

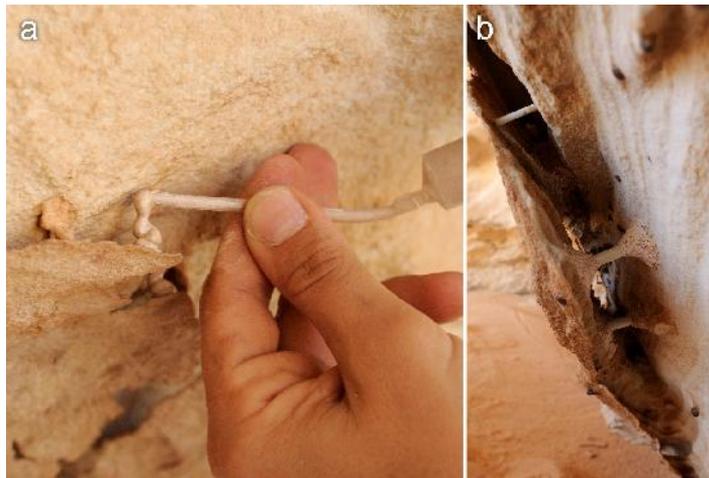
Fig. 12. Caves of Swimmers and Archers. Anchoring the detached sections of the wall: a. Cave of Swimmers; *Paraloid B 44* nails produced using a syringe fitted with a rubber tube; b. Cave of Archers; fiberglass stick nails used to anchor a large detached crust fragment.

In Area 3, characterized by very deep gaps between the crust and the substrate, it was necessary to reinforce the nails with polypropylene fibers. We also applied fiberglass sticks to anchor a large and heavy detached crust fragment found in the Cave of Archers (Fig. 12b).

Fixing partially detached laminae: Different dimensions nails allowed us to fix both thin crustal plates and layers of thicker and cracked sandstone (Fig. 12a). The decision to use *Paraloid B 44* for its higher Tg point (60°C) in place of the more common *B 72* was successful. As already mentioned, the glass transition temperature is a fundamental parameter in the selection of the resin/adhesive. Although it was late fall, the surface had in fact reached a temperature of 52.5°C when it was exposed to direct sunlight, with an air temperature of 32°C. The addition of kaolin as filler improved the thermal resistance of nails (the glass transition temperature of *Paraloid B 44* is normally about 60°C), their dimensional stability, toughness, tensile strength and resistance to abrasion, making the mixture compatible with high temperatures reached by surfaces exposed to sunlight.

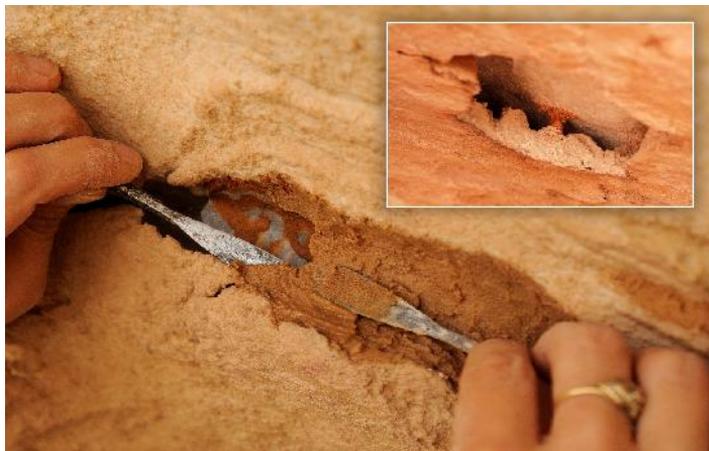
Fig. 13. Cave of Swimmers. Sealing of openings and cracks

Sealing of loss edges: In the three areas chosen for the intervention, interruptions of surface continuity, such as lacunae edges and cracks, were sealed to make the sandstone more resistant to external aggressions and degradation. Sealing of crust contours is considered very effective to prevent the wind from continuing its erosive action below it. Moreover this operation also strengthens the holding nails. For this purpose different colored sands collected in the area surrounding the cave or obtained by grinding sandstones were selected. At the beginning a traditional lime and sand (1:4) based mortar was tested in Area 2, but several reasons led us to choose a colloidal dispersion of silicic acid in water (*Syton® X 30* - Kremer Pigmente GmbH & Co.) as a binder for the mortar. The inert was thus sifted and added to a small percentage of kaolin, and then mixed with *Syton® X 30*. Its affinity with the siliceous matrix of the rock and its quick drying time make it the most suitable material, both aesthetically and in relation to its chemical-physical characteristics.

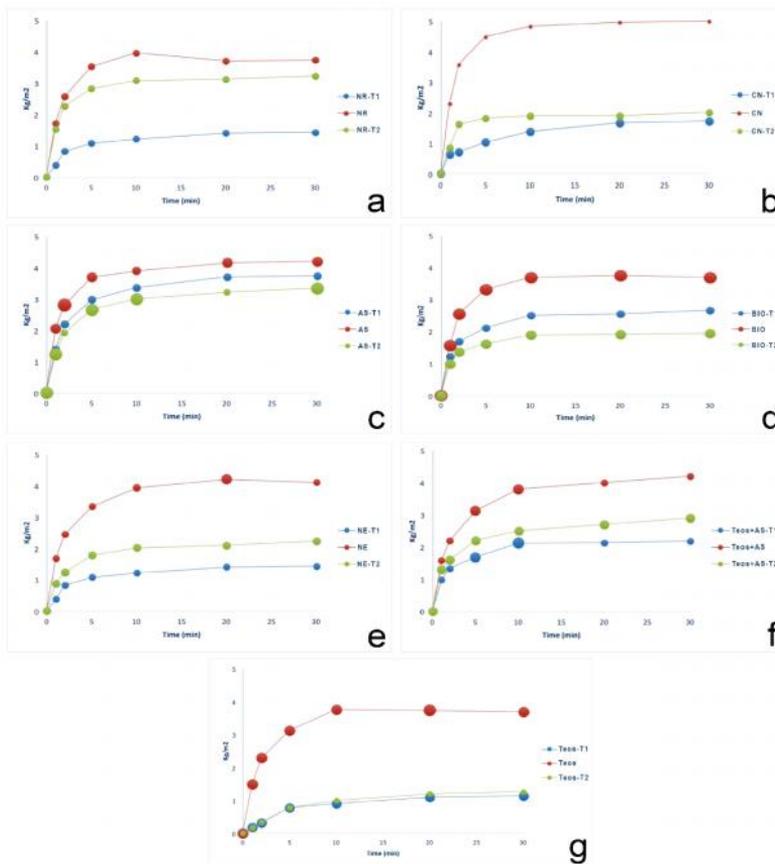
Water absorption: In the water absorption curves (Fig. 14a-g), non-treated specimens reached their plafond values fast (30 minutes). The treated samples absorbed less water than the untreated ones, but with a similar trend (except for the basic solutions). Each of the consolidation treatments reduced the size of large pores, but did not completely close them. The three graphs (untreated - treated surface - opposite treated surface) showed that a different behavior takes place with the use of different consolidants. In particular, the strong reduction of water capillary absorption, for Nanorestore and TEOS, missing in the opposite treated surface group, allowed us to suppose the low penetration of these products in the stone and the production of a film which prevented the passage of additional water.

Fig. 14. Absorption curves of the laboratory samples. The sizes of the circles show the standard deviation of measures; Key: a. Nanorestore (NR); NR: untreated; NR-T1: treated surface; NR-T2: opposite treated surface; b. Consolidata Nano (CN); CN: untreated; CN-T1: treated surface; CN-T2: opposite treated surface; c. Alkaline Solutions (AS); AS: untreated; AS-T1: treated surface; AS-T2: opposite treated surface; d. BIO R-IPC 30 (BIO); BIO: untreated; BIO-T1: treated surface; BIO-T2: opposite treated surface; e. Nano Estel (NE); NE: untreated; NE-T1: treated surface; NE-T2: opposite treated surface; f. TEOS + Alkaline solutions (Teos+AS); Teos+AS: untreated; Teos+AS-T1: treated surface; Teos+AS-T2: opposite treated surface; g. TEOS; Teos: untreated; Teos-T1: treated surface; Teos-T2: opposite treated surface

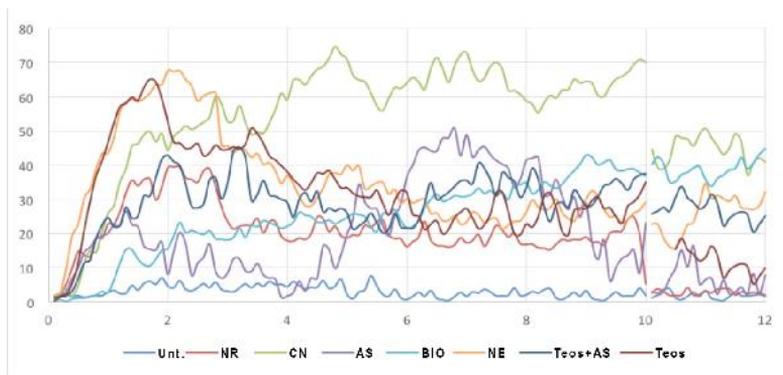
Drilling resistance: The drilling resistance test allowed the evaluation of the effects in these materials (Fig. 15). In terms of the Nanorestore, Estel 1000 and Nano Estel, the consolidation effect is visible only near the surface, and it decreases with increasing sample

thickness. The results obtained from the alkaline solutions are heterogeneous and the drilling plot showed two zones characterized by an increase of resistance (0–2mm and 5.9mm). BIO R-IPC 30 and Estel 1000 + alkaline solution values showed that the consolidant was able to increase the resistance on the total thickness of the sample. The best results were obtained using Consolida Nano.

Fig. 15. Drilling test on laboratory samples: samples treated with different solutions compared to the untreated sample. Key: Unt.: untreated; NR: Nanorestore; CN: Consolida Nano; AS: Alkaline Solutions; BIO: BIO R-IPC 30; NE: Nano Estel; Teos+AS: TEOS + Alkaline solutions; Teos: TEOS.

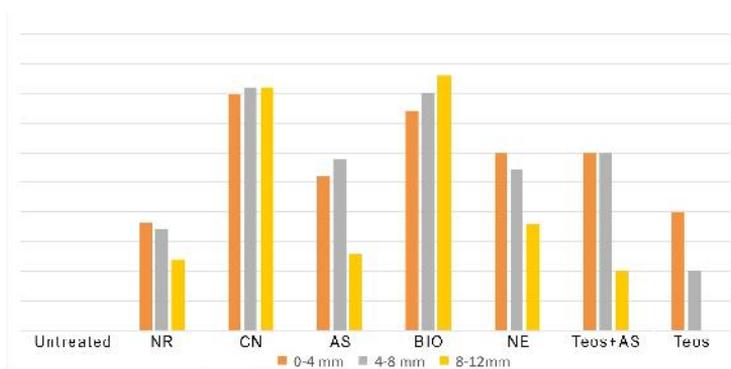
Scanning Electronic Microscopy: SEM observations confirmed that the consolidation products are present in the specimens and showed that the penetration of the TiO₂ marker into the stone occurred to different extents depending on the type of consolidant (Fig. 16). In the present research, the total lack of Ti in all the treated specimens allowed to use this element as a marker to analyze the degree of penetration, although possible particle aggregation phenomena could have taken place. The plot showed the presence of Ti in every zone of the analyzed specimens except for TEOS, where the Ti was missing in the 8–12mm zone. In general, Ti concentration decreased in relation to the depth, while for Consolida Nano Ti was homogeneously distributed in all thicknesses. Alkaline solutions (with and without TEOS) showed a sharp Ti % decrease from 4.8mm to 8–12mm.

Fig. 16. Laboratory samples. SEM/EDS analysis on different sample depths; a: 0–4 mm; b: 4–8 mm; c: 8–12 mm. Key: NR: Nanorestore; CN: Consolida Nano; AS: Alkaline Solutions; BIO: BIO R-IPC 30; NE: Nano Estel; Teos+AS: TEOS + Alkaline solutions; Teos: TEOS.

Titanium was found in all treated samples, except for the TEOS treatment, in which it was missing in the 8–12mm thickness layer. In all treatments, the percentage of titanium
