## SIMULATION OF A PORTUGUESE LIMESTONE MASONRY STRUCTURE SUBMITTED TO FIRE: 3D ULTRASONIC TOMOGRAPHY APPROACH

### **Abstract**

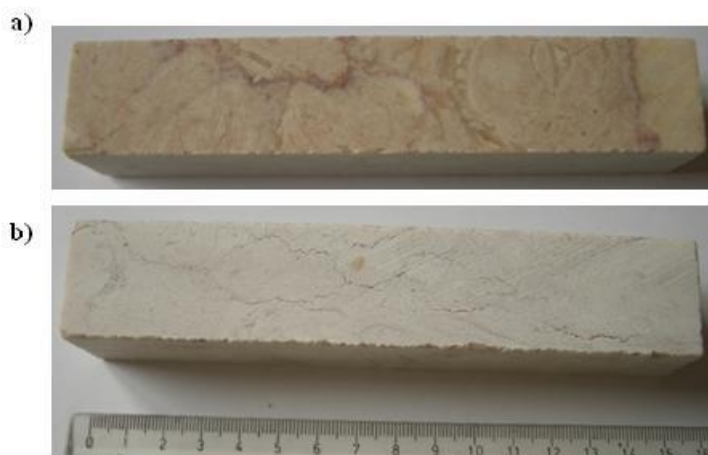
Fig. 1. Lioz limestone with different surface finishes: (a) Polished and (b) Saw cut.

Lioz is a beige colored microcrystalline, bioclastic and calciclastic limestone, with abundant fossils remains (rudists), which give an aesthetics peculiarity to this ornamental stone (Fig. 1a). It is dated Cretaceous in age and formed in an area of shallow sea with warm, clear water that stimulated the proliferation of organisms with calcium carbonate skeletons. Lioz usually presents very low values of properties related to fluid transport in porous media and porosity, and medium to high values of uniaxial compressive and flexural strength [23]. In what concerns thermal linear expansion coefficient, maximum values for Lioz are comprised between  $3.3\text{-}5.9 \times 10^{-6}$  per °C [23], reflecting that of calcite. Further details on Lioz geological context, petrography, mineralogy and physical-mechanical properties can be found in Figueiredo and Aires-Barros [23, 24].

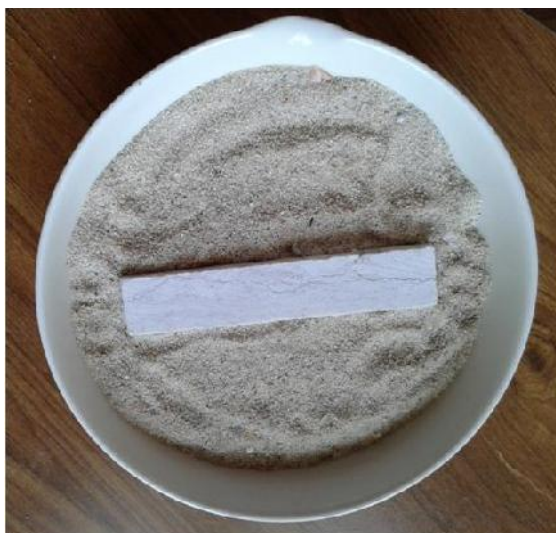
Fig. 2. Sample encased in fine sand.

To simulate the heating generated by fire on natural stone and thus replicate the damage generated, it was used a laboratorial muffle (Ehret, maximum temperature of 1100°C) with an oxidizing environment. The stone samples were partially buried in fine sand (Fig. 2) prior to placing them in the muffle exposing a single face (15×3×0.5cm) to direct heating in order to mimic the real situation of stone blocks in masonry structures. The samples were placed in the muffle at 600°C for 23 h. The warming up started from room temperature (20°C) and followed a heating gradient of 9.6°C min<sup>-1</sup>. After heat exposure, the samples (referred to hereinafter as “heated”) were left to return to ambient conditions, removed from the sand and subjected to several evaluations, as mentioned hereafter.
