ASSESSMENT OF STRENGTH CHARACTERISTICS OF A HERITAGE STRUCTURE - ALAMPARAI FORT, INDIA

Abstract

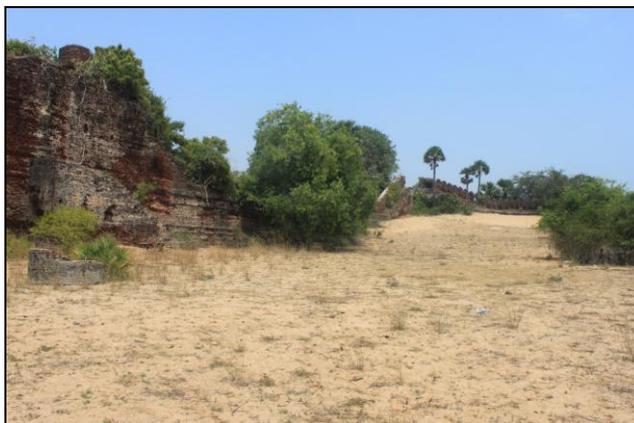
Fig. 1. Alamparai Fort at Alamparai Village of Kanchipuram District

The Alamparai Fort is located on the seashore of the Bay of Bengal, at Alamparai village (Fig. 1). The fort is situated about 106km south of Chennai on the East Coast Road (ECR), Tamil Nadu, India. The latitude and longitude are: 12.266°N and 80.010°E respectively. The Fort was built during the seventeenth and eighteenth centuries (Christian Era), which was under the French rule in 1750. There was a port, on the sea-side that contained a dockyard for the merchandise. The important commodities exported from this port were salt, ghee and clothes mostly traded to Pondicherry and Portonova [1]. There was a canal in operation on the west of Alamparai Fort. This canal was constructed during the British regime in 1878, for transportation of merchandise in the absence of other mode of transports. Country boats were used to transport commodities from Marakkanam to Chennai until 1967 [2, 3].

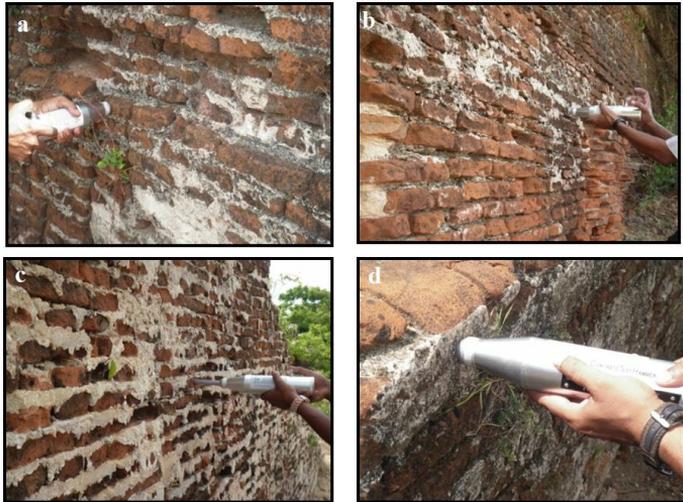
Fig. 3. Performing Rebound hammer (NDTs) at Alamparai Fort walls:
a - north wall, b – south wall, c – east wall, d – west wall

Compressive strength values have been determined at 86 locations as shown in figure 2 at the Fort site using rebound hammer. The purpose of this test was to establish a correlation between in-situ bricks in the masonry wall and corresponding laboratory average compressive strength values. Figure 3 displays the in-situ testing of bricks using the rebound hammer.

The rebound hammer results obtained at the site show that the compressive strength was in the range of 12.50MPa and 41.60MPa. The lowest value of compressive strength (12.50 MPa) was recorded at the Eastern side of the fort, which faces the sea. The highest value of

compressive strength of 41.60MPa was recorded at the Northern and Western sides of the fort, which are protected from direct sea breeze. The average compressive strength found for North, South, East and West walls respectively were 32.51, 18.96, 15.95 and 32.98MPa (Table 5, column 3). The Eastern wall had faced bombshells during periods of war, hit by high waves during cyclones and tsunami. The Southern wall is affected by close proximity of backwaters.

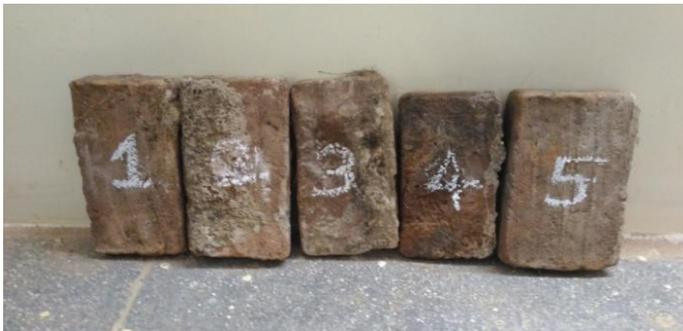
Fig. 4. Bricks from Alamparai Fort site

Typical samples of brick collected from the site are shown in figure 4. Two types of compressive strength tests were performed in which 50 percent of the specimens were tested by placing 3mm thick plywood sheets (IS 3495-Part I; 1992) at the top and bottom of each brick as shown in figure 5. The remaining bricks were tested with spreading a thin layer of talcum powder at the top and bottom of each brick as suggested by Bati and Ranocchiai [5]. All the bricks were tested in different directions namely, load applied in stretcher position, σ_{c1} ; load applied in shiner position, σ_{c2} and load applied in sailor position, σ_{c3} to compare the compressive strength values. Typical tested bricks are shown in figure 6.

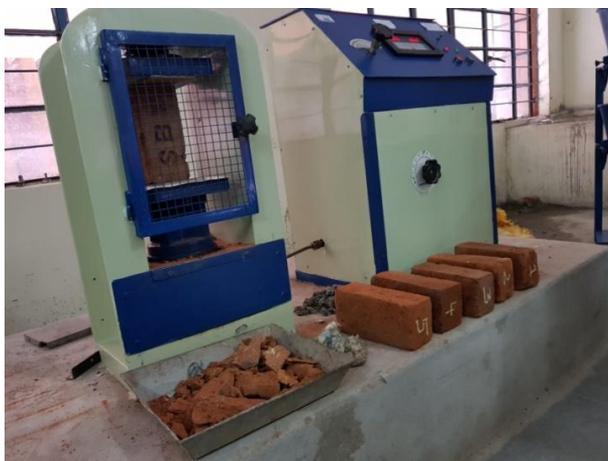
Fig. 7. Compression Testing of Modern Bricks

Compressive strength tests and water absorption tests were performed on modern bricks following identical procedures as for the old bricks. The parameters obtained were compared with that of the strength characteristics and water absorption values of ancient bricks. As mentioned previously, compressive strength tests were carried out using 3mm thick plywood sheets and talcum powder separately. Testing of modern bricks is shown in figure 7. The water absorption values as recorded in the laboratory together with compressive strength are shown in Table 2 for brick specimens of modern bricks.
