# MATERIALS, TRADES AND TECHNICITIES: THE RESTORATION SITE OF THE MERINID CITY MANSOURAH (TLEMCEM, ALGERIA) IN THE WORK OF THE ARCHITECT EDMOND DUTHOIT (1874-1884). GENESIS AND APPROPRIATION OF A PRODUCTION PROCESS

Amel BENGUEDDA<sup>1\*</sup>, Malika KACEMI<sup>1</sup>, Chehrazed NAFA<sup>2</sup>

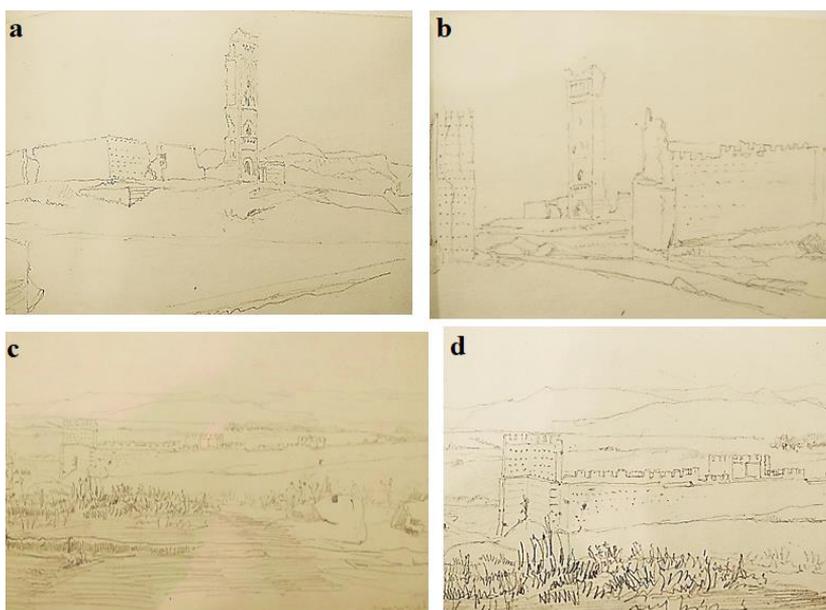
**Fig. 1.** Freehand drawing of the Mansourah site:  
 a - North East View, b - North-West view, 1872,  
 c - The Enclosure and Towers of Mansourah, South Side, 1872,  
 d - Enclosure and Towers of Mansourah, South Side, 1872

During the operations, cuts and surveys are done to reveal the memory of the site as early as 1872. The architect Edmond Duthoit, assisted by his construction inspector Collignon, takes detailed steps to establish a precise plan of the remains (Fig. 1a and b). A correspondence of the architect E. Duthoit preserved with one of these subjects, testifies to the beginning of the investigations carried out on the site of Mansourah. Duthoit quotes: "Our work in Tlemcen is going well, (...) I have already revealed the city walls of Mansourah (Fig. 1c and d), a town whose perimeter was no less than 5,000 meters, in the middle a magnificent mosque with a minaret 57 meters high, all covered with sculptures of onyx columns, multicolored faience ... some of these columns of translucent onyx still exist in the shops of the city, but most of 'between them were sold by the Genius ... what a barbarity! (...)" [6].

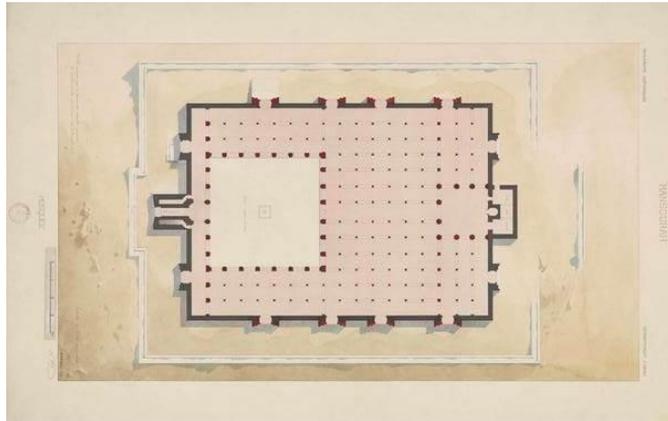
Fig. 2. Architectural plan of the mosque restored by the architect Edmond Duthoit, 1872

- **The plan of the mosque:** The M'salla, discovered mosque consists of a large rectangular enclosure, 109/95m pierced on three sides of six doors opening on gates salient. In the axis of the fourth side was reserved the niches of M'rab (Mihrab). The walls of 1.20m thick, are built of rammed earth of a height of 7m. Entering the mosque through the pierced gates and into the base of the minaret, there was a gallery which led to three naves on the right and three naves on the left (Fig. 2).

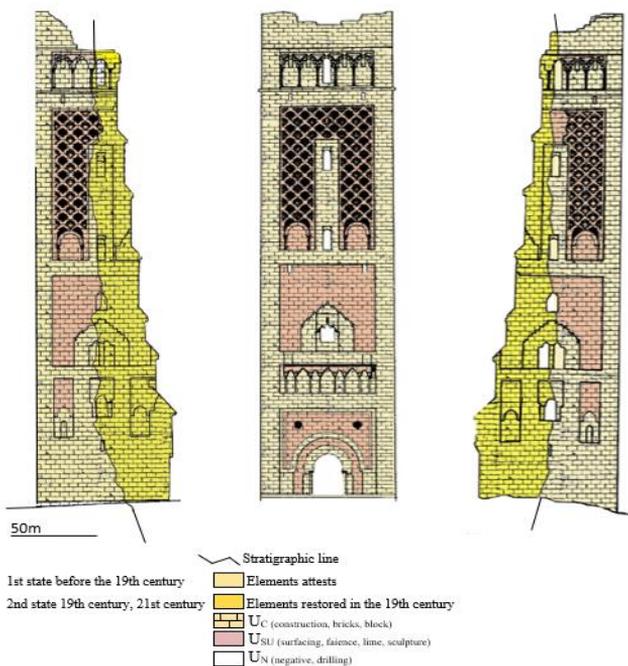
**Fig. 3.** Stratigraphic analysis and archeology of minaret: decomposition of morphological structures

The minaret has a square base of 4.63m<sup>2</sup>. The walls of this tower had a thickness of 1.05 meter; two small rooms of 2.10m<sup>2</sup> were on the ground floor of the minaret. The large banister was largely lit by panoramic bays and loopholes hidden inside the tower (Fig. 3).

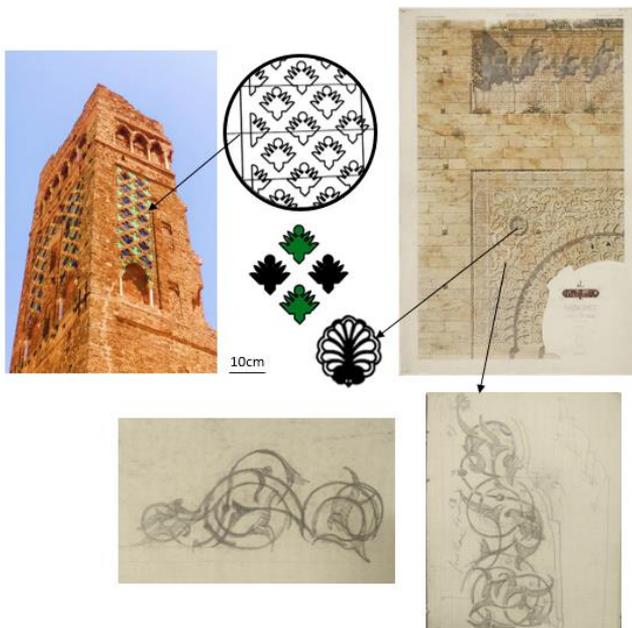
**Fig. 4.** Detail of the carved decoration of the minaret.  
Drawing of the architect Duthoit in support, 1874

Duthoit also certifies the presence of alternately black or pale blue glazed tiles on the black and green main facade on the other two faces still visible (Fig. 4).

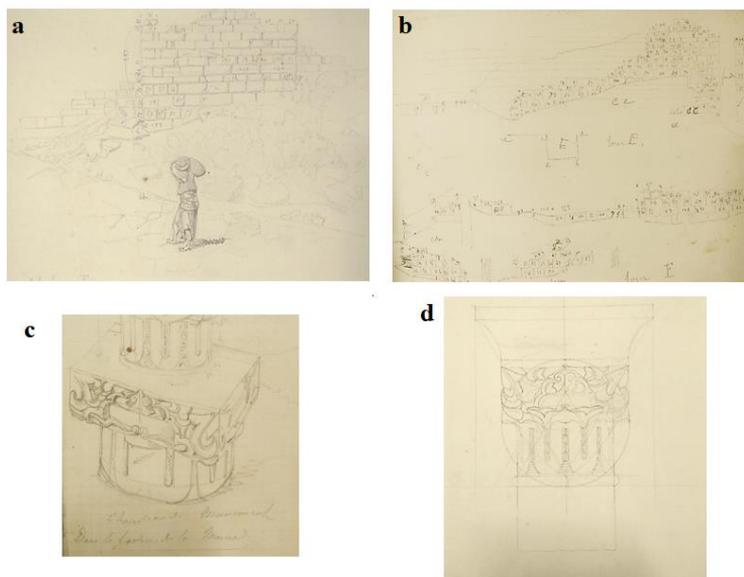
**Fig. 5.** Survey of the location in the structure of all the bricks of the Mansourah precinct, 1876, drawing by the architect Edmond Duthoit (a and b), c - metric survey of the capitals of the columns located at the entrance of the minaret, 1876; d - Geometric drawing of one of the capitals of the minaret, 1876

In an attempt to repair the disorders such as those caused by the collapse of the south face of the minaret, it was necessary, after having secured the existing structure, to diagnose the masonry and to rebuild it by using the various techniques applicable to brick masonry in new construction at the time. However, particular care must be taken to ensure that the connection between the preserved masonry and the new masonry is maintained. The various techniques consisted in first recovering the fallen stones and identifying their position in the structure. The architect E. Duthoit surveyed, on a map, the location in the structure of all the stones and bricks that will have to be put back in place (Fig. 5a and b).

used to reconstruct the two-leaf door with window in each leaf, in a workshop in Tlemcen. To complete the restoration of the door, a series of painting works were undertaken, there was a three-layer oil painting on new wood that was used to repaint the front door and then, the marble work began. This series of works consisted of providing a white marble column of 0.25m in diameter, including the base and the capital (Fig. 5c). The sculpture of the white marble capital was to be executed according to the detailed drawings reported by Edmond Duthoit (Fig. 5d).

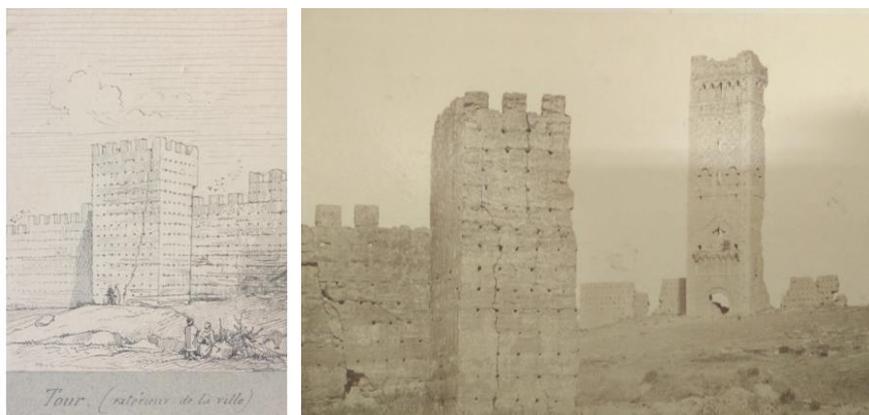
**Fig. 6.** Tower of the Mansourah enclosure in its initial state, represented (drawing and photography) by E.Duthoit, 1872

***Study of the constructive systems*** The construction technique used in the realization of the defense elements of the ramparts of Mansourah is adobe [25], a method of building mud walls, compacted in a formwork in successive layers using a pestle (or lady, pisor, pisou) [26]. The adobe, technique of construction in the mud, involves the compaction of the clay, slightly humidified, in a formwork system sufficiently solid and stable to withstand the damages and the solicitations generated by the earth (Fig. 6a).

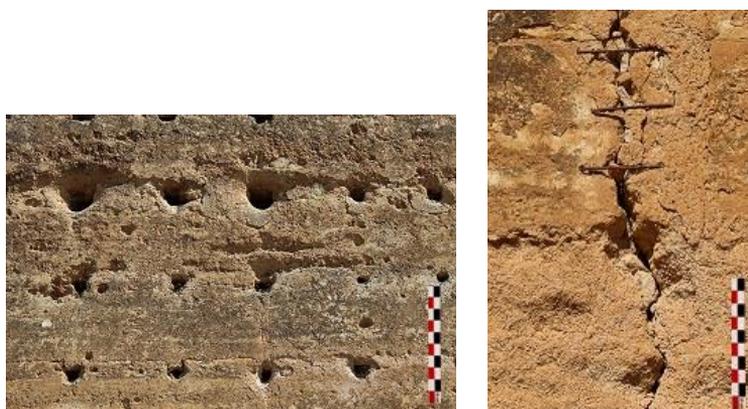
**Fig. 7.** Structural layout of the wall of the Mansourah mosque (current state, 2020)
