COMPARISON OF THE OUTCOMES OF STUCCO REPAIR USING PRIMAL AND GLUE STICK. CASE STUDY OF STUCCO DECORATIONS OF TALAR-E ABYAZ AT GOLESTAN PALACE

Abstract

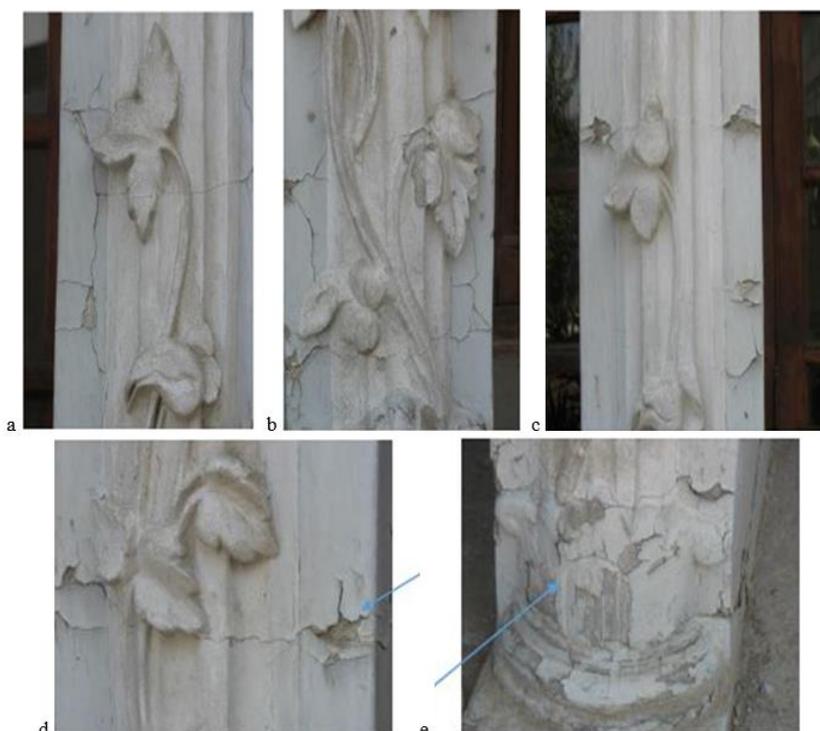
Fig. 1. Images of the stucco: **a** and **b** - cracks in the Abyaz House's column; **c** - erosion in the column; **d** and **e** - stucco falling and cracking at the base of a column.

Museum of Anthropology is one of the oldest and richest anthropology museums nationwide. The two-story museum has different sections and the ground floor includes an administrative department and show halls. Stucco carvings are seen in columns in the exterior façade, which are included in figure 1.

Twelve samples of plaster moldings were prepared and soaked with different percentages of primal and glue stick, respectively. The samples were divided into six binary groups. Sampling location is shown in figure 1d and 1e. (Table 1)

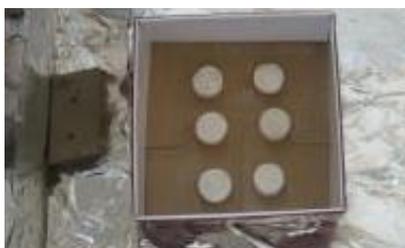
Fig. 3. Samples in the UV lamp compartment

All samples were prepared as shown in figure 2. One sample from each group was selected to be aged and places within a large wooden compartment containing the UV lamps. After a few days, they were taken out and aged naturally (a few days in direct exposure of sunlight and moisture). It should be noted that plaster molding is strength against sunlight; however, in this aging, the measurement is too assessing the changes of adhesives resistance under direct sunlight.

Aging process continued for 16 days and finally aged and non-aged samples were exposed to scanning electron microscopy. An UVA-340 lamp was used and he SEM involved was a TESCAN VEGA one coupled with EDX.
