## ANALYSE AND REPAIR OF STONE MASONRY BUILDING IN MEDITERRANEAN AREAS: CASE OF POUILLON'S HOUSING ESTATES IN ALGIERS, ALGERIA

### *Presentation of the case study: the Diar El Mahçoul tower*

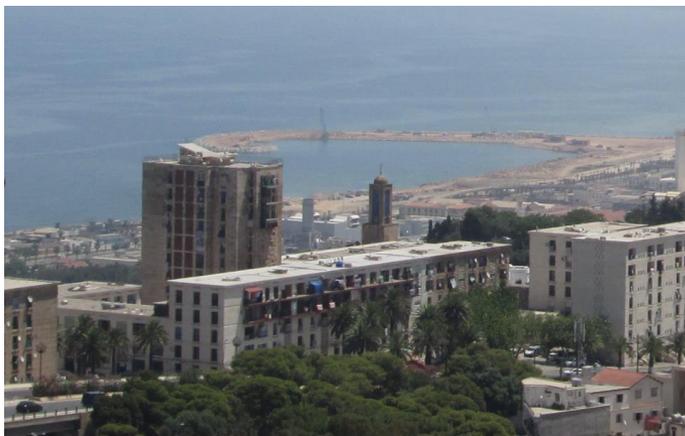
Fig. 1. The city Diar El Mahçoul

Masonry constructions in earlier times were generally designed on the basis of building rules and traditional knowledge and skills. An example of this is the large ensembles of Diar El Mahçoul (Fig.1), designed by the French architect Fernand Pouillon in 1954 [1]. Pouillon is a practical builder who marked the 1950s due to the design of several architectural projects. These buildings are now considered as a remarkable heritage, worthy of being recognized for its exceptional value.

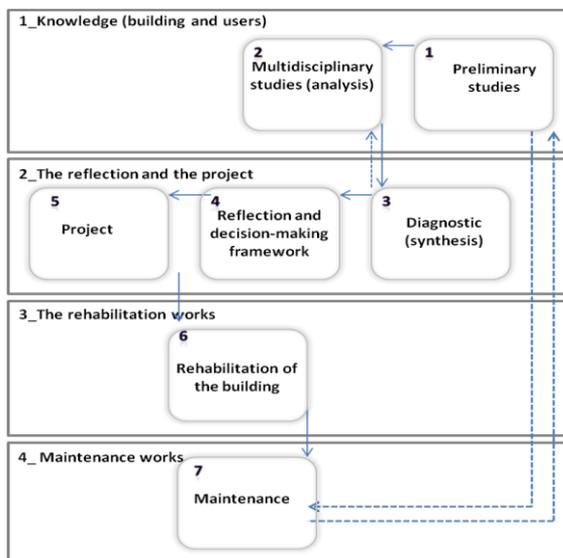
Fig. 2. The flowchart of the Rehabimed method [4]

RehabiMed (Fig. 2) is a method for the rehabilitation of traditional mediterranean architecture. A good diagnosis will help to target and prioritize the interventions.

This study was carried out using the following methodology (Fig. 2).

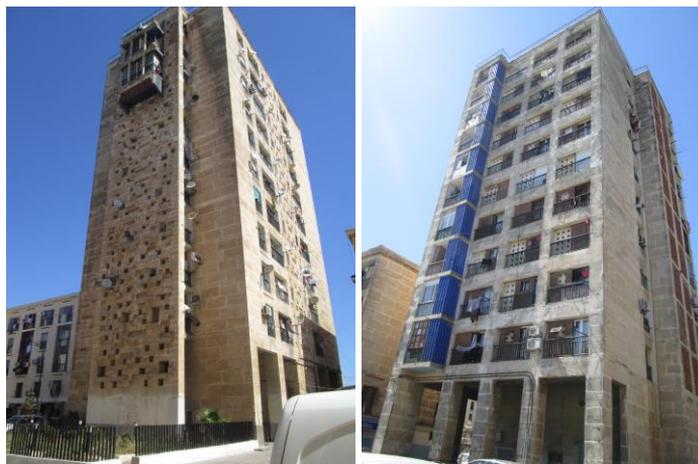
Fig. 3. The views of Diar El Mahçoul tower

For the case study was finally chosen for building J of the city Diar El Mahçoul. This is a tower (Fig. 3) with eleven-storey construction (R+10), designed entirely in solid stone masonry.

According to Pouillon, this tower is designed to be a landmark for the entire neighborhood, in the market square.

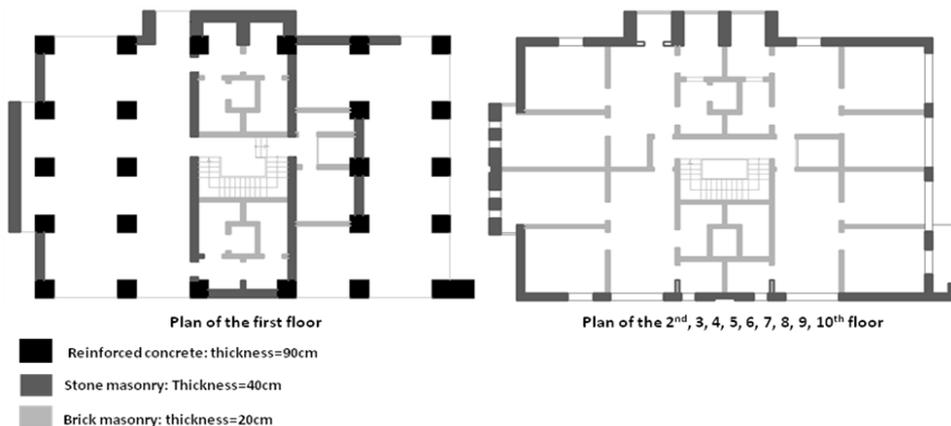
Fig. 4. Representation of deferent walls thickness

The structure of the tower is built using contemporary techniques and traditional materials (Fig.4):

- the foundations: pebble concrete or reinforced concrete footing;
- the walls: white dressed stone and a brick counterpart reserving an air space to isolate the apartment from heat and cold [1];
- the walls: in tubular bricks of 20cm finished thickness, mounted in cement mortar;
- cross-ribbed reinforced concrete slab floors with soundproofing, tiles and plaster-finished ceilings.

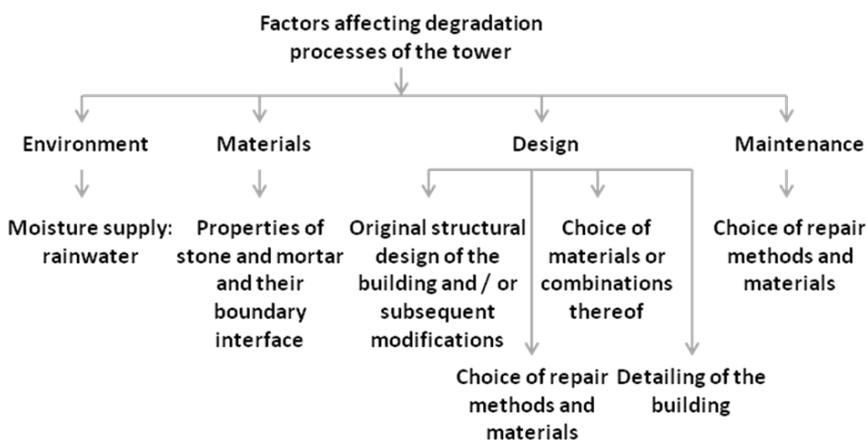
Fig. 6. Important factors for damaging of the tower [15]

The most important factors (Fig. 6) affecting degradation of the tower is related to [9]: environment; materials; design and maintenance.

Principal factors related to the environment are the moisture supply: the tower of Diar El Mahçoul is located on the heights of the municipality of El Madania in Algiers, a few meters from the Mediterranean Sea. Indeed, among the buildings of the allotments of Diar El Mahçoul, the frontages of the buildings facing the sea are the most exposed to deteriorations. Add to this the Mediterranean climate and rainwater, a factor which is not negligible.

Principal material factors are the properties of the stone and mortar and their boundary interface: the limestone used in the construction of the tower comes from France quarries. The main characteristic of this material is its high permeability due to its high porosity.

The design factors are the original structural design of the building and/or subsequent modifications; the rehabilitation of the tower stone in 1981 has weakened its surface, which has led to loss of material at the walls and accelerated the natural degradation of the stone; choice of materials; detailing of the building (especially water shedding details like gutters, downpipes, window sills, copings, flashings, roof overhangs); and respectively the choice of repair methods and materials (treatments, cleaning operations).

Factors related to maintenance are the prompt repair and lack of maintenance: the housing estates of Diar El Mahçoul suffer from lack of periodically maintenance. Since its completion the tower stone has been rehabilitated twice: the first in 1981 and the second recently in 2018.

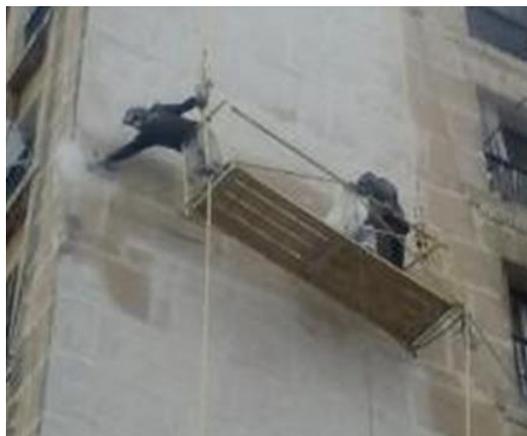
**Fig. 7.** Rehabilitation work on the Diar El Mahçoul tower in 2018

Since its completion, the Diar El Mahçoul city has undergone two rehabilitation interventions since 1981 and 2018 (Fig. 7), which consists of renovating the façades, in order to extend its lifespan [16].

Stone façades are subject to their own pathologies. There is a wide range of interventions available to ensure the conservation of this material. In this case, they opted for mechanical cleaning by sandblasting.

After an in-depth study of the mechanisms of deterioration of the tower stone, the method of mechanical cleaning (sandblasting) was selected for the conservation of the stone. Sandblasting is a mechanical method particularly adapted to remove surface deposits. The advantages of fine sanding are the following: no risk of water soaking, so it can be used in winter; no risk of water infiltration, efflorescence or stains; can be used locally.
