DAMAGE DIAGNOSIS OF PONTE ROTTO, A ROMAN BRIDGE ALONG THE ANCIENT APPIA

This paper describes the results of the damage diagnosis performed on Ponte Rotto, a Roman bridge on the ancient Appia way located close to the city of Benevento (southern Italy). Despite it can be considered one of the most important remains of this type of monument in Campania region, the bridge was abandoned for centuries, being in a rather poor state of conservation; therefore, an accurate damage diagnosis has been carried out using an interdisciplinary approach, in order to plan conservative, preventive and restoration work for the requalification of this archaeological heritage. Photogrammetric survey and damage diagnosis following the Fitzner's method allowed identifying and quantifying the geomaterials adopted for the construction of the bridge and the weathering forms affecting it. Georeferenced orthoimages permitted the mapping of their areal distribution, the definition of the damage categories, and the estimation of the linear and progressive damage indexes, that revealed a definitely bad conservation state.

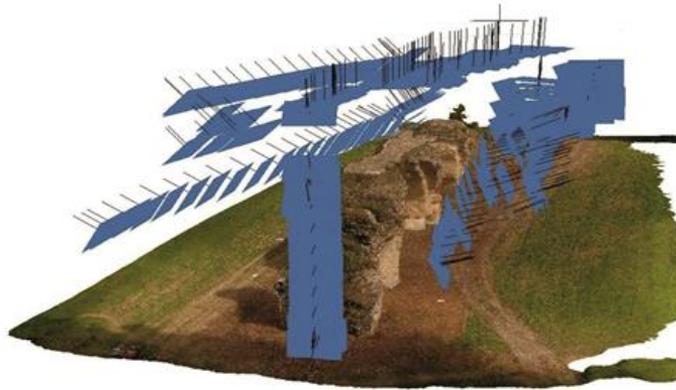
Fig. 2. Positions of camera during the flights of the drone.

Three flights and a total of 273 images were planned, according to 3 consecutive strips, acquired in time-lapse mode (5 s interval). In the first flight, 74 photographic shots were acquired in nadir mode (NW-SE direction, average height 19 m, ground coverage of about 29.9 x 22.3 m). Two other flights, with the camera tilted at 45° on the horizontal plan, were carried out acquiring, respectively, other 96 and 106 photos (17 m and 9 m on both sides; the ground coverages of about 26.8 x 20 m and 14.2 x 10.6 m, respectively) [11].

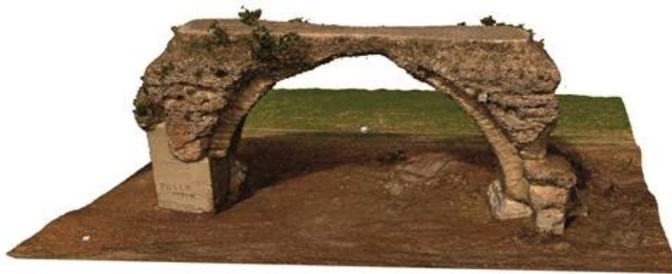
Fig. 3. Perspective view of the arch of the bridge, obtained by the generated point cloud.

Dense Cloud has been generated (Fig. 3), as well as the polygonal model (Fig. 4a) and the Digital Elevation Model (DEM) of Ponte Rotto (Fig. 4b). The model is rather accurate, showing an average error on GPC lower than 4 cm [11,18].

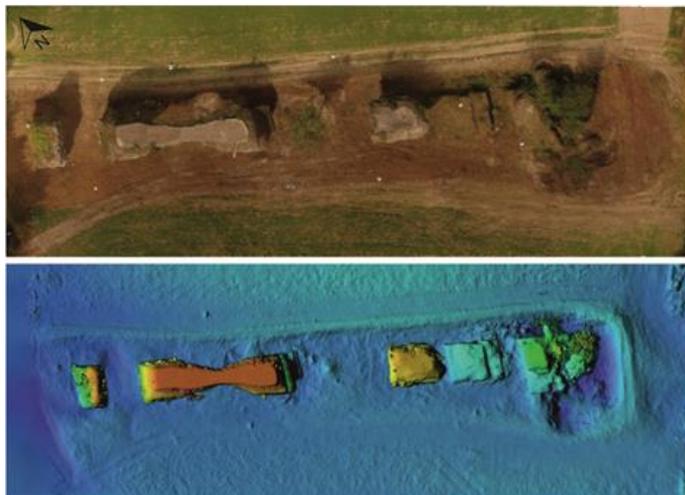
Fig. 4. Orthophoto (a) and Digital Elevation Model (b) of Ponte Rotto.

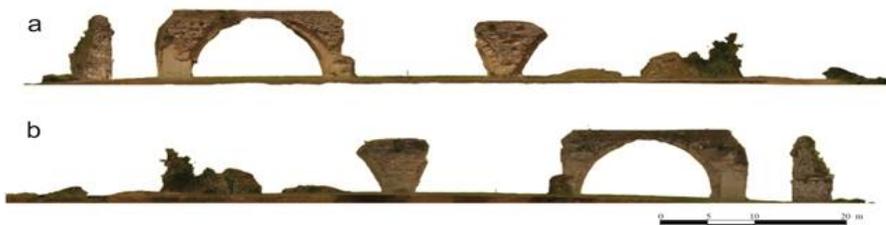
Fig. 5. Lateral orthoimages showing the western (a) e eastern front (b) of Ponte Rotto

Completeness of data acquired and the appropriate resolution permitted the extraction of good quality orthoimages from the point cloud model elaboration of photogrammetric data. Lateral orthophotos, extracted from the coloured model points selecting planes of projection parallel to the western and eastern fronts of Ponte Rotto (Fig. 5), were used for a quantitative evaluation of lithotypes and damage diagnosis, as also carried out for decay analysis of other important monuments (e.g. [19]).
