A MULTI-ANALYTICAL APPROACH TO ADDRESS A SUSTAINABLE CONSERVATION OF THE MAIN MARBLE PORTAL OF THE MONREALE CATHEDRAL

The Main Portal of the Cathedral of Monreale is one of its magnificent external architectural elements. Recently, a conservation campaign was carried out for increasing its state of conservation, endangered by physical decays phenomena. The previous restorations, occurred over time, and the rising damp have contributed to its worsening. An integrated and multi-analytical diagnostic campaign has been provided to investigate the constitutive materials, the decays and the restorations coverings. Thanks to the analytical results, it was set a sustainable conservation treatment aimed to remove the causes of decays in view of the retractability of the original matter in the future. A difficult and complex cleaning was performed to remove the old coverings and safeguard traces of the original polychromy. An inorganic-mineral consolidating treatment, ammonium phosphate based, was carried out to re-give cohesion to the powdered marble especially in presence of water and salts. Several strategies of application were provided to have an efficient consolidation. A so represent

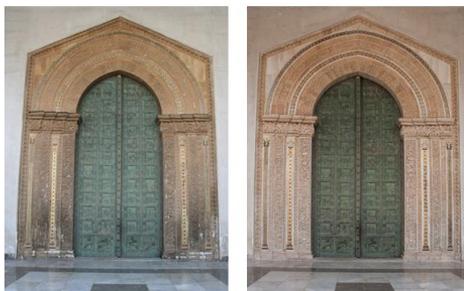
Fig. 1. The main portal of the Cathedral of Monreale before and after conservation treatment. Dimensions: maximum height: 9.8 m; total width: 7.7 m; pier width: 2 m.

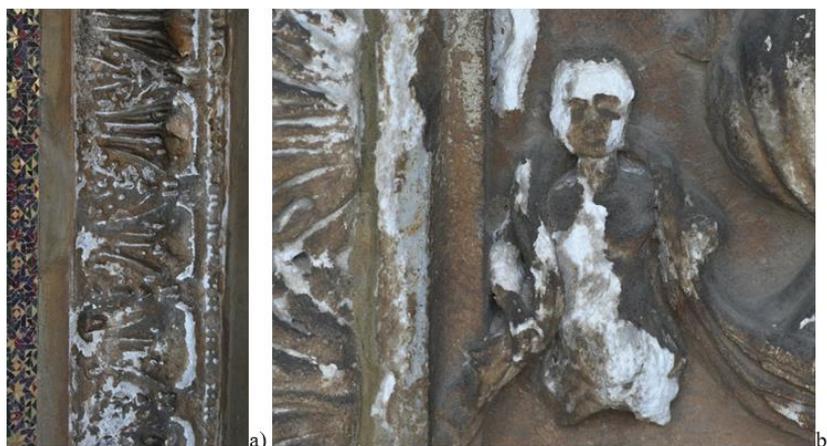
The previous covering treatments, the rising damp and surface condensation have been caused the decays observed, as: browning of the surface, efflorescence, salt crusts, powdering, sugaring, delamination and cracks (Fig. 2).

Fig. 2. Particular of piers: a) state of conservation of the marble with salts efflorescence, sugaring, powdering, black crust, browning of the surface due to the previous covering; b) losing of the flourishing shape due to the effect of the salts efflorescence with following sugaring and powdering of the marble.

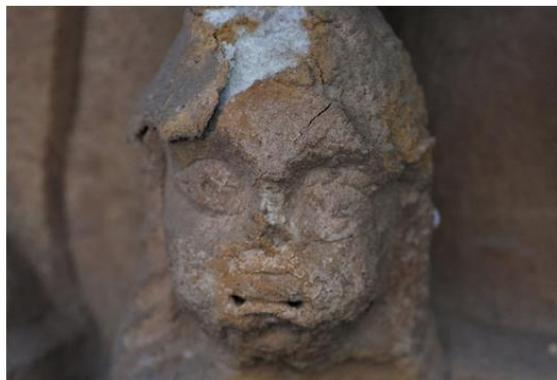
The ageing of synthetic covering, applied in the past for surface protection, created not only an aesthetical damage as the brown film that hid the original marble nature mistaken for limestone, but also it produced a barrier effect on the surface that occluded the marble porosity causing the decrease of water permeability. Unfortunately, the considerable amount of internal moisture due to the rising damp was the main origin of physical degradation led by the carrying of soluble salts [3, 4, 5, 6]. The constant presence of water and salts have caused the ever-increasing losing of marble, not only on the surface, but especially below of the hard-brown crust, originated by the protective. This crust has confined the disgregational processes inside the marble causing the following detachment of portions; the originated surface from the

detachment, already degraded, was still more attachable from the physical phenomena as the wind, favouring secondary faster processes of consumption of carvings (Fig. 3).

Fig. 3. Particular of a capital. Losing of the carving due to the action of the ageing of a synthetic adhesive applied in a previous restoration.

Even if the capitals showed the same decays of piers, probably in this case caused by interstitial condensation phenomena, the previous wide use of a synthetic adhesive for consolidating cracks and powdering have produced the tear-off of the marble surface because of the contraction of this film.

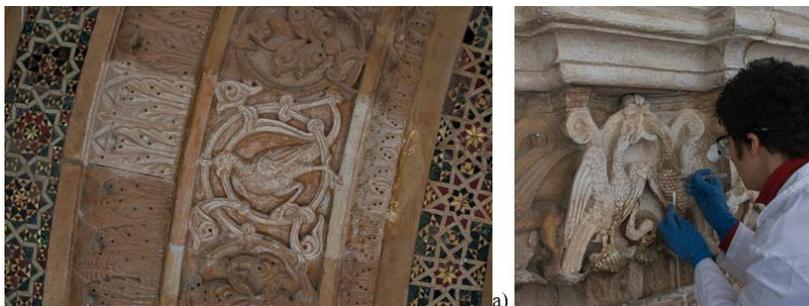
Fig. 8. a) Particular of the archivolt. Cleaning test of polychrome marble surface for removing deposits, black crust and coverings. b) Particular of a capital. Cleaning treatment carried out with surgical scalpel and magnifying eyeglasses.

The removal of siloxane aged covering is not usually easy to do, because it forms a hard crust on the top of the marble surface and underneath whole the stone could be disintegrated by the salts crystallization, like in this case. Each conservative trouble (as salts, deposit, black crust, siloxane covering, disintegration) were faced one by one with a proper strategy by ensuring that each of these it was preparatory for the following step. After the cleaning and before the consolidating measure a desalination treatment has been carried out for two times. The aim of the cleaning was the removal of all the extraneous materials from the surface, as the deposits, previous coverings (waxes and poly-siloxane) and salts. Chemical and mechanical systems were chosen methods for the cleaning, taking into account the state of conservation and the kind of surface (mosaics, bas-reliefs, marble slab) (Fig. 8).

In general, the cleaning was performed in three steps, but not all of them were carried out over the all surface. The cleaning agents used were described in order of applications: 1) non-ionic surfactant in water solution at 2%; 2) compress of cellulose powder and sepiolite (1:1) with ammonium carbonate in water solution; 3) a o/w emulsion of white spirit and ammonium acetate 5% water solution. All the water solutions were made with demineralized

water. Each of these steps have needed the help of the precision mechanical cleaning using by scalpel and cotton tampons.

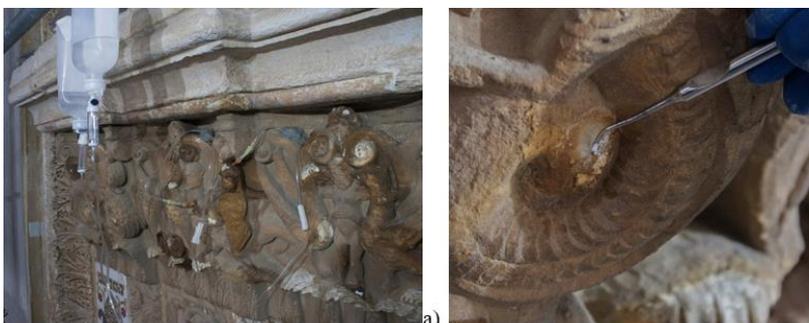
Fig. 9. Particular of capitals. Mineral consolidation treatment with di-ammonium phosphate solution applied by a slow drip. Consolidation treatment of a fissure made by using a lime mortar added with di-ammonium phosphate solution.

The inorganic-mineral consolidating treatment, ammonium phosphate based (di-ammonium-hydrogen phosphate, DAHP), was performed followings different application strategies (compress, slow infusions, mortars) according the seriousness of the disintegration state of the marble (Fig. 9). The ammonium phosphate is a promising consolidant for carbonatic stone [7] useful in the case of presence of water and soluble salts, because the calcium phosphate has a very low solubility [13, 14, 15].

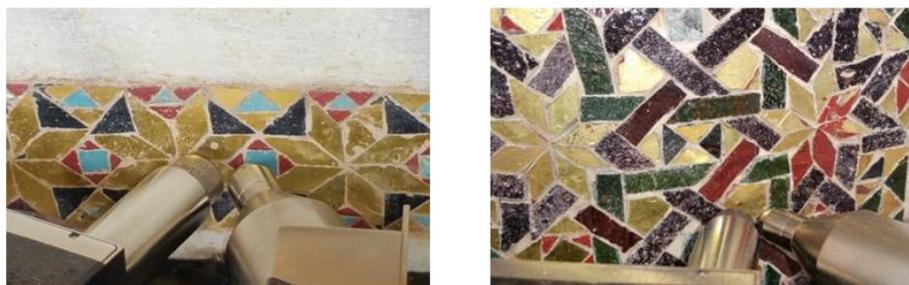
The conservative project of the Main Portal of the Cathedral of Monreale also represented an opportunity for a better understanding of the materials that make up the mosaic decorations that have never been studied to date. Indeed, after the cleaning and consolidation treatments of the precious surfaces, XRF in situ analyses were carried out to identify the chromophores of mosaic glass tesserae for red, green, purple and blue glass and top of gold layers (Fig. 10).

Fig. 10. XRF in situ analyses to identify the chromophores of mosaic glass tesserae.

Blue and green tiles: the chromophore can be identified by copper, detected in association with zinc. The latter allows to hypothesize a derivation of copper from metal processing slag. The intensity of the lead signal is variable: in the green tiles it is present in low counts and also in this case interpretable as the impurity of the metal alloy from which the chromophore is obtained; in the original blue tiles the lead is present with high signal counts, probably added to increase the level of brightness. Finally, the tin identified only in the two blue tesserae probably was added in the form of oxide (cassiterite) with the function of opacifier. The green color is given by the simultaneous presence of Cu^{2+} and Fe^{3+} : the yellow due to the presence of iron neutralize the blue component of the copper thus determining a green tone [16].

Red tiles: the identified chromophore is copper, attributable to the use of Cuprite (Cu_2O) or metallic copper, both verified in the literature to obtain red glass tesserae; it should be noted that for the original red tiles, compared to the red one supporting the gold foil relating to the integration zone, a lower intensity of copper was found and, at the same time, a higher intensity of the iron XRF signal. The latter in the form of oxide was added to the melt in which the copper was already dissolved in a variable quantity according to the shade to be achieved.

Gold foil tiles with vitreous "cartellina" (a thin top glass layer aimed to preserve the gold foil): in addition to the confirmation of gold as the thin leaf, the investigation allowed to verify the presence of manganese also in the composition of the transparent folder added in the form of oxide with bleaching function;

Purple tiles: the high manganese levels found in the purple cards are in accordance with what is known in the literature. It has been verified [16] that an excess addition of manganese oxide, compared to the appropriate quantity normally used with a bleaching function, produces this coloring;
