INFLUENCE OF DETERIORATION ON THE PRESERVATION OF MUD BRICK ARCHITECTURE BASED ON THE MONUMENTS FROM THE TELL EL-RETABA ARCHAEOLOGICAL SITE

Małgorzata ZAREMBA^{1,*}, Jerzy TRZCIŃSKI^{1,2},
Tomasz SZCZEPAŃSKI², Alicja BOBROWSKA², Fabian WELC¹

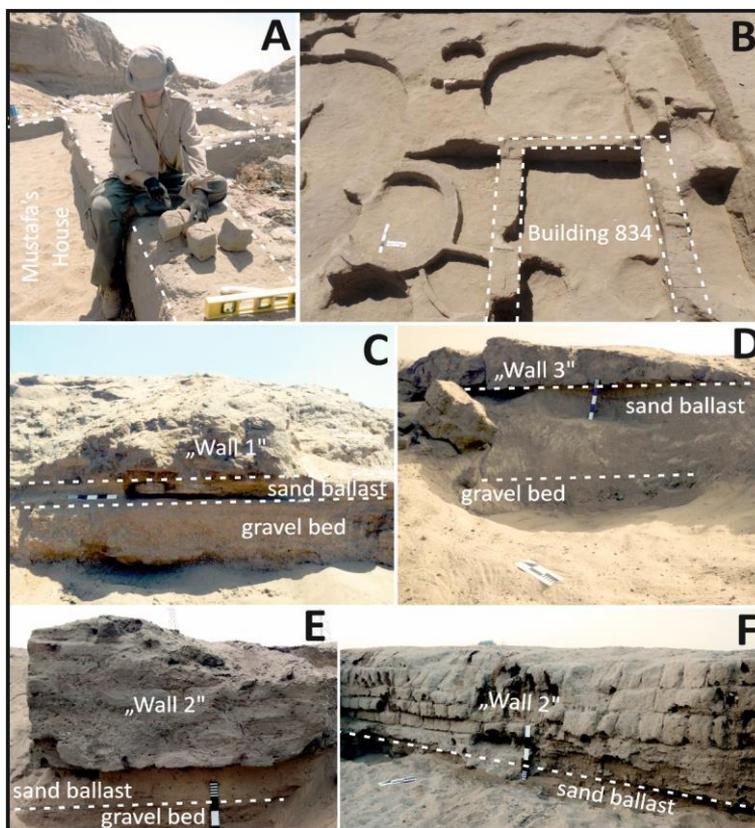
Fig. 3. Defence and residential structures in Tell el-Retaba archaeological site: A – Mustafa’s House, B – Building 834 (photo from the collection of Polish-Slovak Archaeological Mission), C – “Wall 1”, D – “Wall 3”, E – “Wall 2” (cross-section), F – “Wall 2” (in the front). Localisation (Fig. 2B).

The influence of deterioration processes on mud brick properties has been analysed based on material from selected defence and residential objects (Fig. 3), whose location is presented in Fig. 2B. The methodology described by *J. Trzcinski et al* [18, 26] has been used in the analysis of physical and mechanical parameters (Fig. 4). The mud brick material has been reconstructed to determine the properties that the bricks had directly after production. The reconstruction included some aspects of mud brick production, such as water content, consistency and compaction of the mixture and drying [27]. The reconstruction allowed to determine the physical and mechanical parameters of the mud bricks directly after production and to compare them with the present-day parameters of the original mud bricks.

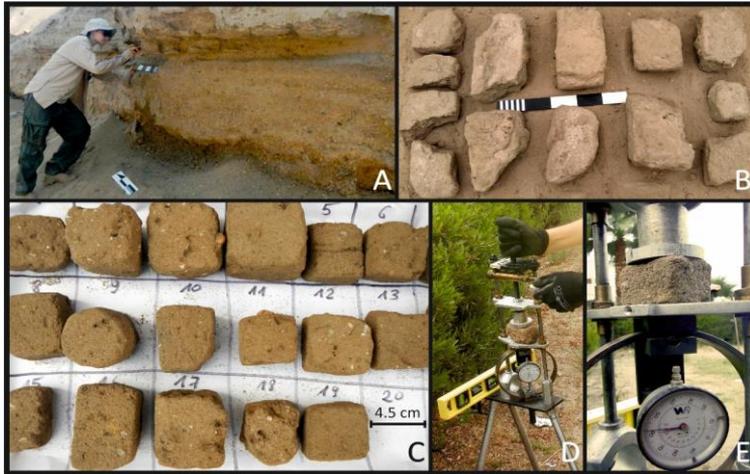
Fig. 4. Methodology of mud bricks analysis: A – fragment of “Wall 1”, B – selected bricks, C – samples for laboratory analysis, D – general view of apparatus for compressive strength analysis, E – sample during analysis of uniaxial compressive strength.

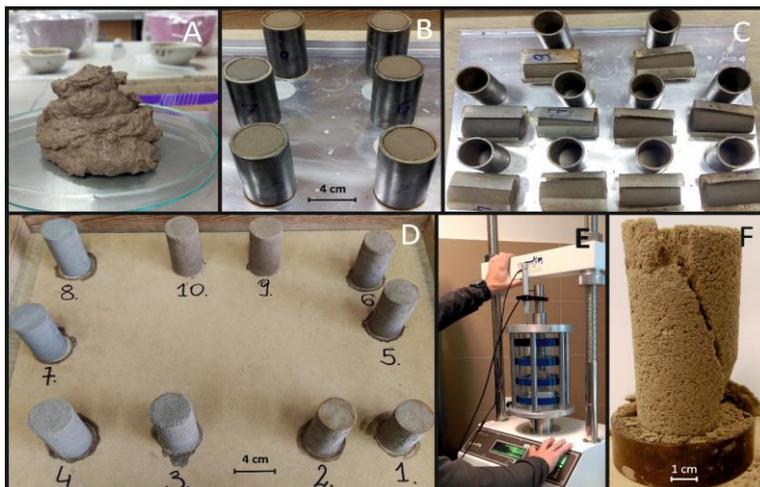
Fig. 5. Methodology of reconstructed brick material analysis: A – preparation of mixture, B – material placed in steel pipes, C – drying of formed samples, D – preparation of samples for compressive strength analysis, E – uniaxial compressive strength analysis, F – sample destruction after compressive strength analysis.

Reconstruction of the mud brick material has been made based on selected mud brick parameters, i.e. bulk density and shrinkage. Amount of water that is required for obtaining a mixture with an appropriate consistency has been calculated [27]. Particular stages of material reconstruction and preparation for further analysis are presented in Figure 5. Dry material was gently crushed with a pestle with a rubber cap and next water was added to obtain a soft plastic paste with an appropriate consistency (Fig. 5A).

The paste was inserted in a steel pipe lined with thin plastic foil, to reduce adherence of the material to the pipe wall during drying (Fig. 5B). After stabilisation and initial drying, the samples were taken out of the pipe and dried for several days to an air-dried state (Fig. 5C). Next, the samples were additionally dried at 45 °C for three days. After complete drying, the

upper and lower surfaces of the samples were levelled so that they became parallel, and later the samples were weighed, measured and photographed (Fig. 5D). Normalised cylinder samples were subject to analysis of uniaxial compression strength according to the norm PKN-CEN ISO/TS 17892-7: 2009 [28] and their destruction was documented (Fig. 5E and F). The procedure was made in four repetitions in order to obtain a better statistics of the results.

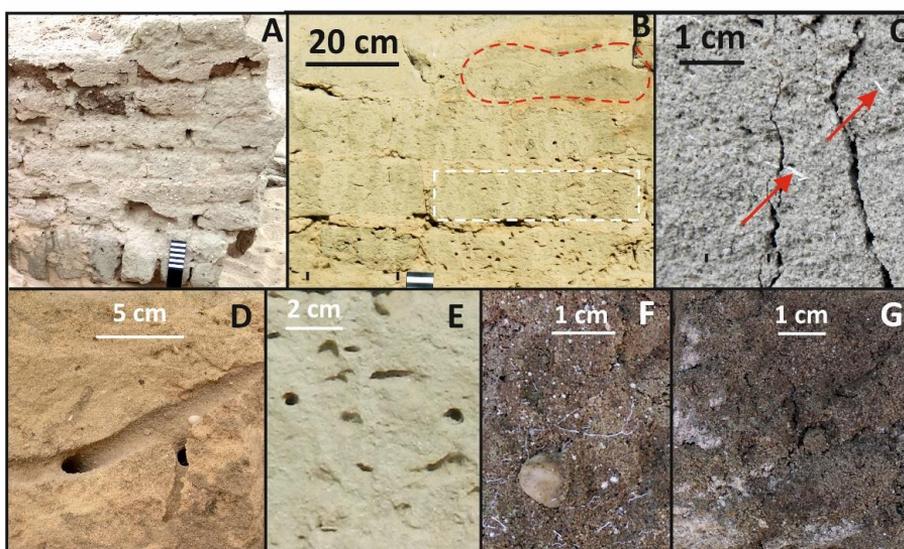
Fig. 6. Manifestations of mud brick deterioration (see text for details): A – exfoliation, B – deformation visible in the wall of Mustafa’s House (white dashed line indicates non-deformed brick, red dashed line indicates deformed brick), C – salt crystallization (arrowed), D – borings, E – borings, F – salt crystallization (white threads and points), G – saline efflorescence on the surface.

Effects of mud brick deterioration have been documented during fieldwork. Exfoliation of mud brick surfaces has been observed on the exposed wall fragments (Fig. 6A).

Exfoliation resulted from the effect of insolation weathering during exposure of the objects for the last few years after their unearthing during archaeological excavation works. The effect is linked with the cyclic process of heating and cooling of the sub-surface layer, which is heated more intensely than the deeper parts of the mud brick. Thermal expansion of minerals is observed. Cyclic temperature changes cause the formation of stress on the contacts and their destruction, which causes loosening of the brick structure, leading to the formation of surface-parallel fractures, and chipping of single grains and particles. Similar processes took place also during exploitation of the objects by the ancient Egyptians. To a lesser degree exfoliation occurred on the wall surfaces of residential objects, because they were much lower than the defence walls and usually located within the fortress, which gave them additional protection against heating. A mud layer, which was used to cover the external walls, acted as additional

During detailed field work, wall fragments with deformed bricks have been observed for example in Mustafa’s House – MH (Fig. 6B) [27, 29]. The deformations bear traces of water influence caused by intensive rainfall, resulting in bricks moistening. Similar brick deformations, caused by rise of groundwater level, have been observed by *J. Trzcinski et al* [26]. Numerous traces of salt crystallisation have also been observed both on brick surfaces and on fresh fractures (Fig. 6C-E). This fact additionally documents the process of cyclic moistening and drying of the mud brick material in strong insolation conditions.

During field studies, breaching of the material structure due to the activity of boring organisms was documented in mud bricks from “Wall 2” – W2 and Mustafa’s House – MH (Fig. 6F and G). Mud brick surfaces are covered by numerous oval holes, 1cm in diameter, whereas long, several centimetre-long networks of bored tunnels are visible in cross-section. The holes formed in the mud brick cause decrease of its strength.

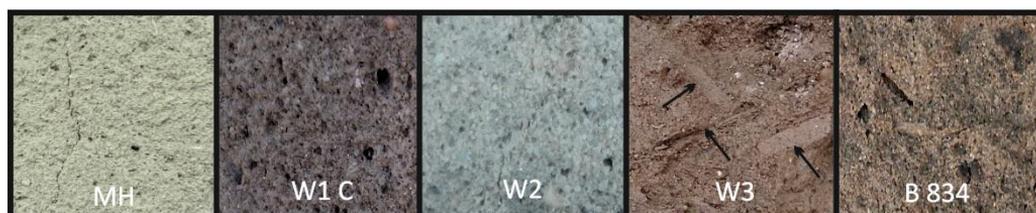
Fig. 7. Mud brick colours: MH – light grey, W1 C – grey-brown, W2 – light grey, W3 – brown (arrows indicate imprints of plant fragments), B 834 – dark brown. Symbols of objects as in Fig. 2B.

protection. Object walls with a NW to NE exposure also did not heat as intensely. Mud brick colour directly influences the effect of heating and exfoliation (Fig. 7). A darker-coloured mud brick warms up more intensely than a lighter-coloured brick, therefore thermal stress is higher and, in consequence, loosening of the mud brick material takes place on a larger scale. Mud brick colour and its significance in the ancient Egyptian constructions have been discussed recently by *M. Zaremba et al* [16]. Analysis of isochronous objects (W2, W3 and B 834) built of variously coloured bricks shows that brick deterioration is caused by brick colour and object location. The fortress walls, being a protection for the objects within the fortress against the impact of atmospheric conditions, were at the same time most liable to these conditions.

Chemical deterioration takes place in case of changes related with the decomposition of organic matter. The decomposition of small amounts of dried and disintegrated plant remains added to the mixture is evidenced by voids after plant fragments, often observed on fresh fractures of the bricks (Fig. 7).

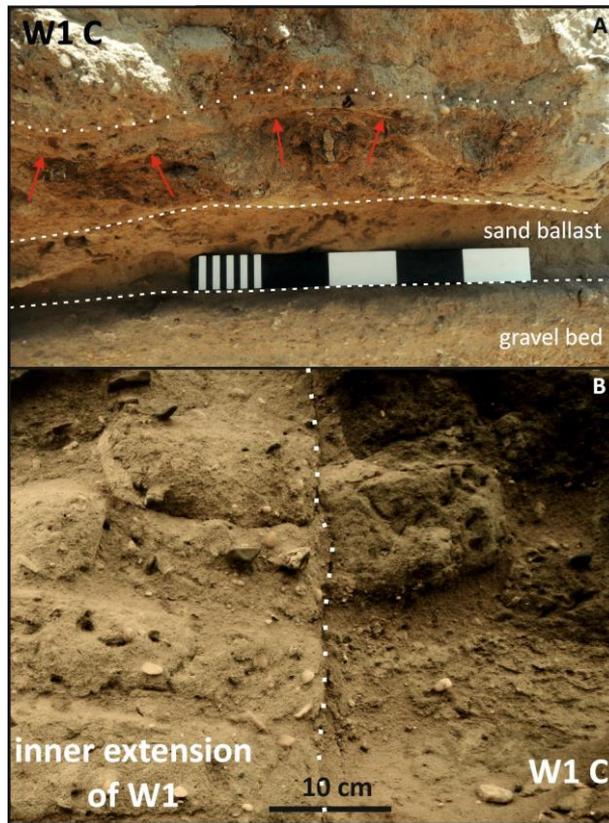
Fig. 8. Deformation visible in “Wall 1”. A – plastic deformations of the bottom mud brick layer (marked with arrows and a dotted line), B – deformed structure in W1 C (poorly visible brick pattern) and non-deformed structure in W1 inner extension (well-visible brick pattern). Symbol of object as in Figure 2B.

Climate change had high impact on the environment, especially on the hydrological conditions in the Nile Delta and the anthropogenic activity in the area, significantly dependent on the annual inundation of the Nile [31]. These changes caused increase or decrease of the water level in the Nile, which resulted in high or low water levels in all tributaries crossing the delta. Changes linked with high and low Nile floods presented by *K.V. Butzer* [31] have been confirmed by isotopic analysis [32]. According to archival data, climate did not change significantly over the last few centuries in the Nile Delta and in the Wadi Tumilat region [23]. In the Pleistocene, a braided river filled the delta with fluvial sediments, mainly sands and gravels (Table 1). Small elevations (plateaux) were formed, which were used for potential settlement in later periods. The Early Holocene was characterised by high levels of flood water and increased lake ranges, which favoured the formation of lake sediments. Such lake reservoir existed in the vicinity of the plateau, on which the fortress was later constructed [29]. The next period is characterised by low flood levels, which lasted till the beginnings of the Second Intermediate Period, when a Hyksos settlement began to function near the plateau. High flood levels and increased lake ranges have been noted from that time till the end of the Ramesses II fortress. Therefore, a catastrophe caused by these factors must have occurred during the construction of “Wall 1”, which caused the instability of its structure. Extensions were added to both sides of the wall to protect it against damage [25]. The wall structure, composed of a core and two extensions (inner and outer), has not been explained yet (Fig. 8).

Field observations performed on the wall and its basement have shown that its lowermost parts contain very deformed bricks. Such deformations were caused by severe soaking of the lowermost parts of the structure. Intense floods must have occurred during “Wall 1” construction or directly after its raising; they caused rise of groundwater level and its rise to the lower parts of the wall, which resulted in the instability of the entire construction. The only rescue for the building endangered by destruction was adding extensions to the wall to stabilize its construction from both sides. A factor that favoured flooding at that time was the close distance to watering channels in the vicinity of the fortress. Such location of the channels must have promoted flooding of the fortress during high water levels of the Nile. Another factor which could have resulted in flooding of the area around the fortress was the occurrence of low ground to the north of the fortress. Geological investigations in the Tell el-Retaba site have indicated the presence of lake deposits in this region [16, 17]. It may be assumed that this region was periodically flooded during high water levels, as confirmed by sediments drilled around the fortress.

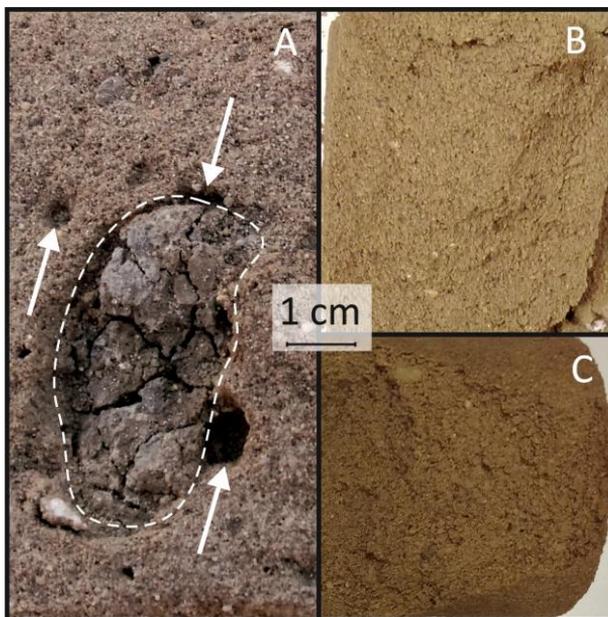
Fig. 9. Brick material structure from Building 834 in macro scale (see text for details): A – heterogeneous structure of mud brick, note large clay clast with desiccation cracks (surrounded by dashed line) and large pores (arrowed), B and C – reconstructed homogeneous structure of mud brick material.

intensification of deterioration processes. In turn, the structure of the brick material reconstructed in laboratory conditions is different. In macro scale it is characterised by a larger uniformity than the original mud bricks (Fig. 9B and C).

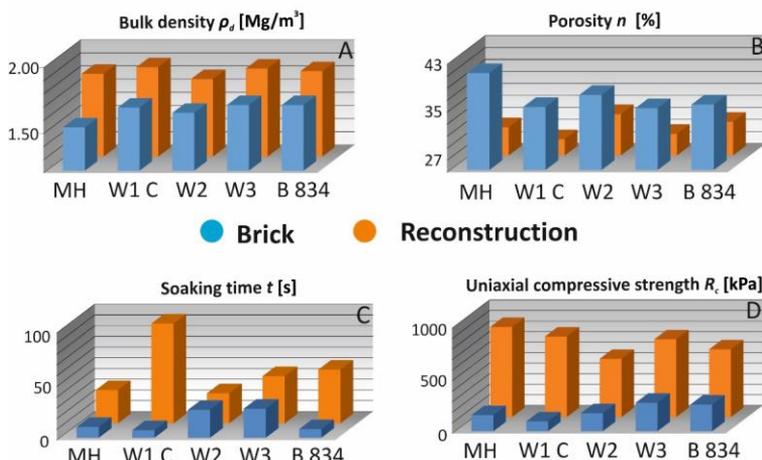
Fig. 10. Comparison of physical and mechanical properties of mud bricks and reconstructed brick material (see text for details): A – bulk density, B – porosity, C – soaking, D – uniaxial compressive strength. Symbols of objects as in Figure 2B.

Results of the analysis of basic physical and mechanical properties of the original mud bricks and the reconstructed brick material for selected objects have been presented in Table 2 and compared in Figure 10.

Decrease of bulk density values and increase of porosity are observed with increasing brick age (Tables 2 and 3, Fig. 10). In turn, values of these parameters for the reconstructed brick material do not show such relationships. The observed trend indicated worsening of brick parameter with longer impact of the deterioration factors. i.e. with brick age. Only in the case of the reconstructed brick material from W2, a decreased bulk density value and higher porosity were observed in comparison to the remaining objects. Bricks from object W2, in which the contribution of the sand fraction with uniform grain size reaches almost 90 %, and the finest fractions, thanks to which the bricks were cohesive, achieve only 10 % [16], from the beginning had lower density and higher porosity compared to other objects from the site. This suggests that the material was used to produce bricks that had poorer parameters. It would seem that after being subject to deterioration processes, these bricks should proportionally lose in quality and possess much lower values of the parameters. In turn, comparison of brick parameters from W2 with bricks from other objects shows that values of their parameters changed insignificantly due to weathering processes. This may result not only from the applied raw materials but also from the untypical form of “Wall 2”, which was a wide, low platform, ca. 2m high [23]. Such construction did not undergo intense deterioration process, contrary to the high wall.

Mud brick properties significantly changed due to deterioration processes (Tables 2 and 3, Fig. 10), particularly: 1) aggregation or disaggregation of the mineral grains, 2) increased hydrophyly of the material due to mineral weathering and decomposition of organic matter, 3) increase of shrinkage of material due to enrichment of the clay fraction with decomposed organic matter, 4) decrease of the degree of packing of the mineral grains, 5) decrease of bulk density and increase of porosity, 6) increased saturation of material and its soaking, 7) decreased strength due to decrease of intragranular cohesion and depletion of structural bonds, as well as 8) diminution of material structure.

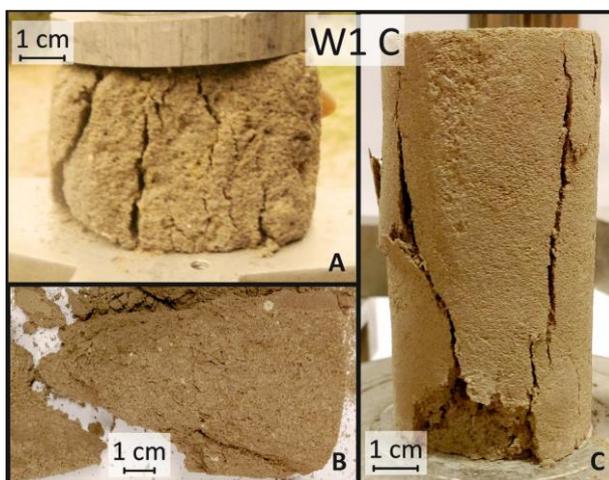
Fig. 11. Type of sample destruction after uniaxial compression test of W1 C (see text for details): A – mud brick, B and C – reconstructed mud brick material. Symbol of object as in Figure 2B.

Values of uniaxial compression strength R_c for bricks are from 92kPa (W1 C) through 160kPa (MH and W2) to over 240kPa (W3 and B 834). The reconstructed material is characterised by much higher values of this parameter than the mud bricks. The highest increase of its values was observed in the case of material from W1 C – from 92 to 765kPa (over 8 times) and from MH – from 161 to 856kPa (over 5 times). For the remaining objects the values of this parameter rose by three times. Comparison of the damage style shows that both original bricks and the reconstructed material behaved similarly. Destruction surfaces with a similar dip angle and with a characteristic shear fan have been observed (Fig. 11).

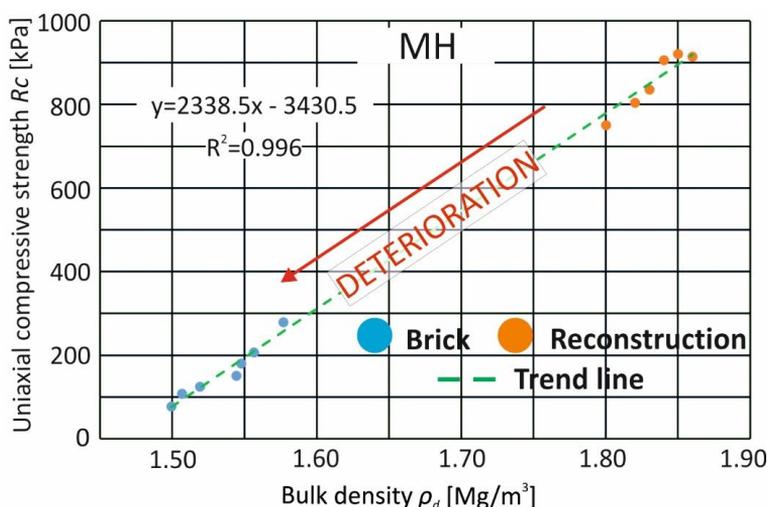
Fig. 12. Influence of deterioration processes on the mud bricks properties from Mustafa's House (MH). Correlation of uniaxial compressive strength with bulk density (see text for details).

An important role in mud brick degradation is played by time. The largest changes of the parameters between mud bricks and the reconstructed material are observed in the case of the oldest object studied, MH, and the smallest – in the case of the youngest object B 834 (Table 3, Fig. 10). A very large loss of strength is observed for all bricks, from 59% in B 834 up to 88% in W1 C, at an insignificant decrease of bulk density, from 8 % in W2 and B 834 to 11% in MH (Table 3). Large loss of strength is well expressed by correlation with a high correlation coefficient R^2 (Fig. 12).

The reason for such intense decrease of strength values at a small loss of bulk density values must be the lack of strong bonds at the boundaries between grains and particles, which during deterioration processes must have undergone strong weakening. In turn strong structural bonds in the reconstructed brick material result in high strength values. A more precise estimation of the type and influence of deterioration processes on the properties of mud bricks require further detailed studies.

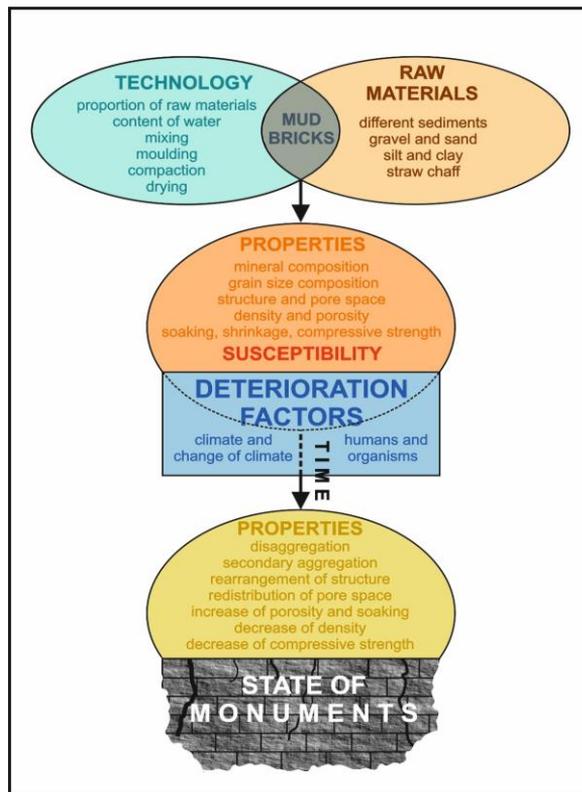
Fig. 13. Diagram showing the influence of deterioration processes on the preservation of mud brick architecture.

preservation of the monuments in Tell el-Retaba. Figure 13 presents a diagram of deterioration of mud brick monuments.
