PREVENTIVE PRESERVATION APPROACH FOR THE PRESERVATION OF UNIQUE EARLY NEOLITHIC ARCHITECTURAL REMAINS OF THE ARCHAEOLOGICAL SITE OF BEIDHA-JORDAN

Ziad AL SAAD*, Mohammad BATAINEH

Department of Conservation and Management of Cultural Heritage –
Faculty of Archaeology and Anthropology, Yarmouk University-Irbid-Jordan

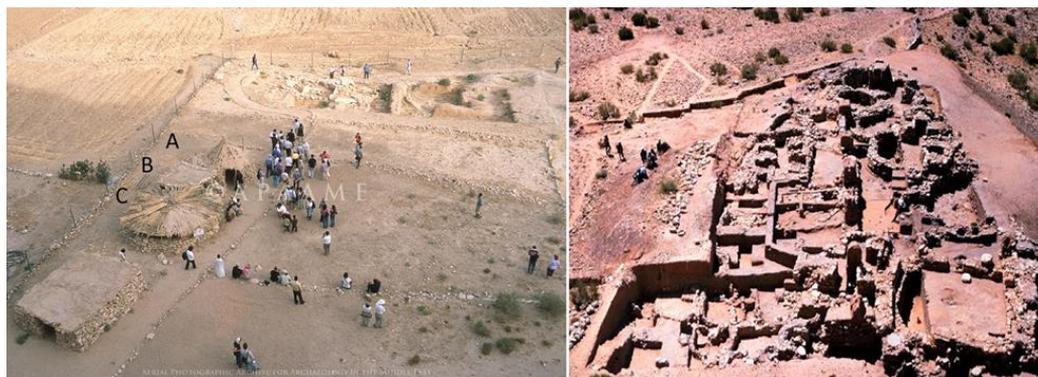
Fig. 2. General view showing the three styles of houses at Beidha

Beidha is a unique site in terms of the evolution of its architecture with a long continuous history of use. Archaeological research reveals evidence of a continuous architectural sequence ranging from clusters of round post houses, through individual sub-rectangular examples, and then ultimately true rectangular buildings (primarily corridor buildings) as shown in figure 2 [13].

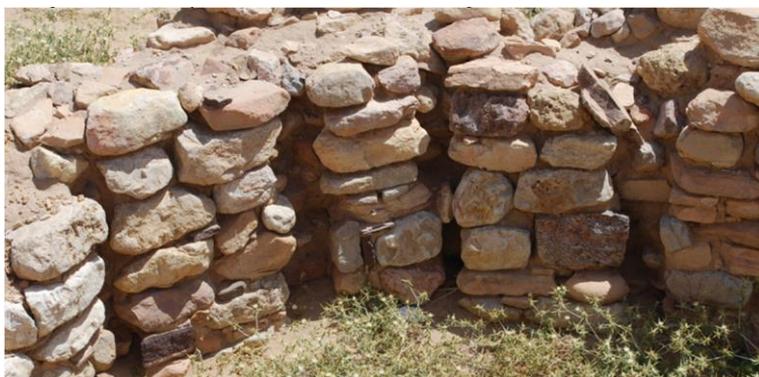
Fig. 3. Remains of one of the houses showing stones, remains of the mortar and the gaps resulted from the loss of the wooden posts

The field survey and laboratory analyses show that the structures of Beidha were built using local materials. Undressed limestone and earth mortars were the basic building materials used in the construction of the houses and the city wall. Thin layer of lime plaster was used to cover some internal walls and floors and tree trunks (Oak, Juniper) were used as posts to carry the roofs which were made of reeds covered with mud. Currently the only remaining building materials are the stones, remains of the binding mortar of the walls and some scattered patches of the floor plaster. Stones have survived and are in good preservation conditions while the mortar suffered severe deterioration and disintegration and wood posts were completely decomposed as indicated by the cavities left behind as shown in figure 3.

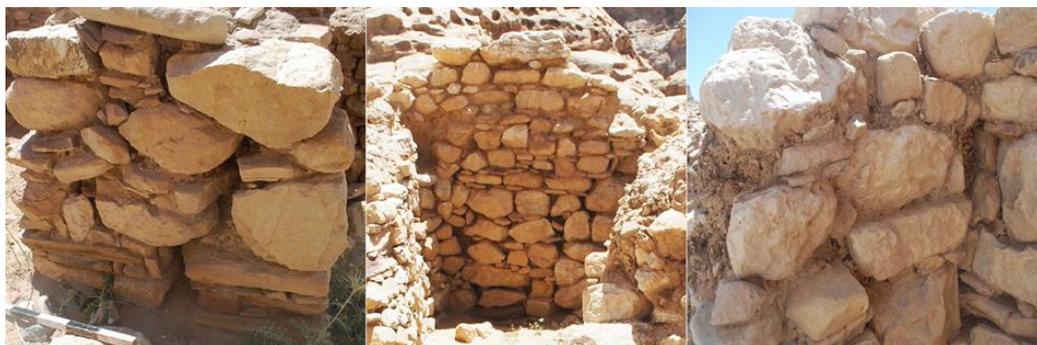
The most noticeable problem that has caused loss of strength and integrity of structural remains in Beidha is the weathering and disintegration of the binding and rendering mortar. Mortar decay resulted in weakening of the overall structure and collapse of stone especially the upper part of the walls (Fig. 4). This type of weathering can be noticed clearly where there is a great difference between the strength of mortar and building stones, so the weathering clearly appears on the mortar.

Fig. 4. Decay and loss of mortar lead to weakened structures

Mortar weathering has been caused by many natural agents particularly running water and persistent dampness as earth mortar is vulnerable to water damage. High levels of moisture gradually destroy the clay matrix, leading to increasingly friable mortar, a loss of structural integrity and ultimately the deformation of masonry elevations. Other factors such soluble salts, wind, plant growth effect and daily cycles of fluctuation in temperature and relative humidity which caused change in volume and dimensions of the mortar have contributed to the acceleration of the weathering process.

Consolidation of the walls can be done by applying repair mortar in the voids and deep joints between the stones, which are susceptible to fall. Proper application of mortar provides more cohesion to the friable structures. Depending on the condition of the structure, different techniques of mortar application can be used including grouting, repointing and injection.

Capping is applying a layer of mortar over the fragile stone walls to prevent their collapse especially for the upper stone courses. Capping acts as a protective layer that reduce significantly the effect of rainwater falling at the wall and eroding mortar, also it penetrates the wall and move down through voids in the mortar washing the mortar from inside the wall. Capping also help in fixing the stone blocks at their location by the effect of the weight of the capping layer. Capping is advised to be applied after stabilizing and repointing.

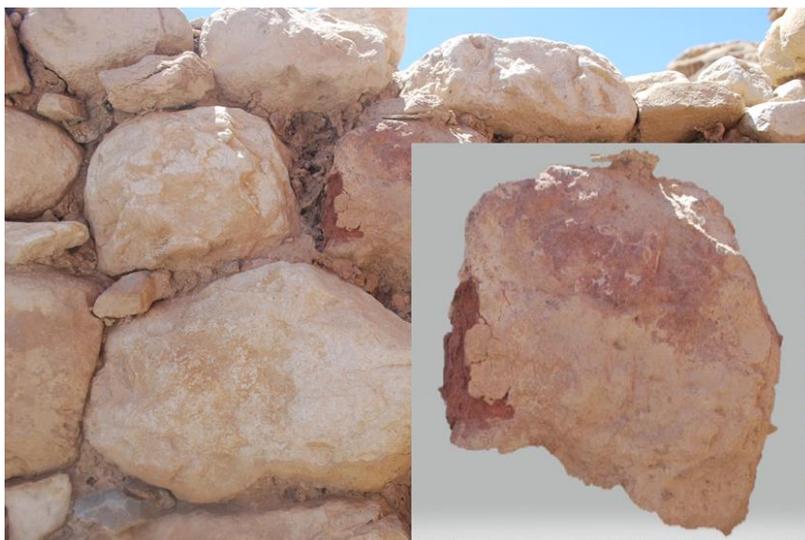
Unlike mortar, most stone blocks used in building Beidha structures are in good preservation condition indicated by their good mechanical strength. However, it has been observed that few examples of the stone blocks have been selectively deteriorated as manifested by their flaky surfaces and weakened structures. Laboratory analyses by XRD and ICP-OES prove that the basic difference between the deteriorated stone blocks and the preserved ones is their content of the iron oxide limonite - $FeO(OH) \cdot nH_2O$. The deteriorated stones contain a high percentage of 5.26% of limonite while the preserved ones contain as low as 0.78%. Limestone that contains high percentage of limonite is weaker, softer and has more porosity and less specific gravity when compared with limestone that contains no or low percentages of limonite [25]. This explains the selective weathering of these stones as shown in figure 5.

Fig. 5. Selective weathering of limestone blocks that contain high percentages of limonite

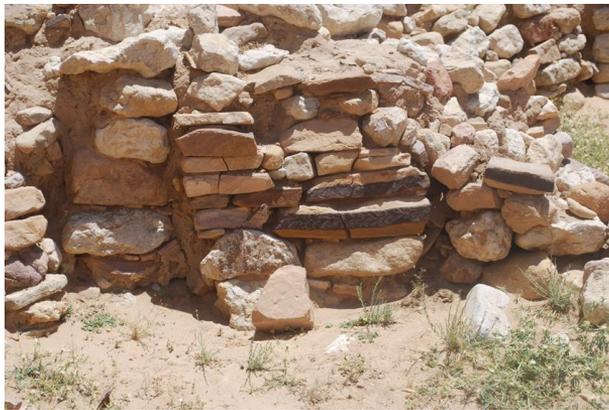
Cracking of some of the building stones, which are flat and with large surface area in comparison with thickness, could be attributed to excessive load as a result of the accumulation of deposits over the wall with the laps of time (Fig. 6). Other cause may be binding mortar weathering and fall of some small supporting gravel underneath the stone which creates an uneven distribution of load from the weight of stone above and directed over small areas of the stone surface.

Fig. 6. Stone cracks due to excessive load

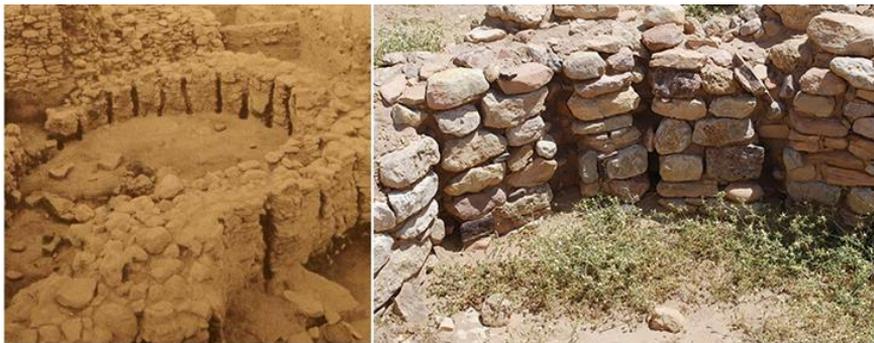
Wood posts were set up during the beginning of constructing of Beidha houses. They were used to transfer the load of the walls horizontally and distribute the force between stones. Wood is an organic material that is very susceptible to biological and physical deterioration caused mainly by fluctuations of humidity and temperature [26]. All wooden posts were totally lost leaving gaps between wall stones. This resulted in imbalanced distribution of the force and concentration of force over some stones which caused them to crack and fall apart as shown in figure 7.

Fig. 7. Gaps between stones as a result of wooden posts deterioration

As earth mortars have very low tensile strength, they provide little restraint to movements caused by change in load patterns.

Wood posts should be reinstalled at their original locations, to protect the structures from further damage and stone failings. Wood posts were used as a construction material in Beidha structures to transfer the load of the walls horizontally and distribute the force over the whole height of the wall, which helps in preventing collapse. The complete deterioration of the wood posts created gaps between the wall's stones and imbalanced distribution of the force that caused a concentration of force over some stones. This resulted in stone cracking and falling as shown in the Figure 11.

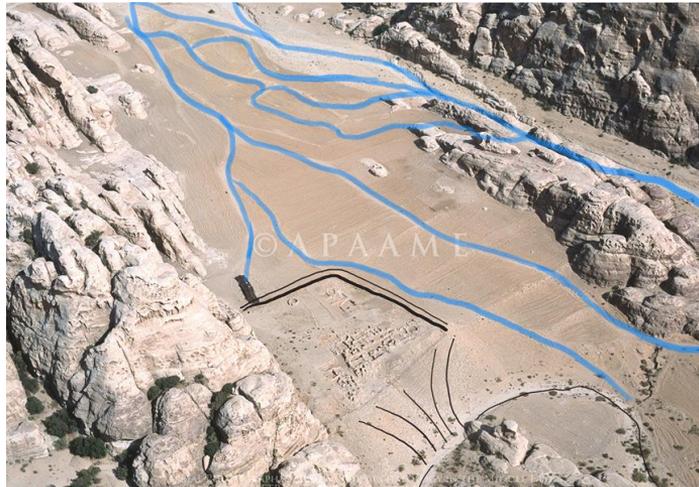
The average mean rainfall in millimeters per year in Beidha is about 200-300mm/y. [27]. However, the nature of rainfall at Beidha is described to be a short period of great abundance causing a quick rise in the level of water and the formation of streams of water moving to the lower places carrying soil, and gravel. The size and amount of stuff carried out by the stream is proportional to its speed and the amount of water. The sandy soil of Beidha has very low absorption affinity of water, which causes very fast rise in the level of rainwater and the formation of streams. The site is located in flat area surrounded by Rocky Mountains from all the sides, near the maximum flow point of the catchment area which makes running water a serious damaging factor that causes instant mechanical damages and long-term increase of dampness [28].

Fig. 8. Proposed water diversion channels

Based on understanding of the hydrology of the area, the best solution for this problem is the diversion of the runoff water away from the site. This can be achieved by constructing channels mainly alongside the mountain to divert water to the lower area outside the site, as represented in figure 8.

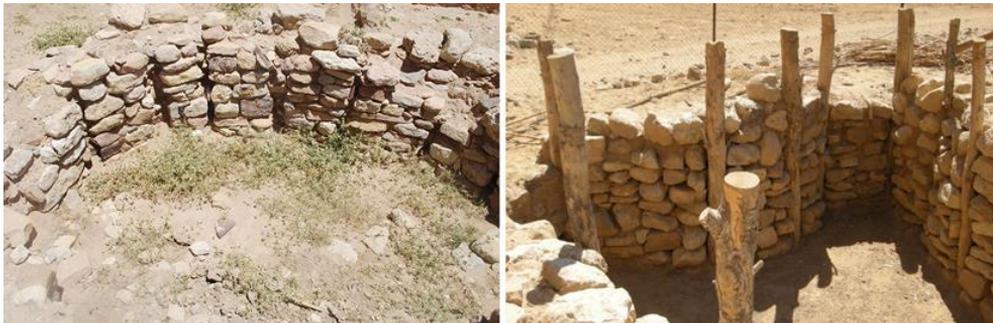
Fig. 11. Re-installing wood posts in the gaps
