DAMAGES CAUSED BY MICROORGANISMS IN HISTORICAL BUILDINGS ON THE EXAMPLE OF A MULTI-FAMILY RESIDENTIAL BUILDING

Agnieszka MALEC^{1*}, Monika GARBACZ², Beata KLIMEK³, Łukasz GUZ¹,
Paweł GOLIANEK¹, Zbigniew SUCHORAB¹

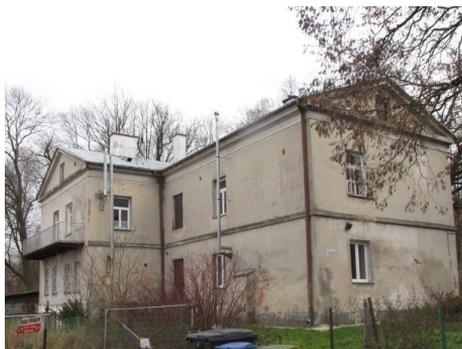
Fig. 1. View of south-west elevation

The object, where the survey was carried out, is a detached building at 1 Czechowska Street in Lublin, Poland on a plot of land no. 11/7 (Figs 1 and 2). The building has two floors, a partial basement, previously (before the fire of 1999) with a usable attic. The building has a gable roof of a wooden, rafter and purlin structure. Partially covered with metal sheet (fragment above the southern elevation), the remaining part covered with tar paper. The building was constructed using traditional technology, its construction and partition walls are made of solid brick with cement-lime mortar. External cement-lime plasters smooth, repaired and rubbed down with cement mortar. Gutters and downpipes made of galvanised sheet. Partly above the basement: brick vaults and wooden ceilings and contemporary thick-ribbed ceilings of Teriva type. Ceilings for overground storeys were made of wood with a blind ceiling. Floors in rooms are wooden on joists, in some rooms there is oak parquet on a blind floor. In rooms, on most walls there are gypsumboards, in staircases there are cement-lime plasters with emulsion paintings and oil varnishes. Currently, the building is not heated. The window and door frames have been partly replaced, and the historical "Polish type" windows and single- and double-leaf panel doors have been preserved. On the southern elevation, there is a balcony with a structure

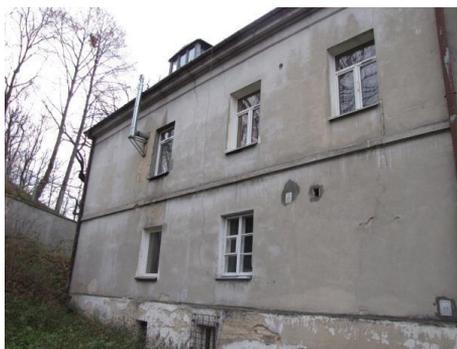
Fig. 2. View of the east elevation

based on cantilever steel beams, and the "balcony plate" is covered with wooden planks. The building is located directly on a wetland adjacent to the Czechówka river. On the eastern side, a reinforced concrete retaining wall was erected behind the building, on which the adjacent slope is based.

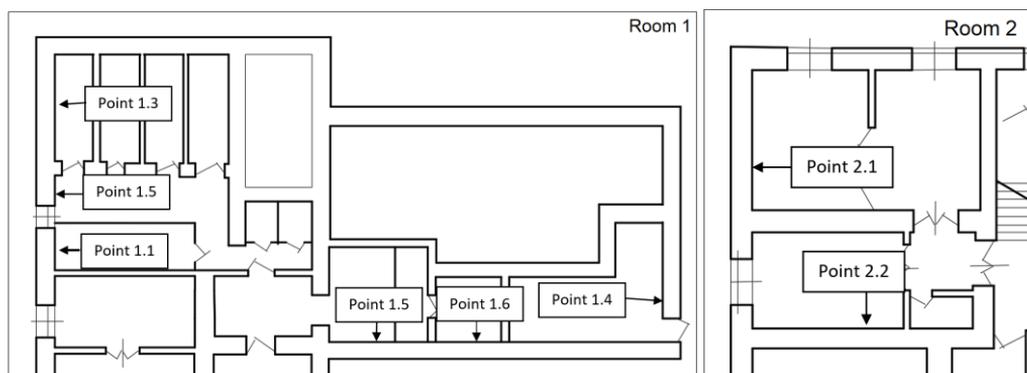
Fig. 3. Schematic views of room 1 and room 2 showing the positions of the measurement boreholes

A total of 8 boreholes were drilled - six in the basement (room 1) and two in a (room 2) on the ground floor. Three samples were taken from the east wall of the basement, two samples from the north wall of the basement and one sample from the west wall (Fig. 3).

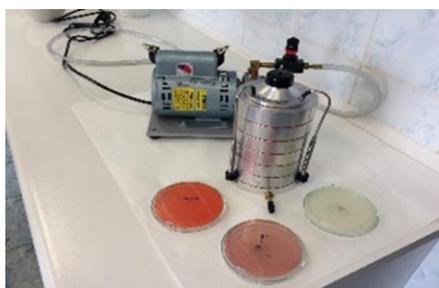
Fig. 4. The cascade impactor and Petri dishes

The cascade impactor (Fig. 4) is a device used to determine the specific size distributions of any aerosol-forming dust. Using appropriately shaped aerosol guide channels, dust of different diameters is deposited at different locations.

Six petri dishes with Sabouraud's medium were placed in the cascade impactor and air was drawn for 10 minutes using a pump. The impactor was placed in the centre of the room 1 and room 2 at a height of 1 metre. The plates were then located in a greenhouse at 27°C with incubation time of the samples set for 2 weeks. The cascade impactor (Fig. 4) is an appliance for determining specific size distributions of aerosol-forming dusts. With use of appropriately shaped aerosol guide channels, dust of different diameters is deposited at different locations [18, 20].

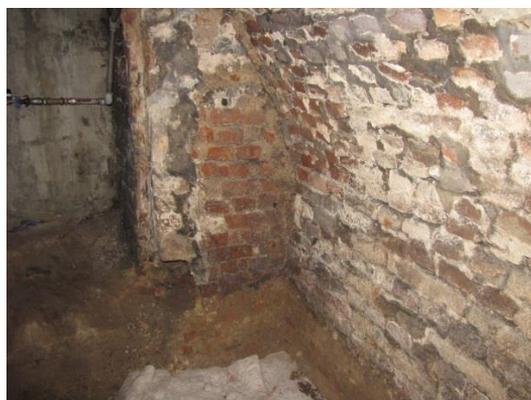
Fig. 5. Dampness and biological corrosion – moulds

In all cases examined, the degree of dampness was exceeded, with the basement walls showing the highest dampness. Such a high level of moisture, which persists for a long period of time, is the reason for significant corrosion of masonry materials - bricks and joints are heavily degraded. Locally, the damage does not concern only the surface of walls and plasters, but the degradation causes damage to deeper structures of bricks. In the parts of the masonry where the moisture is not so high, the corrosion related to building salts is visible. Both types of corrosion are accompanied by the development of microorganisms, moulds and algae.

- The lack of vertical and horizontal water insulation as well as the ineffective rainwater drainage system caused the basement walls to become completely damp (about 20%_{mass}). At the basement level, the beginnings of material structure deterioration and signs of biological corrosion were identified.

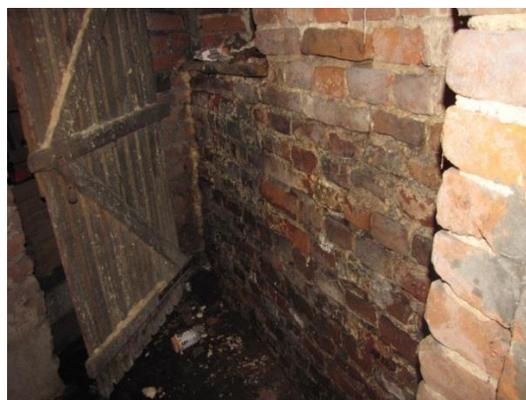
Fig. 6. Visible dampness and loss of joints and bricks, crystallisation of building salts

enable draining water "from" the building to the outside. Rainwater directly penetrates the basement walls and the ground floor. The influence of dampness is also visible on the walls of the ground floor. Crumbling plaster and peeling paint indicate the negative influence of moisture on the structure. The structure of basement walls locally shows crumbling of materials (bricks and mortar) and development of biological corrosion.
