## ADVANCED DOCUMENTATION METHODOLOGIES COMBINED WITH MULTI-ANALYTICAL APPROACH FOR THE PRESERVATION AND RESTORATION OF 18<sup>TH</sup> CENTURY ARCHITECTURAL DECORATIVE ELEMENTS AT PALAZZO NUZZI IN ORTE (CENTRAL ITALY)

*This contribution reports the documentation of the conservation status and the pictorial technique of a wall painting and a stucco arch at Palazzo Nuzzi in Orte, central Italy (Viterbo district), achieved using a wide combination of non-invasive and micro-invasive diagnostic techniques. Specifically, a photogrammetric approach has been used for 2D and 3D ultraviolet fluorescence (UVF) acquisitions. Moreover, the conservation status of the wall painting has been also investigated by a non-invasive active infrared thermography technique, i.e. Pulse Compression Thermography (PuCT), used here for the first time on a wall painting to map the surface and sub-surface cracks in the first layers.*

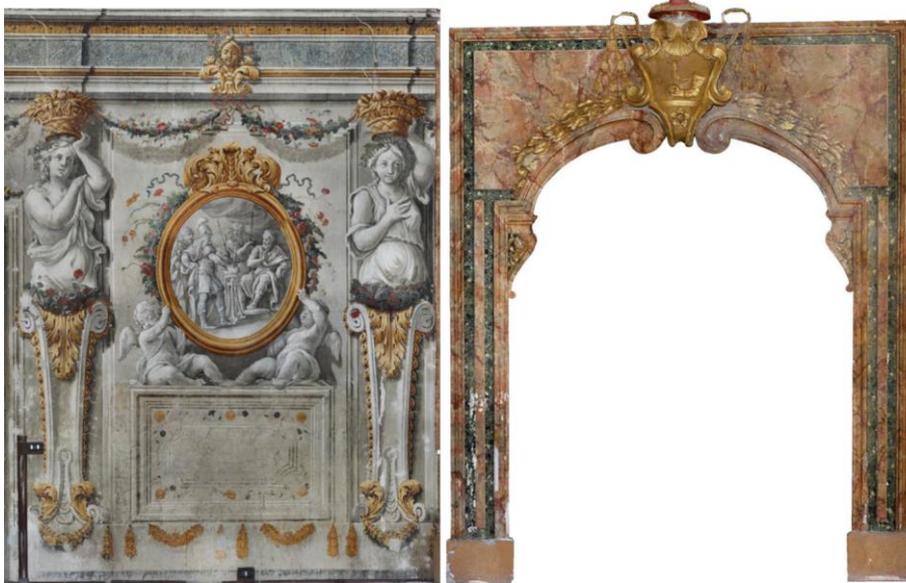
**Fig. 2.** Orthophotomosaic of the wall painting (left) and the stucco arch (right) after the first restoration step performed between 2019 and 2020 (Credits: Francesca Groppi and Davide Vigliotti)

The architectural decorative pattern of this room was commissioned by Cardinal Ferdinando Nuzzi around 1715 to embellish his bedroom [6]. The wall painting depicts the episode of Muzio Scevola and Porsenna framed by figures in grisaille and floral elements (Figure 2, left). The stucco decoration consists of an arch with the Nuzzi's family heraldic coat of arms on top of it and decorated with imitation marble and gold leaf elements (Figure 2, right).

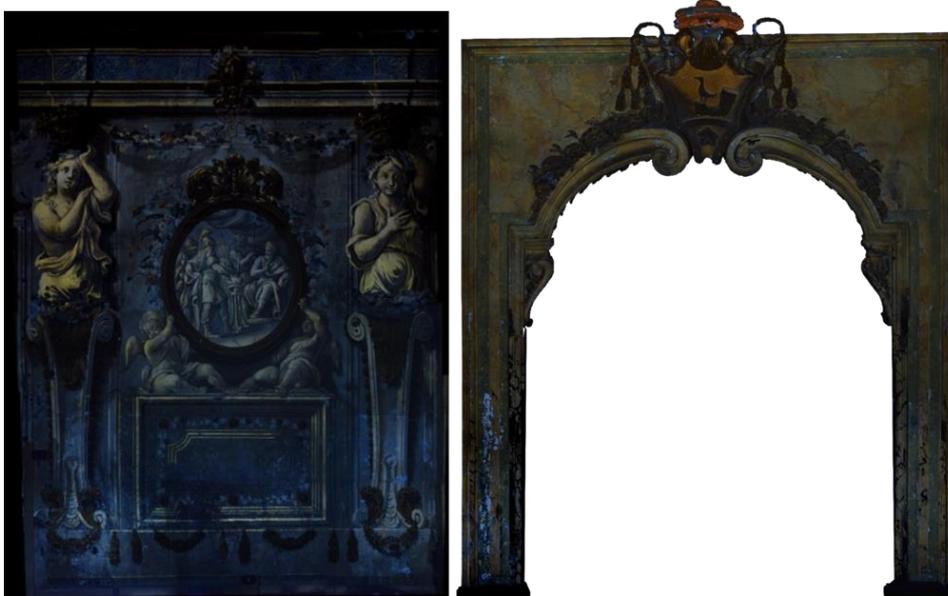
Concerning the wall painting, the UVF photography highlighted three main kinds of fluorescence: (i) light blue fluorescence diffused on the entire surface, being particularly evident in the background and on the floral wreaths. This fluorescence could be associated to the organic binder of the painting, as it is visible on the whole surface; (ii) a yellow fluorescence observed in the white areas, possibly caused from the presence of zinc white [25]; (iii) an orange fluorescence localized in few limited areas of the painting and probably associated with pictorial reintegration due to past restorations, such as in the base of the right caryatid [4].

In the case of the arch, UVF images highlight the presence of a thick varnish layer above the imitation marble. Furthermore, it is possible to appreciate the thickness of this surface varnish. In fact, this material acquires a markedly browner colour in many areas of the arch surface, significantly masking the false marble decoration beneath. It is also possible to recognize the recent pictorial reintegration interventions of the '80s, as they are well highlighted by a dark colour under UV radiation [5].

**Fig. 3.** UVF orthophotomosaic of the entire wall painting and of the stucco arch after recomposition and processing of the acquired images, before restoration (Credits: Francesca Groppi and Davide Vigliotti)

The first step of the diagnostic campaign involved the UVF photography, which is commonly used by restorers as a fundamental step to look at the conservation status of the surfaces, to observe repainting and reintegration, to map cracking and possible defect of the surface etc. [14, 22-24]. The results of photographic acquisition and image processing through photogrammetry are reported in figure 3.

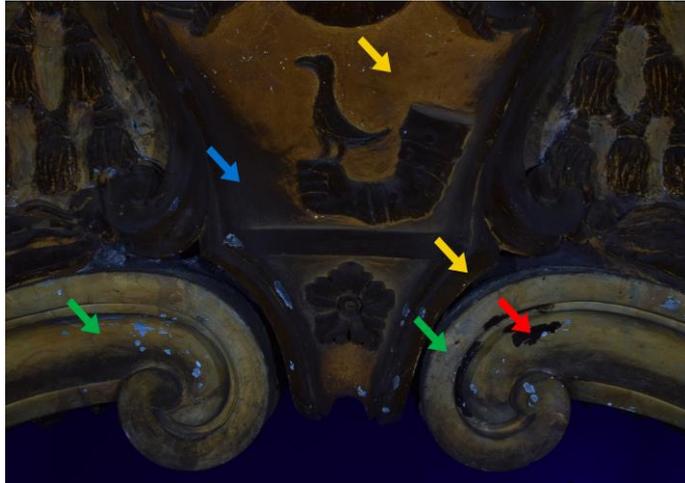
The gold leaf of the decorative elements is characterized by a dark-brown fluorescence, while the ground layer shows a yellow-orange fluorescence. Lastly, the presence of surface dirt deposits, characterized by a dark colour under UV, makes the interpretation of the original gilding even more complicated. Details of the above-mentioned fluorescence typologies are shown in the figure 4.

**Fig. 4.** UVF detail image of the lower portion of the heraldic coat of arms. It is possible to observe: the heterogeneous thickness of the varnish (green arrows); the repainting of the 80s of the last century (red arrow); the different ultraviolet response of the gold leaf and its ground layer (yellow and orange arrow respectively); the fluorescence of the dirt deposit (blue arrow). VF images of the entire wall painting and of the stucco arch after recomposition and processing of the acquired images, before restoration (Credits: Davide Vigliotti)

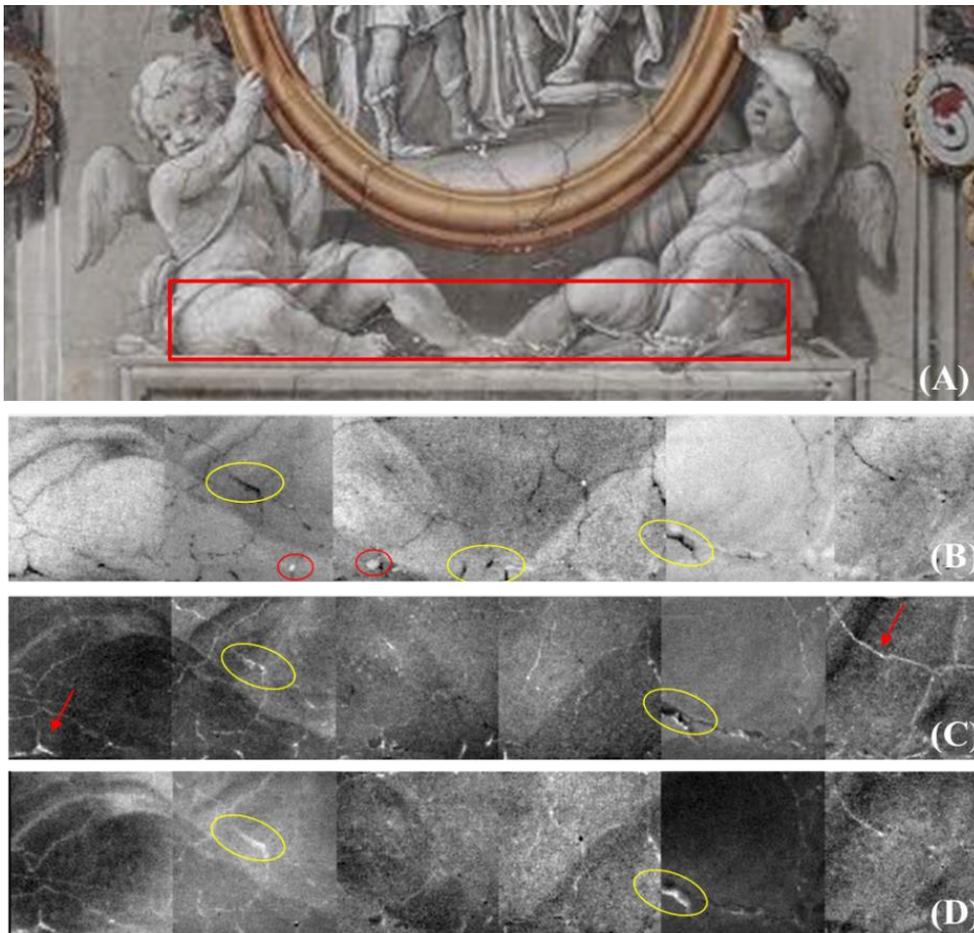
From the results of the thermographic campaign before consolidation, a series of significant information regarding the state of conservation have been obtained. In the first series of images, relating to the initial cooling phase of the surface ( $T = 1.5s$ ), dark areas appear near to the fractures and correspond to lacunae and lifting of the first painting layer (Figure 5B, yellow ellipses). White lacunae appear in some points of the thermogram suggesting the flaking of the pictorial film (Fig. 5B, red circles) [4].

In the thermograms related to longer cooling times ( $T = 3.5$  and  $12.5s$ , Fig. 5C-D), it can be seen that some of the forms of alteration initially recorded ( $T = 1.5s$ ) are no longer visible

here, while others seem to be accentuated. The defects which in the  $T = 1.5s$  thermogram are more marked and appear as black, are thought to belong to deeper preparatory layers (see yellow ellipses in the figures 5C-D and red arrows in the figure 5C).

**Fig. 5.** Results of PuCT analysis before restoration. (A) The investigated area in the red frame; (B) thermogram at time 1.5s; (C) thermogram at time 3.5s; and (D) thermogram at time 12.5s

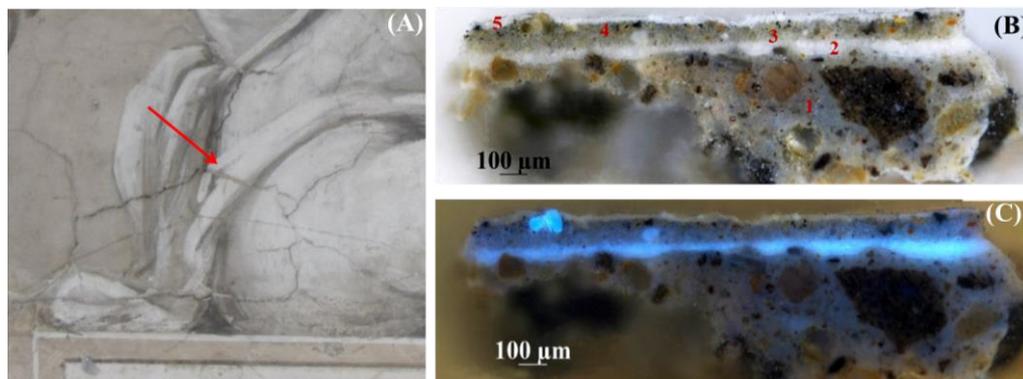
The stratigraphic analysis allows for obtaining information about the the wall painting' layers: (1) is the ground layer (mortar); (2) a white priming characterised by an intense light blue fluorescence: (3) and (4) light yellow painting, probably applied in two different layers and (5) white surface layer with light yellow fluorescence. By combining the results derived by FTIR spectroscopy and cross-section examination, it can be derived that the painting was applied by secco technique on priming made of gypsum and protein binder (light blue fluorescence). This result is highly meaningful as it confirms that the execution technique is in accordance with the indications supplied in the *Trattato* by Andrea Pozzo [7, 28-30].

**Fig. 6.** Microstratigraphic analysis: (A) image of the sampling point; (B) cross-section under reflected light; and (C) the same cross-section under UV fluorescence

Results of XRF spectroscopy on selected analysis points of the wall painting and stucco arch are provided in table 1 in terms of the main detected elements. In all points of analysis of the wall painting, Ca and Sr elements have been detected, suggesting the presence of gypsum. In fact, Sr is systematically associated to Ca, as occurs when Ca and Sr sulphates are present [26, 27]. This hypothesis was confirmed by the presence of S, and also by FTIR spectroscopy analysis that revealed the use of gypsum in the wall painting (Table 2) and also by the micro-stratigraphic analysis (Fig. 6).

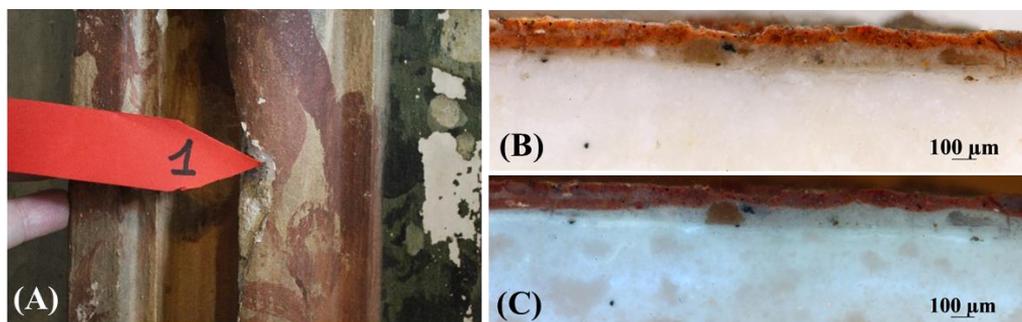
This visual observation has been further confirmed by FTIR spectroscopy that showed the main signatures of calcium carbonate (Table 2), and by micro-stratigraphic analysis that allowed distinguishing the limestone powder under UV as it results in less fluorescent areas compared to the mortar matrix (Fig. 7). The other materials detected in the FTIR spectrum are due to partial contribution of the red layer and of the surface restoration materials that were not completely separated from the ground.

**Fig. 7.** Microstratigraphic analysis on the false marble decoration in the stucco arch: (A) image of the sampling point; (B) cross-section under reflected light; (C) the same cross-section under UV fluorescence

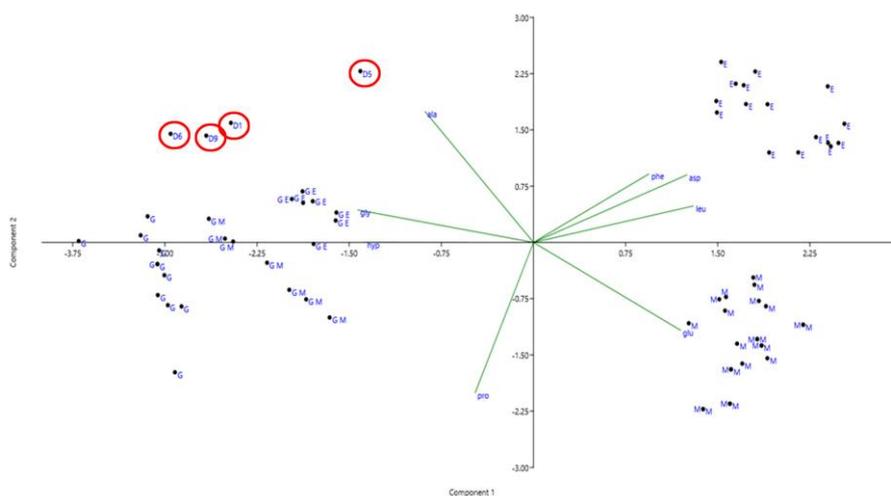
The PCA-based evaluation, whose score plot is reported in figure 8, locates all the samples in a new cluster suggesting a mixture of egg and animal glue binders.

**Fig. 8.** Score plot of reference materials and artistic samples (G: animal glue; GE: animal glue and egg, GM: animal glue and milk, M: milk; E: egg)
