## CHARACTERIZATION OF LIME MORTARS FROM AN 18<sup>TH</sup> CENTURY RIVER TAGUS QUAY (LISBON, PORTUGAL)

*The monumental quay Cais das Colunas was built in the decades 1770 to 1790, merged in the reconstruction plan of the city of Lisbon after the great 1755 earthquake. Characterization studies of mortars from this period are still very few. In 1997 the quay was partially dismantled and in 2008 was reconstructed. During the reconstruction intervention ancient mortars, from the core, were sampled in order to study them. This paper presents the mineralogical, chemical and granulometric characterization and capillarity water absorption of samples from these mortars. The analytical methodology comprised: the qualitative mineralogical analysis by powder method of total sample by X-Ray diffraction; the quantitative chemical analysis of total sample by X-Ray fluorescence; the water absorption by capillarity coefficient; the determination of hydrochloric acid insoluble residue; and the granulometric analysis of insoluble residue. This methodology allowed determining the simplified composition of mortars. It was confirmed the use of local sands and aerial lime based binder.*

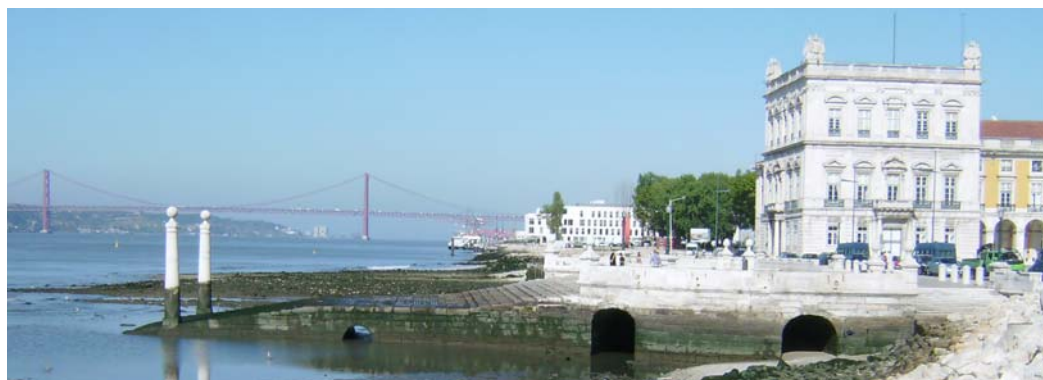
**Fig. 2.** The quay Cais das Colunas, 2011.

The limestone quay is 50.8 metres long, its width ranging from 12.4 metres to a maximum of 44.2 metres, and is crossed by three transverse galleries. The current columns stand 6.2 metres high.

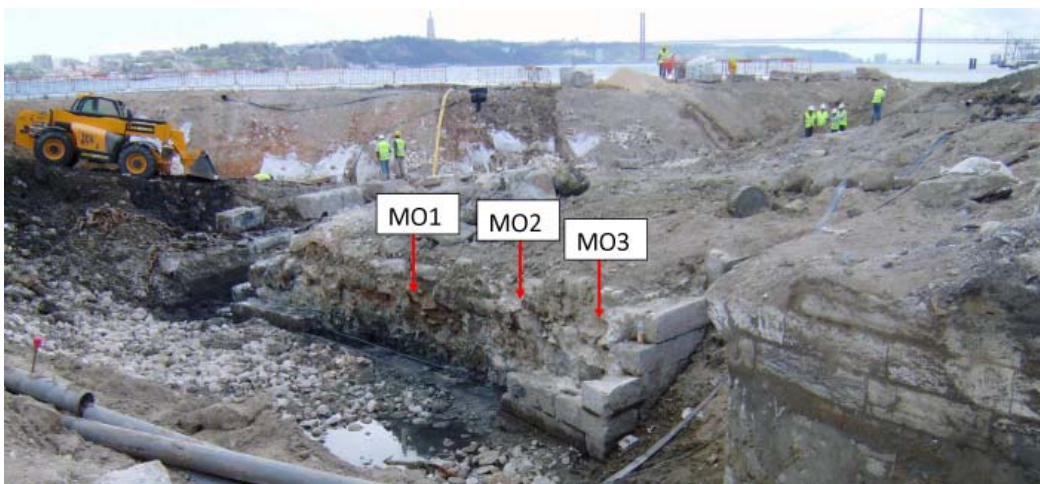
Fig. 3. Sampling of mortars at the core of *Cais das Colunas*. West elevation, 2008.

Sampling was carried out on the core of the quay (Fig. 3) prior to the reconstruction of western elevation in 2008. The samples collected were obtained from masonry mortars prepared and applied during the original construction of the quay from 1770 to 1790.

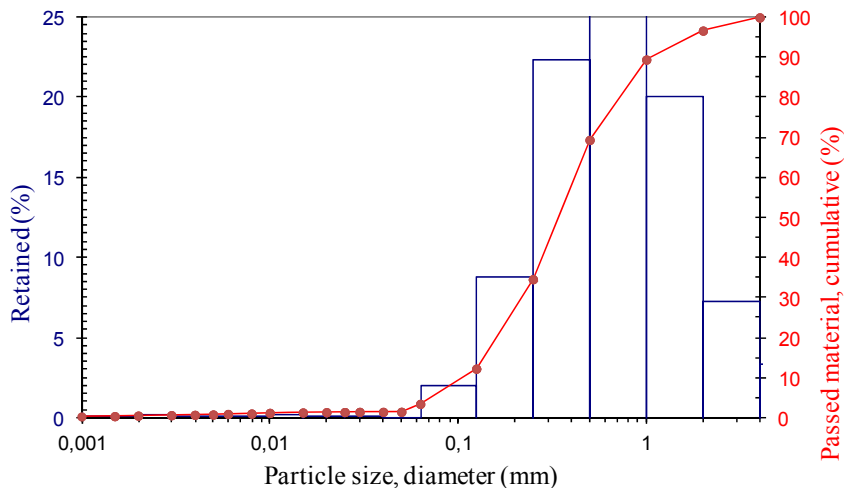
**Fig. 7.** Insoluble residue granulometric distribution and granulometric curve.

The particle size distribution curve and insoluble residue granulometric distribution values (Table 3 and Fig. 7) allows calculation of the grain size distribution of the aggregates. Aggregates with 0.500 to 1.000 mm diameter constitute the greatest proportion of the sample.

MO2 contained 1.53% of fine fraction, under 0.063mm. The fine particle size distribution was performed using the sedimentation process. Fineness modulus is 2.9.
