## THE EFFECTS OF AIR POLLUTION ON THE STATUE OF SAINT GEORGE AND THE DRAGON IN CLUJ-NAPOCA, ROMANIA

*The study presents the effects of air pollution on a historical symbol of Cluj-Napoca. The statue of Saint George and the Dragon is a copy made in 1904 by Kalman Lux. The original statue built in 1373 by two metalworkers Martin and George from Cluj, is in Prague, Czech Republic. The pedestal of the statue was built using the "Baciu Limestone" due to its famous white color. The "Cluj Limestone" is a white-yellow Cenozoic limestone, with high water uptake and porosity, which allows large amounts of water to easily be stored within the limestone. According to the emissions inventory provided by The Regional Agency for Environmental Protection from Cluj-Napoca for the years 2004-2010 the emission values of SO<sub>2</sub>, NO<sub>x</sub> and SPM decreased comparing to the years 1992-2002, and the ammonia values were relatively constant. The results indicate the presence of a black layer of different thickness on the surface of the samples which consists mainly of new formed gypsum. The sample extracts indicate a dominance of phthalates, and the pyrolysis has identified substances chara

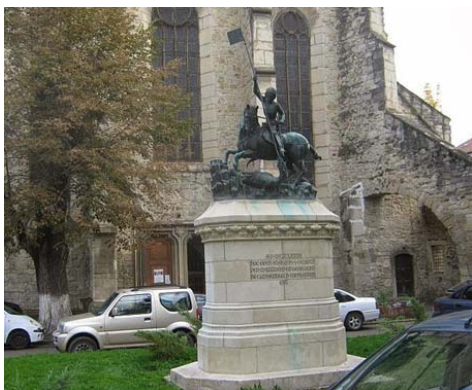
**Fig. 1.** Location of the Statue of Saint George, and the Dragon in the Cluj city center and the main source of air pollution (cars)

The “St. George and the Dragon” statue in Cluj (made in 1904 by Kalman Lux) is a replica of the statue built in 1373 (by two metalworkers, Martin and George from Cluj) and initially was located in Saint George Square (which is now known as “Lucian Blaga Square”). In 1960 was moved to the small square in front of the Reformed Church of Calvin on Mihail Kogalniceanu Street, which was considered to be a more suitable location (Fig. 1).

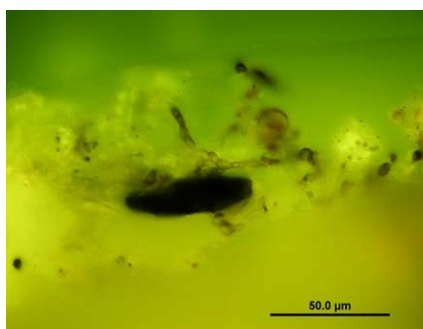
The black crust on the statue of Saint George and the Dragon (sample S.G.) is composed of basic mineral material with small amount of carbonaceous particles on the outside part (Fig. 7-10).

**Fig. 7.** Massive char fragment and plant organism residues. Reflected white light, immersion objective.

**Fig. 8.** Massive char fragment and plant organism residues. Reflected blue light, immersion objective.

**Fig. 9.** Massive char fragment and plant organism residues. Reflected white light, immersion objective.

**Fig. 10.** Residues of plant organism. Reflected white light, immersion objective.

On the surface, there is a thin lamina containing a few bigger particles of massive char (up to 50µm) with high reflectance ( $R_r = 1.5 - 3.8\%$ ), small portion of soot and more residues of plant tissues and organs with chain structure too.
