BIODETERIORATION AND PRESERVATION OF SITA DEVI TEMPLE, DEORBIJA, CHHATTISGARH, INDIA

Sanjay Prasad GUPTA^{1*}, Kavita SHARMA²

¹⁾ Archaeological Survey of India, Raipur Circle, Raipur, India.

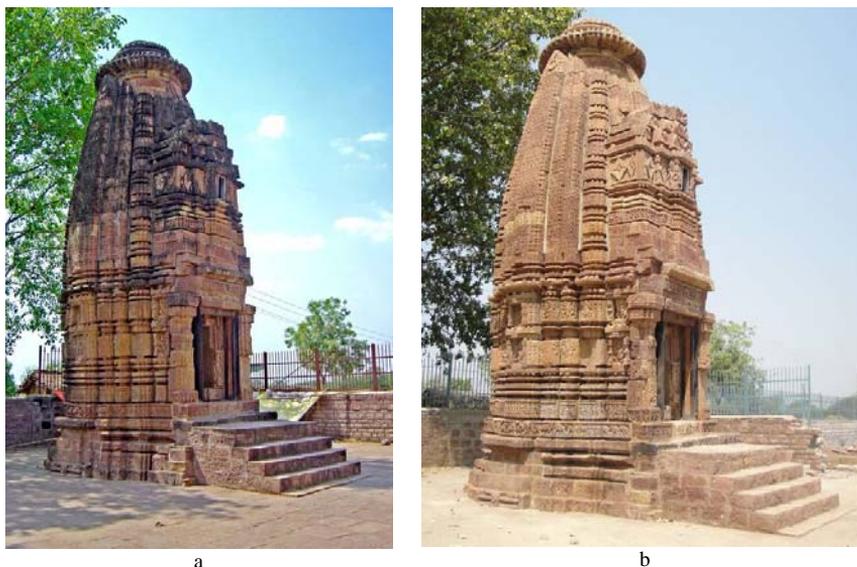
Fig. 1. Sita Devi Temple: a - before conservation; b – after conservation

The stone surface of the temples became blackish in appearance due to deposits of dust, dirt and dried vegetation and micro vegetation [4]. The deposit covered area seems to be very old due to the formation of secondary dull green, pale, white lichens, present all over the stone surface. Due to these deposits the aesthetic beauty of the temple is seriously affected. Moreover, these depositions are very harmful for the health of the stone surface. It is necessary to remove these accretions from the surface of the monument [3].

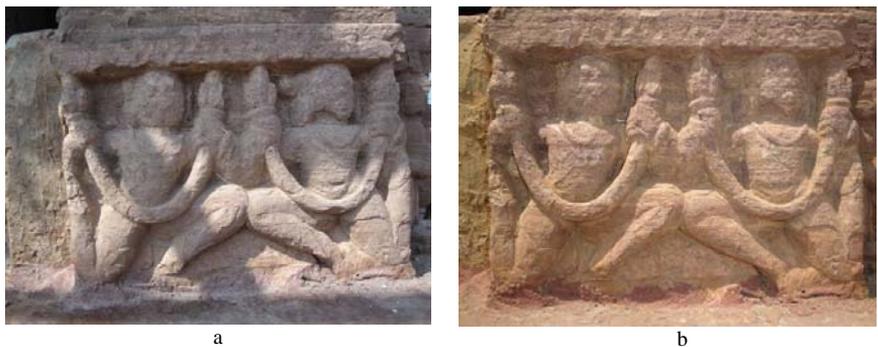
Fig. 2. Sita Devi Temple detailed structure: a - before consolidation; b – after consolidation

Measures were taken by the Archaeological Survey of India for the removal of dust and dirt accretion to keep the stone in neutral pH and to preserve and strengthen the stone by soft brushing (Fig. 4b). The moss, fungi and lichen were removed by applying 2-3% solution of ammonia in water and by scrubbing with a nylon brush [8]. Black patches of remains of micro-vegetational deposits appeared after removal of thick layer of moss, fungi and lichens which were washed out with the help of dilute solution of oxalic acid in water because due to very deep penetration of micro – vegetational growth inside the stone, only superficial cleaning done by using ammonical solution with the help of aid of soft nylon brushes. A diluted solution of a non ionic detergent with liquid ammonia was applied on the treated surface to remove dirt, dust and any traces of acid and ammonia left on the surface during the chemical treatment (Fig. 3b). To stop further growth of micro vegetation, 2% aq. solution of sodium pentachlorophenate was applied on the clean, dried surface. The brittleness and powdering of stones were preserved by the application (brushing and impregnation till saturation) of an ethyl silicate based coating material, which forms a glass like silica gel binder (SiO_2 aq.) with release of ethanol (by evaporation) as byproduct [6]. Noteworthy is that the intake of stone strengthener materials was comparatively higher in the case of damaged and pulverized stones (Fig. 2b). That can be attributed to the presence of more pores for penetration. The coating of stone strengthener was applied on the deteriorated and flaky stone surface by simple brushing and impregnation till saturation.
