## GEOMECHANICAL INVESTIGATIONS FOR ARCHITECTURAL HERITAGE PRESERVATION. THE HABIB SAKAKINI PALACE IN CAIRO, EGYPT

*The understanding of the geotechnical problems and failure mechanisms of stone structures of Sakakini palace (1897 AC) entails a comprehensive study on the mechanical behavior of the stones and other construction materials. In addition to micro analysis, geological and geomorphologic interests, several investigations on stone deterioration and engineering geology were performed. First phase included more advanced techniques, which provided additional information on particular aspects of site deterioration and it included laser analysis (LIBS), electron probe micro analysis, micro XRD and XRF analyses, scanning electron microscope analysis coupled with EDX probing, transmission electron microscopy and grain size distribution analysis, permeability and pore size distribution of stone, mortars, core binders and other construction materials. Second phase included the determination of mechanical properties of building stones, such as compressive strength, modulus of elasticity, tensile strength, and shear strength. To obtain reliable values for these properties, a suitabl

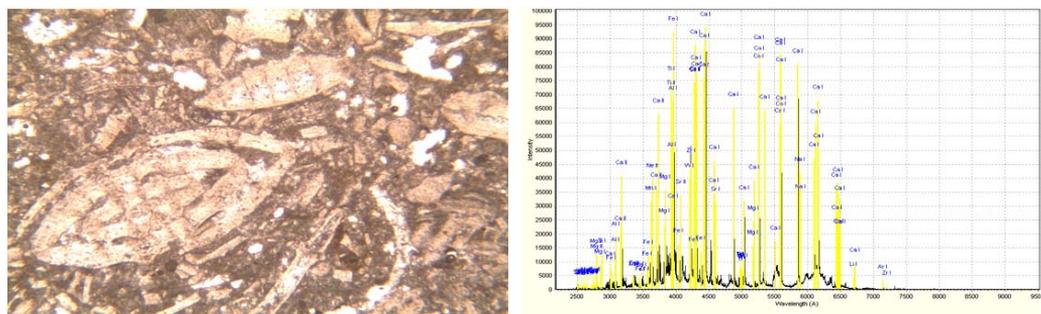
Fig. 2. Thin section and laser analysis (LIBS) results of chalky limestone.

The limestone can be characterized as medium grained with uniform relative grain size, angular to sub angular grain shape with equidimensional form and rough surface texture. Sound or non weathered pieces of stone can be characterized of medium compactness and durability and the weathered pieces characterized of low compactness and durability. It must be mentioned that the weather variations affected strongly the masonry units, starting from the surface and continuing inward thus loosing the mineral fabric.

The EDX micro analysis indicated that, the elemental arrangement for the chalky limestone samples collected from Sakakini place can be put in a decreasing order according to their concentration as follow: Ca (33.50%), O (29.80%), S (16.94%), K (9.01%), C (6.53%), Fe (1.76%), Si (1.48%), Al (0.55%), Mg (0.44%) (Figs. 2 and 3).

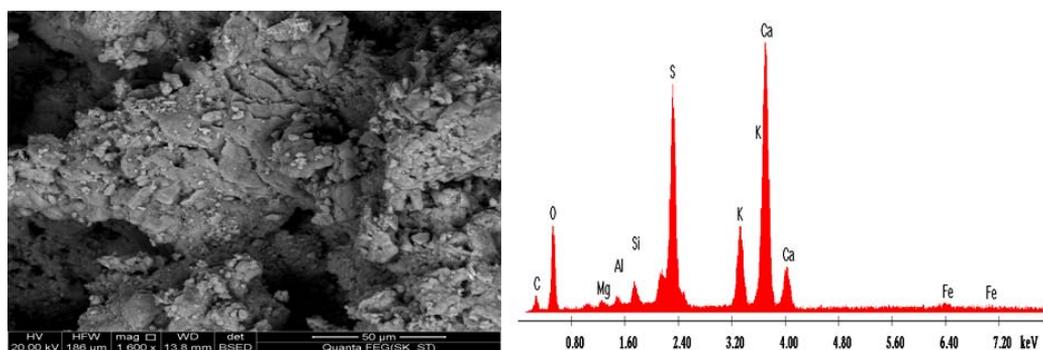
Fig. 3. SEM with EDX analysis results of chalky limestone

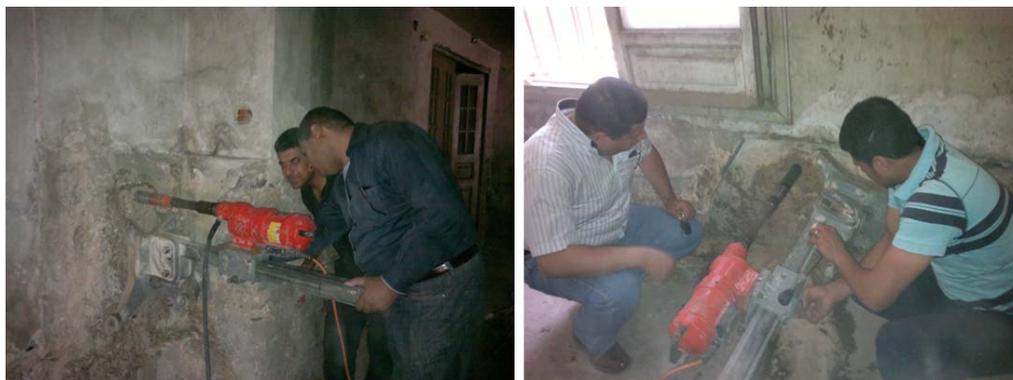
Fig. 4. The Core Samples extraction from the basement of the palace

The testing program includes the extraction of seven cylindrical cores from the basement stone walls of Sakakini's mansion in down town Cairo (Fig. 4 and 5). The cores are extracted

using rotary cylindrical diamond blade coring machine. The top and bottom surfaces of every core were prepared to be flat circular surfaces perpendicular to the vertical axis of the core.

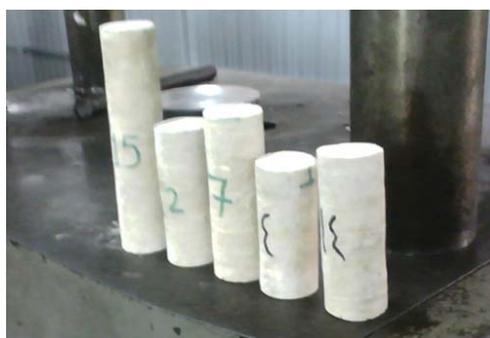
Fig. 5. Some Core Samples after Preparation for Mechanical Testing

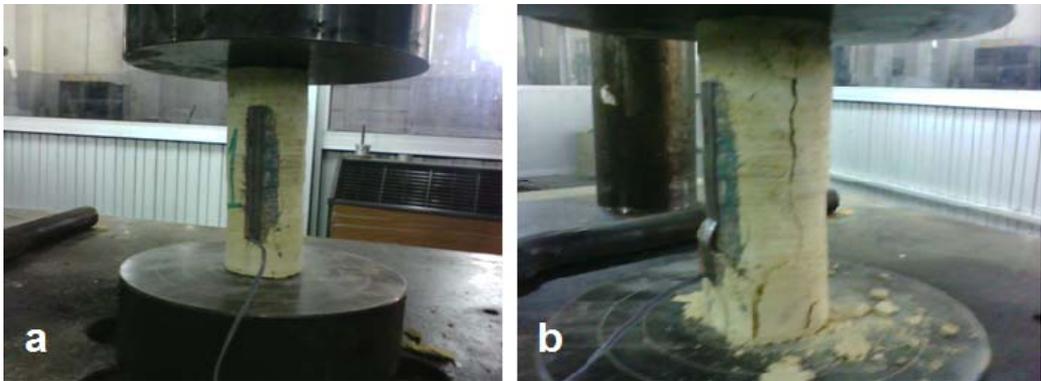
Fig. 6. Compressive Strength Sample in the Test Set-Up (a) and failure (b)

Three samples were equipped with 100 mm long electric strain gauges. One strain gauge was fixed to the core parallel to its vertical axis to measure the longitudinal compressive strain corresponding to the applied compressive stress. The vertical compressive stress was increased gradually until failure (Fig. 6). The compressive strength of every core was determined. Table 3 shows the results of the compressive strength of the three cores.

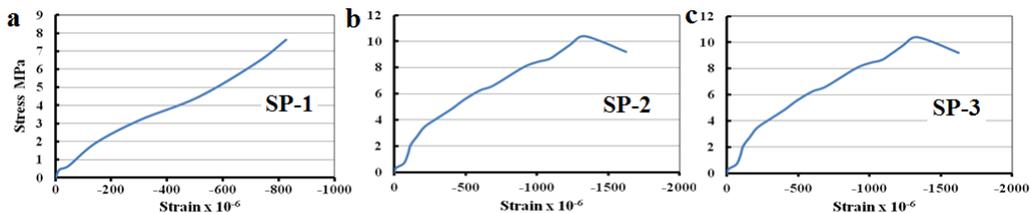
Fig. 7. Stress-Strain Curve for Samples: a – Sample 1, b – Sample 2, c – Sample 3

The recorded stress-strain data for the three samples are graphed as shown in figure 7. From these figures, the value of the modulus of Elasticity can be obtained. For brittle materials with non-linear stress-strain relationship; the modulus of elasticity may be determined as the chord modulus between a low stress value (0.5 MPa) and a stress value equals one third of the compressive strength. For such definition the values of the modulus of elasticity obtained for the three tested samples are given in Table 4.

Sample No.	Strain at 0.5 MPa ( $\times 10^{-6}$ )	Ultimate Strength $f_{ult}$ (MPa)	Strain at $f_{ult}/3$ ( $\times 10^{-6}$ )	Modulus of Elasticity (GPa)
1	10	10.5	301	17.182
2	13	10.4	213	22.500
3	4	10.6	250	18.293

Average value for Modulus of Elasticity = 19.325 GPa
