## CHEMISTRY OF PRESERVATION OF THE AJANTA MURALS

### **Abstract**

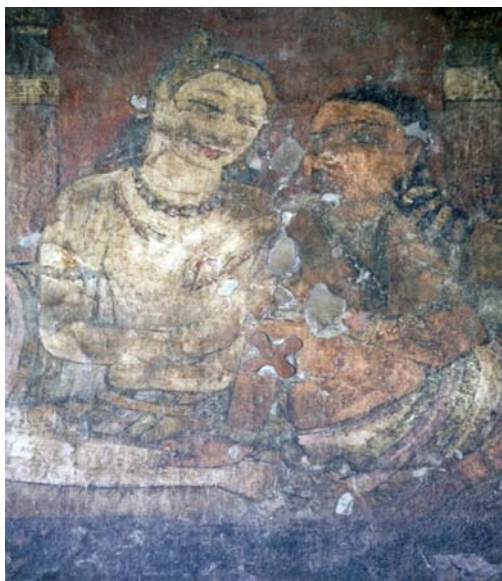
**Fig. 2.** Painted figure with Copper Nails, Cave No. 17

- Injection of casein in lime where the gap was narrow;
- Filling with plaster of Paris or lime, fine pozzolana where the cavity was large;
- Fixing of copper nails in dangerous parts for supporting the coarse plasters (Fig. 2);
- Strengthening of the plaster by sticking strips of linen on the surface with hot gelatin and removal of the linen by means of hot water, after the parts were secured to the wall;
- Liberal use of unbleached shellac, dissolved in alcohol for general preservation.

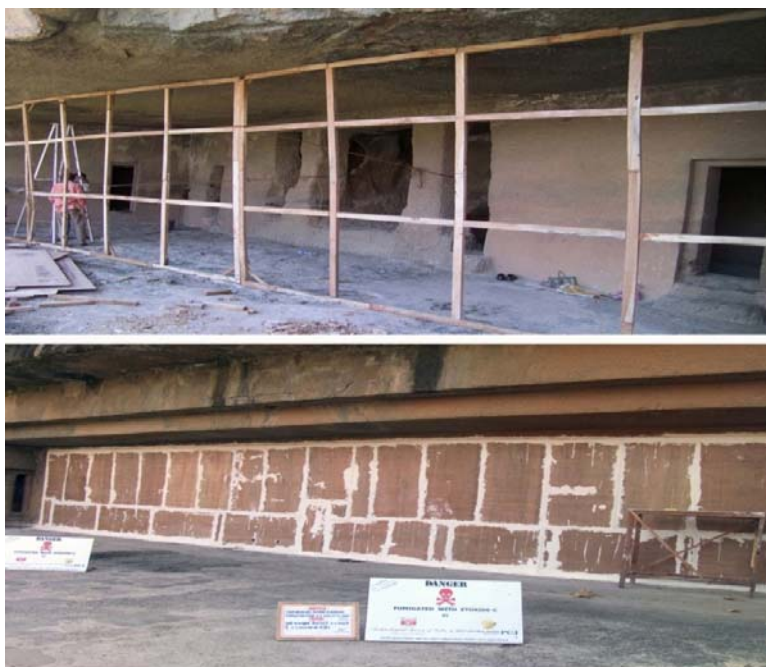
Fig. 3. Showing the fumigation of the Ajanta Caves

in Feb/March 1998. Therefore, regular spraying of pyrethrum was being carried out on the unpainted part of the cave, along with the path ways at Ajanta (Fig. 3).

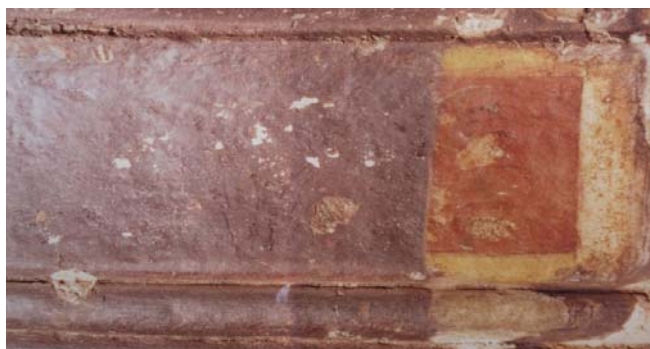
**Fig. 4.** Partly cleaned painted surface of cave no 17, pilaster of Ajanta

During the course of works, it was also noticed that the solvents recommended after long experimentation for the removal of soot are being absorbed by the painted surface at a very high rate. As such absorption of organic chemicals is not advisable in the long run and it may probably be one of the reasons for the frequent appearance of chalkiness on the paintings, necessary corrective measures were taken in that regard for scientific cleaning works at Ajanta. The partly cleaned painted surface of cave no. 17, at pilaster of Ajanta, is shown in Figure 4.
