## PHYSICAL DETERIORATION OF EGYPTIAN LIMESTONE AFFECTED BY SALINE WATER

### *Abstract*

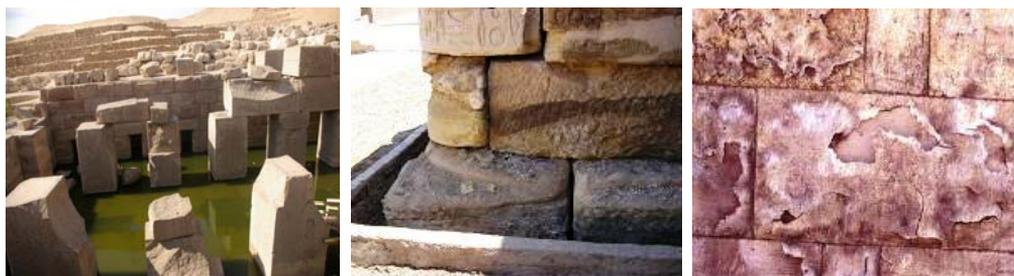
These cycles greatly limit the durability of porous building materials [17]. They can produce some aggressive stresses and strains within the building materials [18], leading to the development of some cracks types and micro-fussers, in addition to the increasing of voids inside their body, thus, stones lose their cohesion and may occasionally collapse [6]. This type of weathering mostly creates some forms of deterioration such as *salt crystallization* (efflorescence, sub-efflorescence and crypto-efflorescence) [7], *scaling, crumpling, flaking* and *cracking*. All of these forms lead to severe effects on different optical characteristics and physical properties of the affected stone body which could be summarized in the following sections. These symptoms are widespread in most of the archaeological sites in Egypt both in the southern part of Egypt such as Esna, Edfu, Abydos temples, as well as some Pharaohic tombs. Furthermore, some Islamic archaeological sites in Northern part of Egypt especially in *Fatimid* and *Mamluk* Cairo, and the most of the archaeological sites and Delta (Fig. 1).

**Fig. 1.** Forms of physical deterioration affecting some Egyptian monuments resulted from the effects of salinity water

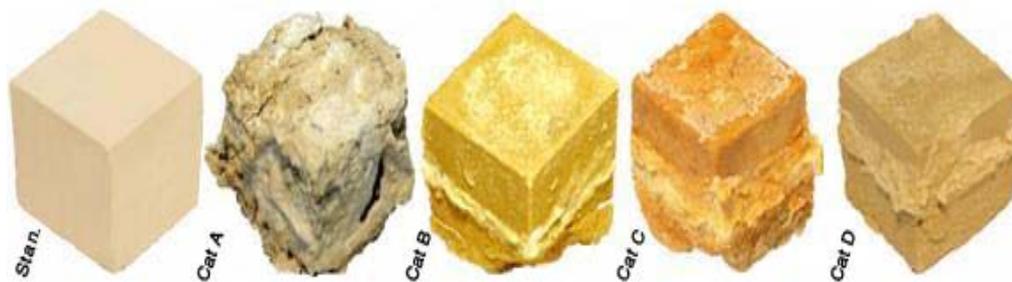
- The samples belonging to category **A**, were highly affected, collapsed and completely changed to bordered body, also their color changed to black gray (Fig. 2a);
- The samples of category **B**, were affected where their visual appearance as their color turned into light yellow, in addition to partly loosing some of their cohesive resistance, (Fig. 2b);
- The visual appearance of category **C** samples was highly changed and affected, where they turned into dark red color, furthermore, they aggressively lost their cohesive resistance, in addition to presence of some cross-linking cracks (Fig. 2c);
- The samples belonging to category **D** were partly affected where there visual appearance were colored by dark yellow without loosing there cohesive resistance (Fig. 2d).

Fig. 2. The visual appearances of affected samples compared with standard sample

*Visually*, analysis of figure 2 and 3 reveals that the evaluation of salt formation, salt crystallization and their distribution affecting the investigated samples, essentially depends on several variables as previously reported by Lubelli et al. [31]. These variables are the kind and concentration of soluble salt in the salty baths, the kind of stone itself, and the effects of alternative cycles between hydration and crystallization pressures as essential processes of masonry deterioration [32, 33]. Where salt formation is highly remarkable in the samples belonging to 1<sup>st</sup> category which characterized by *fluffy white crystals* appeared when projecting 15-20mm from the surfaces. The samples belonging to 2<sup>nd</sup> category also had been visually affected by *light yellow color salty powder layers* that owe to the effect of some natural impurities present both in *thenardite* and *halite*. The samples belonging to 3<sup>rd</sup> category that also affected visually by light red color, essentially owes to the effect of the presence of *Fe ion*. Finally the samples belonging to 4<sup>th</sup> category characterized by the presence of light dark brown color. This color which may have been the result of the chemical reaction between the components of salty bath especially Na and K ions, in addition to the effect of equilibrium relative humidity (ERH) or the effects of Salt contaminated masonry as argued previously by Pickering [34], and Hong et al. [35]. Also, it could be seen that there are typical distributions of salt according to the type and the characteristics of the dominated anion. Whereas the sulphates are mainly concentrated in the lower parts of the samples, the other salt types appear in the upper parts [36].

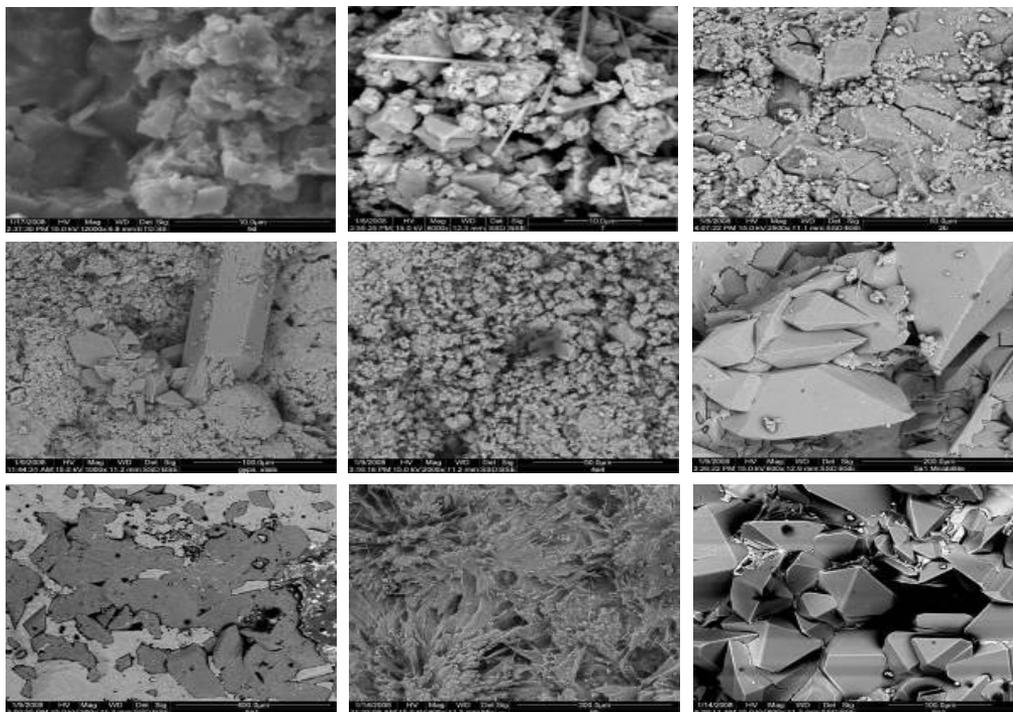
Salt crystallization in the specimens has been studied by FEI Scanning Electron Microscope (SEM) equipped with an Energy Dispersive X-ray system of EDAX. The investigations have been carried out mainly by the use of a back scattered electron (BSE) detector. Low magnifications were used to study salt distribution and location, while higher magnifications were used to investigate crystal shapes. The investigated electronic mapping using SEM of cross sections reveals that there are several harmful forms which affected the substrate of the samples' surfaces by some aggressive kinds of salts (*halite, gypsum, anhydrite, thenardite* and *mirabillite*). In addition, it could be noticed that there is a mixture of very fine fragments on the samples' surfaces mostly composed of (*kieserite, epsomite, sylvite, natrite* and *thermonatrite*). Furthermore, there is a clear border between the original stone surface and superficial layers resulted from the effects of weathering cycles, in addition to dissolution forms affecting the calcite grains (Fig. 3).

Fig. 3. The photomicrograph of affected samples compared with standard sample

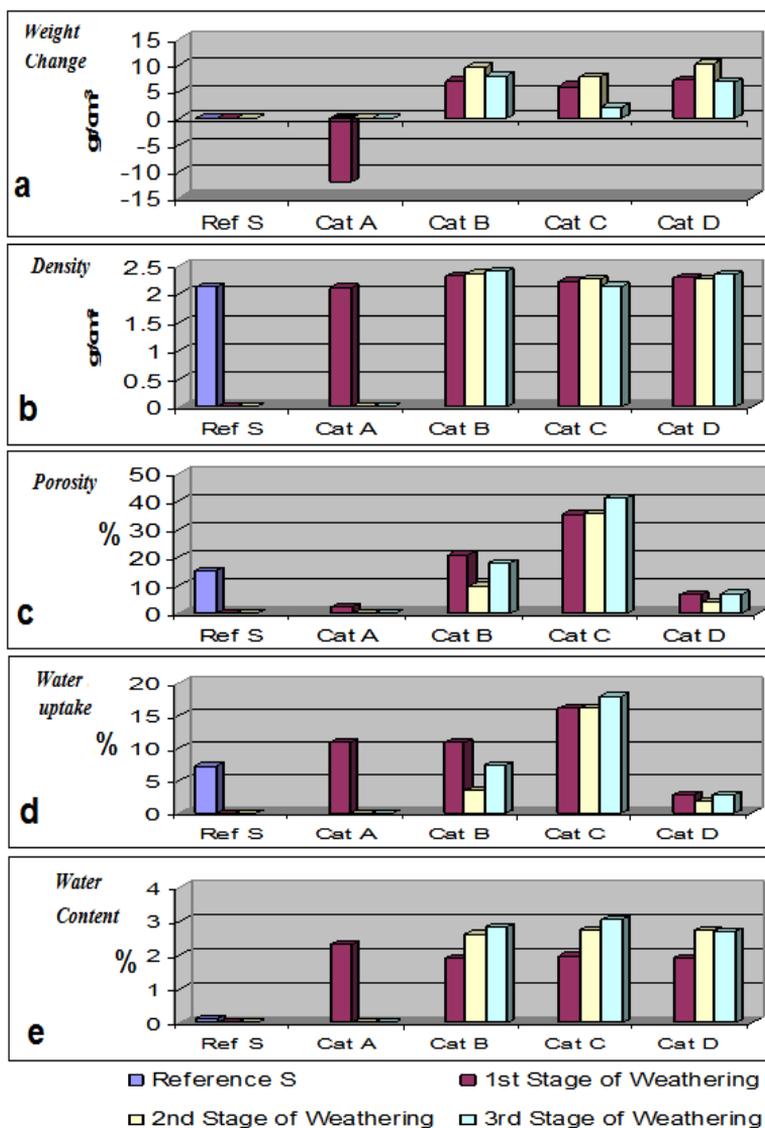
- The samples belonging to category **A** (exposed to 20%  $\text{Na}_2\text{SO}_4$ ) have a higher index of weight lost (about 12.01%) especially in the 1<sup>st</sup> stage of weathering where they were collapsed completely after this stage.

- The weight of other categories **B**, **C** and **D** increased where it was in category **B** (exposed to 1:1 20%  $\text{Na}_2\text{SO}_4$  and 20%  $\text{NaCl}$ ) (6.99% in 1<sup>st</sup> stage, followed by 9.62% in 2<sup>nd</sup> stage, finally by 7.97% in 3<sup>rd</sup> stage). On the other hand, the weight samples of category **C** (exposed to 1:1:0.5 of 20%  $\text{Na}_2\text{SO}_4$ , 20%  $\text{NaCl}$  and 10%  $\text{FeCl}_2$ ) increased, where it was (6.04% in 1<sup>st</sup> stage and 7.90% in 2<sup>nd</sup> stage), finally, it highly decreased in 3<sup>rd</sup> stage where equal 2.10%). Within the same context the weight samples of category **D** (exposed to 1:1:0.50 of 20%  $\text{Na}_2\text{SO}_4$ , 20%  $\text{NaCl}$  and 10%  $\text{KNO}_3$ ) also increased as follow (7.11% in 1<sup>st</sup> stage and 6.76% in 2<sup>nd</sup> stage, finally 10.21% in 3<sup>rd</sup> stage).

- The weights of all affected samples increased in the 2<sup>nd</sup> stage of exposure compared to other stages (Fig. 4a).

**Fig. 4.** The variation of weight change among the affected and non-affected samples (a), the variation of D among the affected and non-affected samples (b), the variation of P among the affected and non-affected samples (c), the variation of WUP among the affected and non-affected samples (d), variation of WC among the affected and non-affected samples (e)

The investigations showed that the densities of all samples were slowly affected with different grades according to the quality of salinity paths where, in category **A** it decreased compared to reference sample of 2.11g/cm<sup>3</sup> and equal to 2.109g/cm<sup>3</sup> recorded after 1<sup>st</sup> stage of weathering. On the other hand, category **B** the recorded densities were 2.3g/cm<sup>3</sup> after 1<sup>st</sup> stage of weathering, 2.35g/cm<sup>3</sup> after 2<sup>nd</sup> stage and 2.39g/cm<sup>3</sup> after 3<sup>rd</sup> stage. In category **C** they were 2.21g/cm<sup>3</sup> after 1<sup>st</sup> stage of weathering, 2.25g/cm<sup>3</sup> after 2<sup>nd</sup> stage and 2.13g/cm<sup>3</sup> after 3<sup>rd</sup> stage. Finally, the recorded densities in category **D** were 2.27g/cm<sup>3</sup> after 1<sup>st</sup> stage of weathering, 2.26g/cm<sup>3</sup> after 2<sup>nd</sup> stage and 2.33g/cm<sup>3</sup> after 3<sup>rd</sup> stage (Fig. 4b).

The porosities of investigated samples show that there is a high increase in the tested samples after weathering cycles compared to non-affected ones where it was 15.30% and became 20.20% after in category **A**. Moreover, the recorded porosity indexes of category **B** is 21% after 1<sup>st</sup> stage of weathering, 9.55% after 2<sup>nd</sup> stage and 18.11% after 3<sup>rd</sup> stage. Also, they became higher in category **C** 35.55% after 1<sup>st</sup> stage of weathering, 35.95% after 2<sup>nd</sup> stage and 41.25% after 3<sup>rd</sup> stage. On the other hand, the records highly decreased in category **D** 6.40% after 1<sup>st</sup> stage of weathering, 3.94% after 2<sup>nd</sup> stage and 6.87% after 3<sup>rd</sup> stage (Fig. 4c).

The water up take of the samples under investigation showed that there are great differences between before and after finishing the weathering cycles. Whereas water up take was 7.26% before, it became 10.83% after in category **A**, and it was 10.81% after 1<sup>st</sup> stage of weathering, then, decreased to 3.55% after 2<sup>nd</sup> stage and finally increased to 7.36% after 3<sup>rd</sup> stage in category **B**. Moreover, the recorded data became higher in category **C** 16.10% after 1<sup>st</sup> stage of weathering, 16.03% after 2<sup>nd</sup> stage and 17.92% after 3<sup>rd</sup> stage. On the other hand the records w decreased in category **D** wher they became 2.82% after 1<sup>st</sup> stage of weathering, 1.74% after 2<sup>nd</sup> stage and 2.90% after 3<sup>rd</sup> stage, (Fig. 4d).

The investigated samples showed that there are noticeable variations in recorded water content indexes before and after weathering cycles whereas water 0.141% before, and became 2.302% after in category **A**. Within the same context, the recorded data in category **B** were 1.914% after 1<sup>st</sup> stage of weathering, 2.633% after 2<sup>nd</sup> stage and 2.818% after 3<sup>rd</sup> stage. Furthermore, the recorded data in category **C** were 1.978% after 1<sup>st</sup> stage of weathering, 2.733% after 2<sup>nd</sup> stage and 3.038% after 3<sup>rd</sup> stage. Finally, the data were 1.916% after 1<sup>st</sup> stage of weathering, 2.733% after 2<sup>nd</sup> stage and 2.702% after 3<sup>rd</sup> stage in category **D** (Fig. 4e).

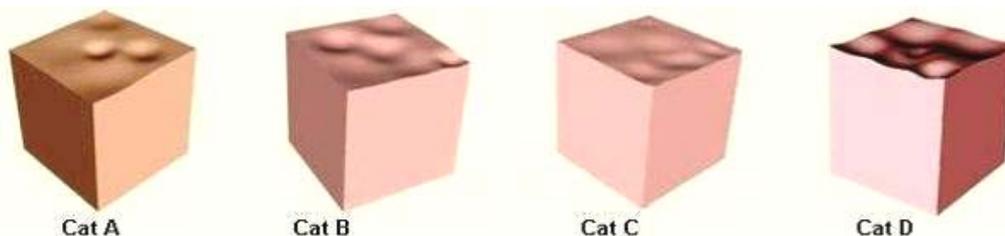
The results of this test proved that all investigated samples were affected with different grades due to the effects of salts on the external surfaces and internal grins of the samples. In addition to the degradation and solubility of the cement materials of the samples, all obtained results are listed in Table 1 and figure 5.

**Fig. 5.** The morphological surfaces of affected samples after abrasion cycles

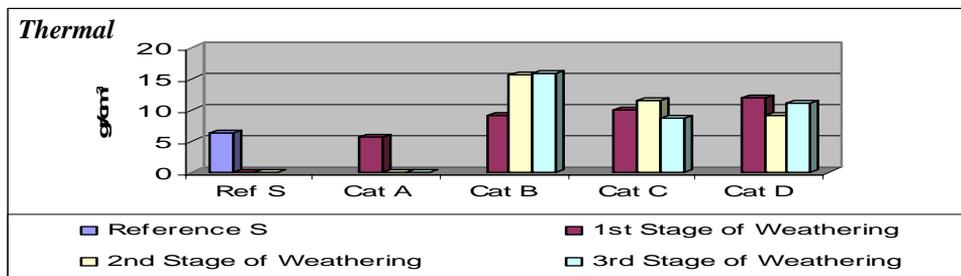
The average results of the investigated samples proved that the thermal dilatation of reference samples was  $6.3 \times 10^{-6} (\text{}^\circ\text{C)}^{-1}$ , where it decreased to  $5.6 \times 10^{-6} (\text{}^\circ\text{C)}^{-1}$  in category A. In category B, the recorded measures were consequently  $9.2 \times 10^{-6} (\text{}^\circ\text{C)}^{-1}$  after 1<sup>st</sup> stage,  $15.7 \times 10^{-6} (\text{}^\circ\text{C)}^{-1}$  after 2<sup>nd</sup> stage and  $15.9 \times 10^{-6} (\text{}^\circ\text{C)}^{-1}$  after finishing the 3<sup>rd</sup> stage. On the other hand, this property decreased in category C where they became  $10 \times 10^{-6} (\text{}^\circ\text{C)}^{-1}$  after 1<sup>st</sup> stage,  $11.5 \times 10^{-6} (\text{}^\circ\text{C)}^{-1}$  after 2<sup>nd</sup> stage and  $8.7 \times 10^{-6} (\text{}^\circ\text{C)}^{-1}$  after finishing the 3<sup>rd</sup> stage. Finally, the samples belonging to category D showed minor differences; where they were  $11.9 \times 10^{-6} (\text{}^\circ\text{C)}^{-1}$  after 1<sup>st</sup> stage,  $9.2 \times 10^{-6} (\text{}^\circ\text{C)}^{-1}$  after 2<sup>nd</sup> stage and  $11.1 \times 10^{-6} (\text{}^\circ\text{C)}^{-1}$  after finishing the 3<sup>rd</sup> stage (Fig. 6).

Fig. 6. The variation of TD among the affected and non-affected samples.

*Thermally*, the results proved that the decreasing average of thermal dilatation coefficient per unit mass of salt is the lowest for the 1<sup>st</sup> cat., due to the destruction of the samples which resulted from the effects of crystallization/hydration alternative cycles. On the other hand, the results proved that the thermal dilatation increased due to varying extents in salted samples compared to salt-free samples in all other categories. These increases mainly depend on the type and nature of the salt, in addition to the catalyst agent found, where, the increasing value was 115.87% in 2<sup>nd</sup> category which contains mixtures of (1:1) of 20%  $\text{Na}_2\text{SO}_4$  and 20% NaCl. Also, it was 59.30% in 3<sup>rd</sup> category which contains mixtures of (1:1:0.5) of 20%  $\text{Na}_2\text{SO}_4$ , 20% NaCl and 10%  $\text{FeCl}_2$ . It was 70.00% in the 4<sup>th</sup> cat., which contains mixtures of (1:1:0.5) of 20%  $\text{Na}_2\text{SO}_4$ , 20% NaCl and 10%  $\text{KNO}_3$ . Finally, it can be clearly seen that the thermal dilatation coefficients of the samples are higher after they have been artificially salted than for the salt-
