THE PROTECTIVE EFFECT OF GREASE STAINS CAUSED BY HANDS TOUCHING STONE RELICS

Yi-Min MA¹, Hui ZHANG², Bing-Jian ZHANG^{1,2*}, Mei-Feng SHI³, Run-Ping ZHANG³

Abstract

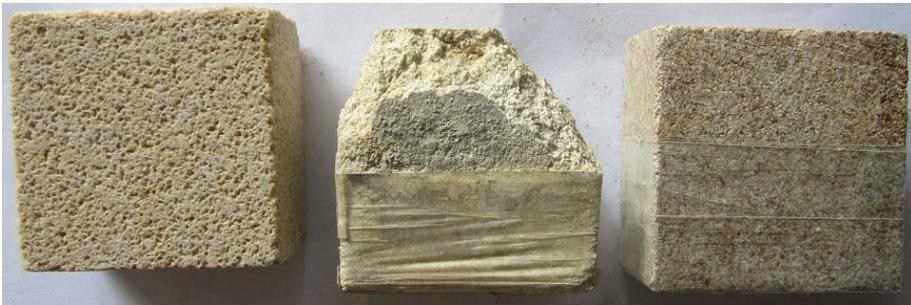
Fig. 9. (Left) fresh sandstone; (Middle) blank sandstone sample taking part in wetting, SO₂ corrosion and drying tests; (Right) grease sandstone sample taking part in wetting, SO₂ corrosion and drying tests

The pictures of blank and grease sandstone samples after SO₂ corrosion test are shown in

figure 9 with fresh sandstone as a reference. The sandstone sample coated with grease almost remained unchanged, while the blank sandstone sample was broken down. The result suggested that grease might protect the sandstones from SO₂ corrosion.

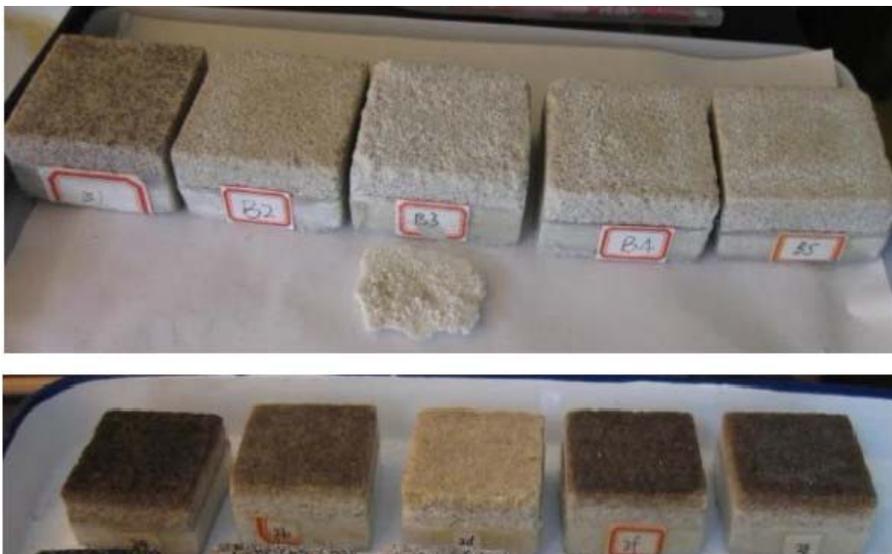
Fig. 10. Picture of sandstone samples after salt destruction cycle

The cycle of destructive test lasted for 56 days. The phenomenon of salt crystallization was visually observed, as shown in figure 10. Surface of B1 and 2a sandstone samples, which didn't take part in salt solution soaking, changed slightly. However there were large amounts of salt crystals on the surface of other blank samples, and further destruction was shown obviously at the end of the cycle. Sample B3 was the most severe with stone pieces peeling off the surface. There were also some fragments peeling off the surface of B2, B4, B5. On the contrary, sandstone samples coated with grease remained almost unchanged, while only a few salt crystals could be observed. Salt could destroy the structure of sandstone by transporting and crystallizing. However, grease stains may resist the salt damage according to our results.

Sandstone deterioration results from continued precipitation of salt crystals, which is caused by evaporation of water from the sandstone surface. Crystallization pressure of salt is one of the major factors that may induce serious damage to stone relics [26, 27]. When grease penetrated into sandstone and filled the pores, the amount of salt crystals on the surface decreased so that their crystallization pressure was relieved. On the other hand, salt could precipitate on the grease surface and salt crystal fragments could be seen on the grease. As a result, the damage by salt crystallization pressure could be reduced.
