ASSESSMENT OF PHYSICAL AND MECHANICAL PROPERTIES OF HISTORICAL AND TRADITIONAL MASONRY BUILDINGS: A CASE STUDY

Mohamed Mostafa ABDELMEGEED^{1*}, Efstratios BADOGIANNIS²,
Gerasimos KOTSOVOS³, Emanuel VOUGIOUKAS²

The building that forms the subject of the case study presented herein is located at the intersection of Aktaiou and Lykomidon streets and will be referred to as ‘Aktaiou’ building, thereafter. It was built in the early 1900’s and it is considered to represent the structural and architectural trends prevailing in Athens this period. Over the years, this house (see Fig. 2) has suffered significant damage due to various causes, such as seismic excitation, lack of maintenance, construction defects, etc.; now it is in the process of being rehabilitated and converted into a cultural centre.

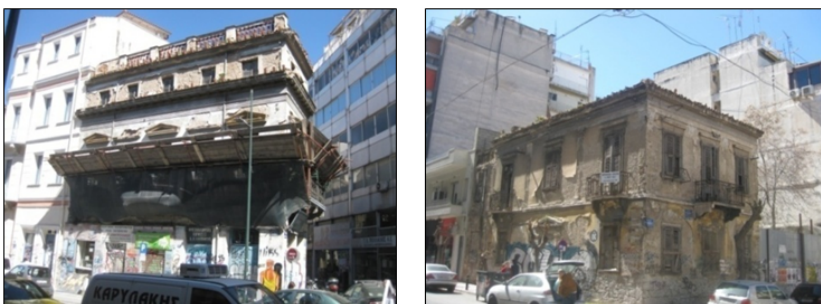
There are significant variations in construction methods, materials and structural elements connections. In general, the historic traditional houses in Athens have slightly square or rectangular in-plan geometry, with two or three floors at most. Their first floor elevation is usually the highest, with that of the third floor, if existing, being the shortest (see Fig. 1). Most of these building are constructed with rubble ashlars masonry stones which may have polished, droved or broached finish [6].

Fig. 1. Typical two and three floor houses in Athens with different floor elevation heights

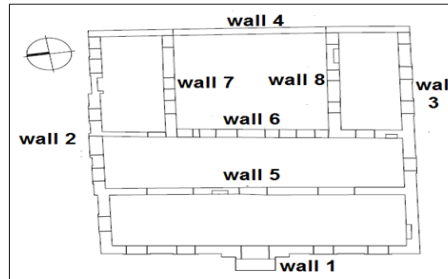
The Aktaiou building is a two-storey masonry building with basement; the bearing walls forming part of its structural system are shown in figure 3, which also shows the wall names

adopted for the work. The facade of the building lies in Aktaiou Street (wall 1) and has a length of 18.40m (Fig. 4); its left-hand side face (wall 2), which lies in Lykomidon street, has a length of 18.00m, whereas its right-hand side face (wall 3) sees in an internal open space and has a length of 17.00m. Wall 4 is essentially forms the fence separating the building from the adjacent property.

Fig. 3. Bearing masonry wall system

The basement extends within the part of the plan enclosed by walls 1, 5 and parts of walls 2 and 3. The in-plan geometry of the building has a U shape with a central part (CB) extending between walls 1, 6, 2, and 3 and two wings extending between walls 6, 4, 2, and 7 (W1) and walls 8, 3, 6, and 4 (W2), respectively. An open space forms between walls 7, 8, 6 and 4.

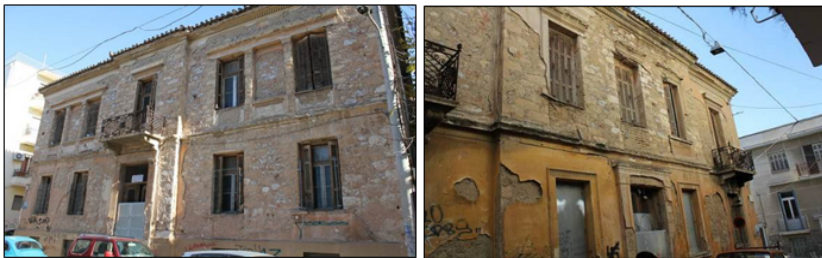
Fig. 4. Building façade: a - wall 1, b – wall 2 (Northern face)

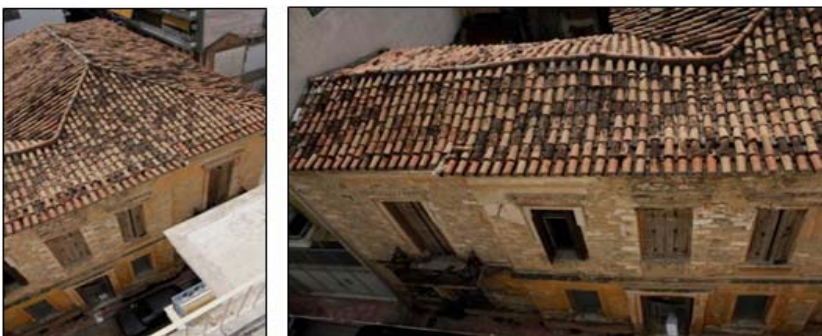
There are a number of internal walls which, as discussed later, are classified as bearing or partition walls depending on the wall width. The timber floors are supported by wooden beams simply-supported at the opposite walls, whereas the roof is supported by a simply-supported truss system (Fig. 5 and 6).

Fig. 5. Building's roof: a – central roof 1, b – wing roof

The roof of the central part of the building (CB) is two-way supported and comprises single and double slope trusses, whereas the roof of the wing parts (W1 and W2) of the building are one-way supported and comprise double slope trusses. The latter comprise one vertical and two inclined struts, a horizontal tie and two diagonal struts as indicated in figure 6. The inclined struts of the trusses support 2 cm thick purlins extending in parallel to the supporting walls, with the purlins being covered by planking which underlies the byzantine tiles. The trusses of the wing roofs comprise inclined struts and horizontal tie only. Although carpenter connections were formed for the truss members, steel connectors were also used in certain cases.

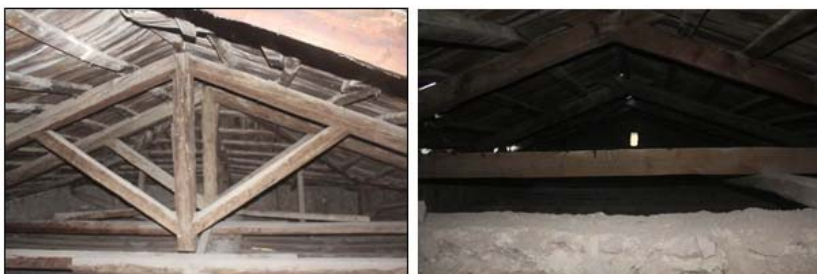
Fig. 6. The truss: a – central roof 1, b – wing roof

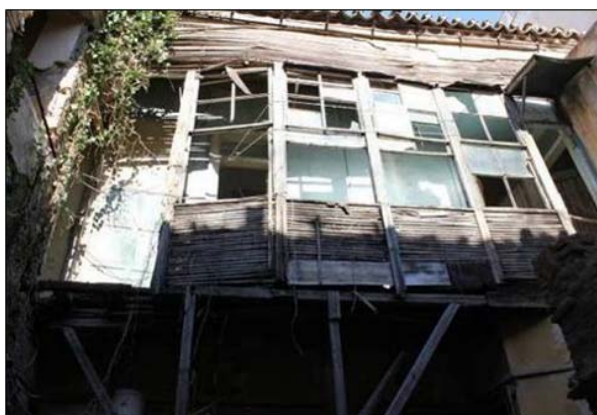
Fig. 7. Typical galleries looking in the internal open space with temporary prop

The stair steps of the main entrance to the building are made of marble stones, whereas the internal staircase is made of timber. The balconies on the faces on the Aktaiou and Lykomidon streets are made of marble plates supported on marble cantilevers. The galleries looking in the open space forming between the building's central and wing parts essentially form extensions of the 1st floor and roof beams, and they are currently in a state of collapse (Fig. 7).

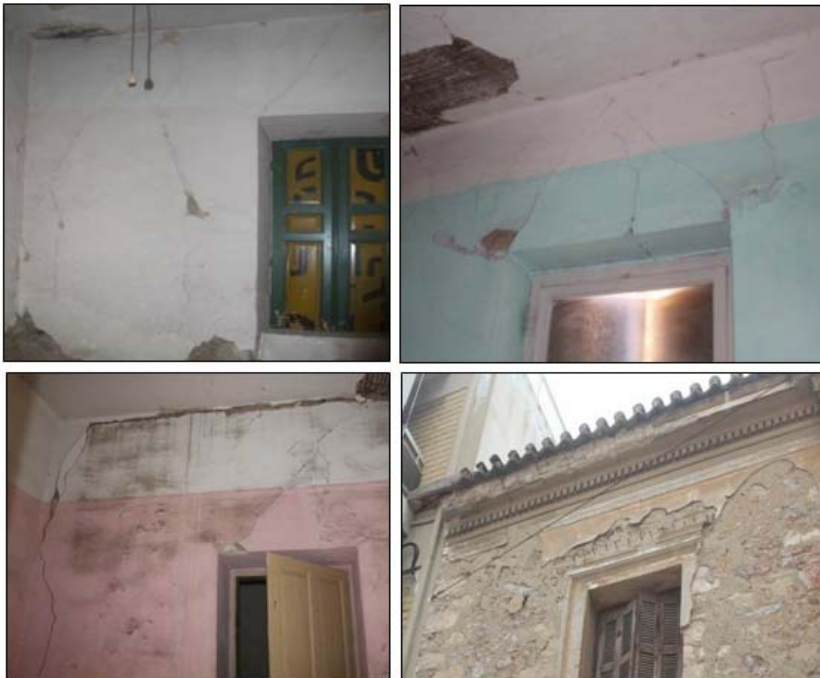
Fig. 8. Typical damage of main bearing walls from left to right and top to bottom – Cracking of wall 3 (ground floor); Lintel cracking of wall 1 (1st floor); Vertical crack of wall 6 near wall connection (1st floor); Cracking of wall 2 at top of building

From visual observation, it has been established that the building did not suffer any significant structural damage in the perimeter masonry walls, such as crushing or sliding, swelling, out-of-plane displacements, loss of mass, deep cracking, collapse of corner wall connections, etc. The damage suffered as a result of aging, construction faults, lack of maintenance, seismic and environmental actions may be broadly described as follows (see Figs. 8 to 10):

- Inclined and vertical cracking with a relatively small width not extending throughout the wall thickness
- Fragmentation of masonry mortar
- Extensive detachment and loss of wall plaster
- Failure in localized regions and large deflections of the bearing members of the roof structure
- Collapse of timber balconies

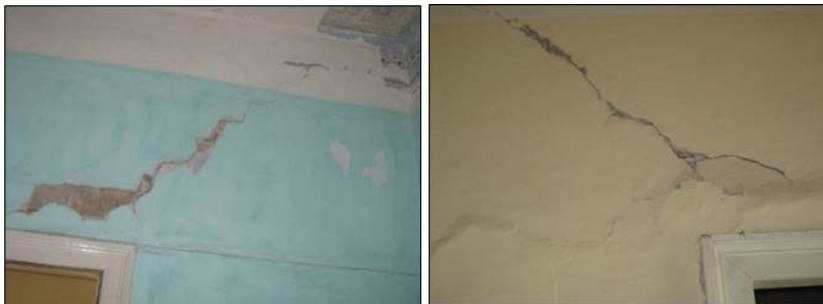
Fig. 9. Typical diagonal cracking of secondary walls

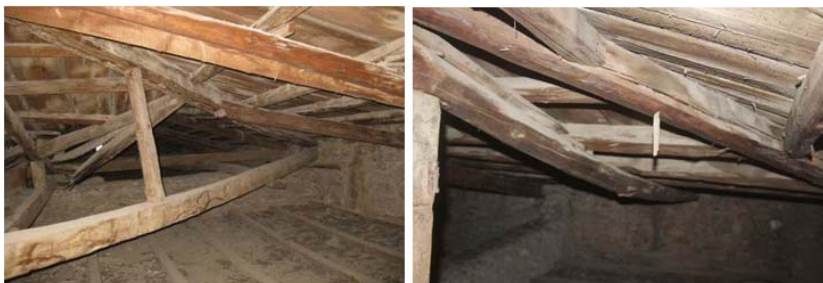
Fig. 10. Excessive truss deflection and typical failure of truss member

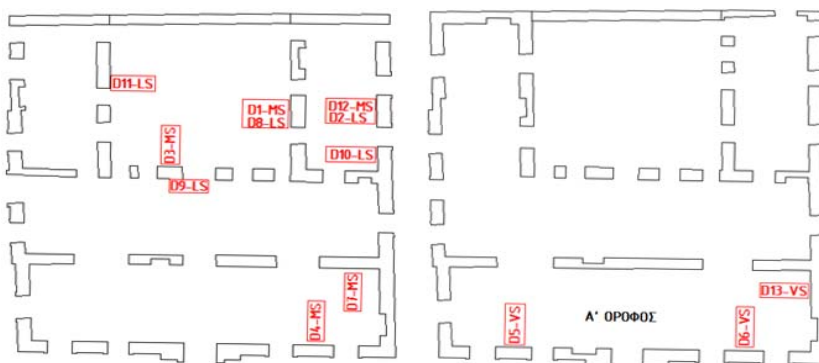
Fig. 11. Location of sampling at the ground floor and at the 1st floor

The material and specimen types are provided in Table 1 and the locations of sampling in figure 11. The precise locations of materials sampling (stones and mortar) are shown in figure 12. It must be noted that from the in-situ examination the mortar was found weak and friable (Fig. 12c) and, as a result, it has not been possible to obtain any samples.

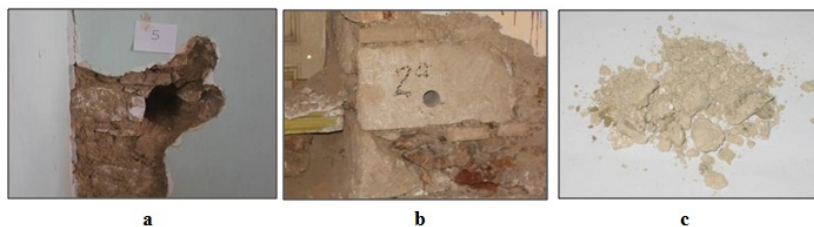
Fig. 12. Precise locations of sampling specimens D7-MS (a) and D10-LS (b), and physical state of mortar sample (c).

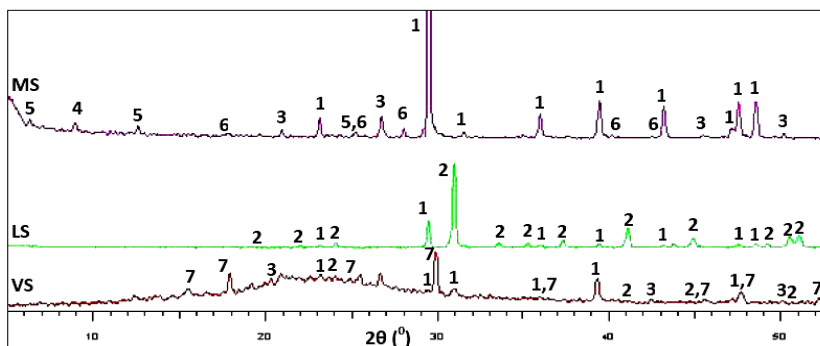
XRD patterns of the stones samples examined are presented in figure 13 According to XRF and XRD analyses, sample of type VS is a stone of volcanic origin, while samples of types LS and MS, derived from carbonate rocks (crystalline to microcrystalline limestone). In sample VS, a large proportion of amorphous phase is recorded by the XRD analysis, while the main detected mineralogical phases were quartz, alunite, dolomite, and calcite. MS derived from metamorphic carbonate rocks, microcrystalline and grainy. The main mineral phase is that of calcite. Other recorded phases are those of quartz, muscovite, clinocllore, and anorthite, but it is estimated that they exist at a low quantity level. LS is a limestone mineral with the main mineralogical phase of dolomite and secondary of calcite. As far as the masonry mortar is concerned, XRD and optical microscopy were used in order to mineralogical characterize the sample and to assume whether or not a lime-pozzolan mortar was used for the masonry

Fig. 13. XRD patterns of the three types of masonry materials (LS, MS and VS); 1: Calcite; 2: Dolomite; 3: Quartz; 4: Muscovite; 5: Clinocllore; 6: Anorthite; 7: Alunite.

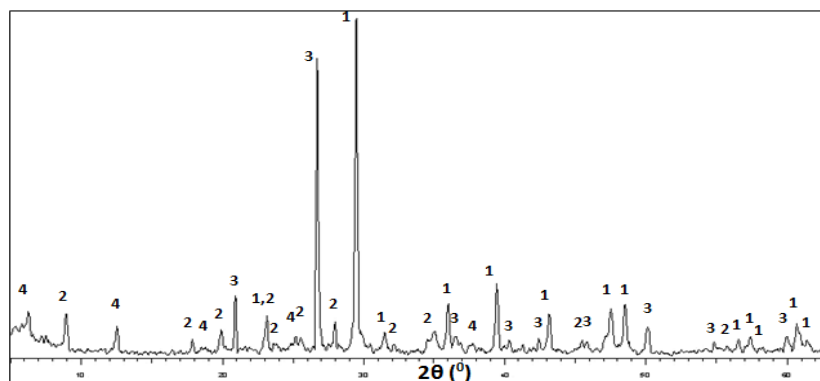
construction. The segregation of the mixed aggregates was achieved using ambient grinding and sieving in a 0.63mm sieve. XRD analysis was made to the passing fraction of the mortar and calcite, quartz, muscovite, and clinocllore were the main detected mineralogical phases (Fig. 14).

Fig. 14. XRD pattern of mortar sample, 1: Calcite, 2: Muscovite, 3: Quartz, 4: Clinocllore

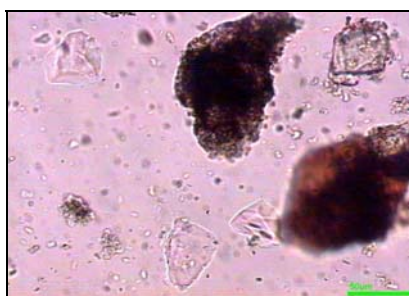
Following to this, an appropriate specimen was prepared for optical microscopy examination. The same sample, passing the 0.63mm sieve, was treated by a 10% w/w 0.1N HCl acid, in order to dissolve calcite. The filtered residual was dried at 105°C and examined by optical microscopy. It was found that a finely ground glassy phase exists in the sample (Fig. 15), which mostly is attributed to a pozzolanic material.

Fig. 15. Optical microscopy photographs of the mortar sample

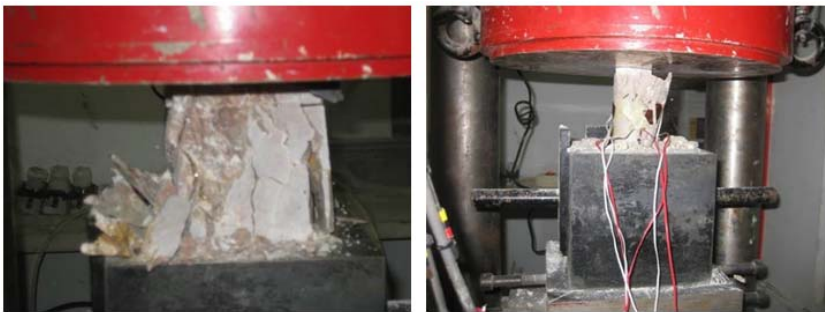
The mechanical characteristics of the samples were established from uniaxial compression tests. The samples chiseled out of the walls were machined to form cubes, whereas those cored out from larger stones had their end faces abraded so as become cylinders with a height-to-diameter ratio of 2. All specimens were weighted before testing. The specimens' dimensions and weight are shown in Tables 3 and 4. The cubes were used to assess strength only. The axial and transverse strains were measured by placing electrical resistance strain gauges within the middle zone of the cylinders at diametrically opposite each other in the axial and circumferential directions. The testing arrangement for the cubes and cylinders are shown in figure 16. The values of the compressive strength obtained from the tests are given in Table 4, whereas typical stress-strain curves are shown in figure 17.

Fig. 16. Testing of the samples: cube and cylinder

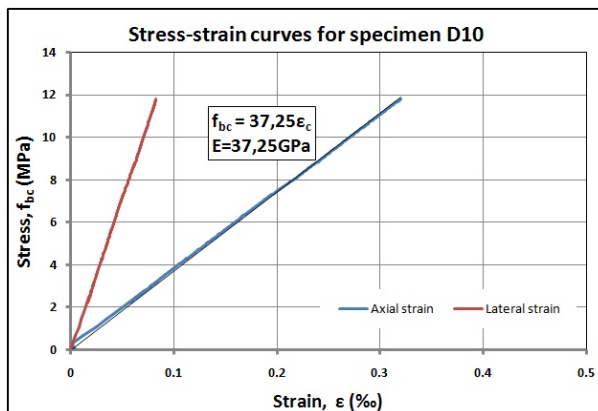
For specimens D10, D11, D12, the stress-strain curves obtained from testing specimens in uniaxial compression are shown in figures 17-19. For each curve, only the branch corresponding to low deformation level is presented, as for larger deformations strain gauges do not perform reliably, due to their local detachment from the specimens.

Fig. 17. Typical stress-strain curves obtained from testing specimens D10 in uniaxial compression

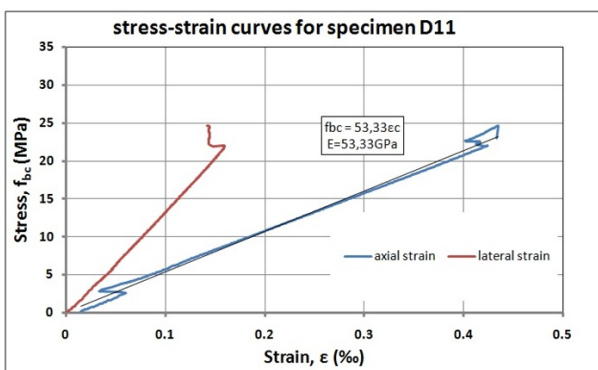
Fig. 18. Typical stress-strain curves obtained from testing specimens D11 in uniaxial compression

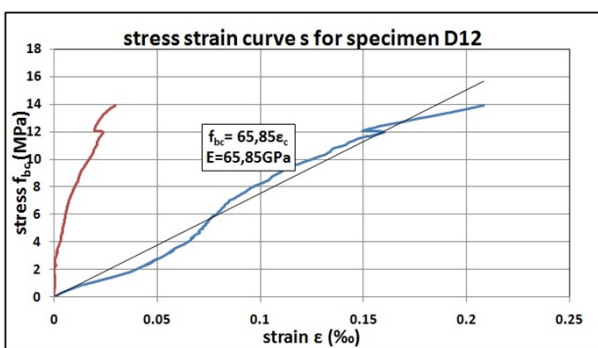
Fig. 19. Typical stress-strain curves obtained from testing specimens D12 in uniaxial compression
