ERADICATION OF VEGETAL GROWTH AND SYSTEMATIC SCIENTIFIC CONSERVATION APPROACH OF BALLALESHWAR TEMPLE, TRIMBAKESHWAR (INDIA)

Selvam Vinodh KUMAR¹, Manager SINGH^{1*},
Sujata Arun WAGHMARE¹, Nilesh Eknath MAHAJAN¹, Pandurang Digamber SABALE²

¹Archaeological Survey of India, Science Branch, Bibi-ka-Maqbara, Aurangabad 431 004, India.

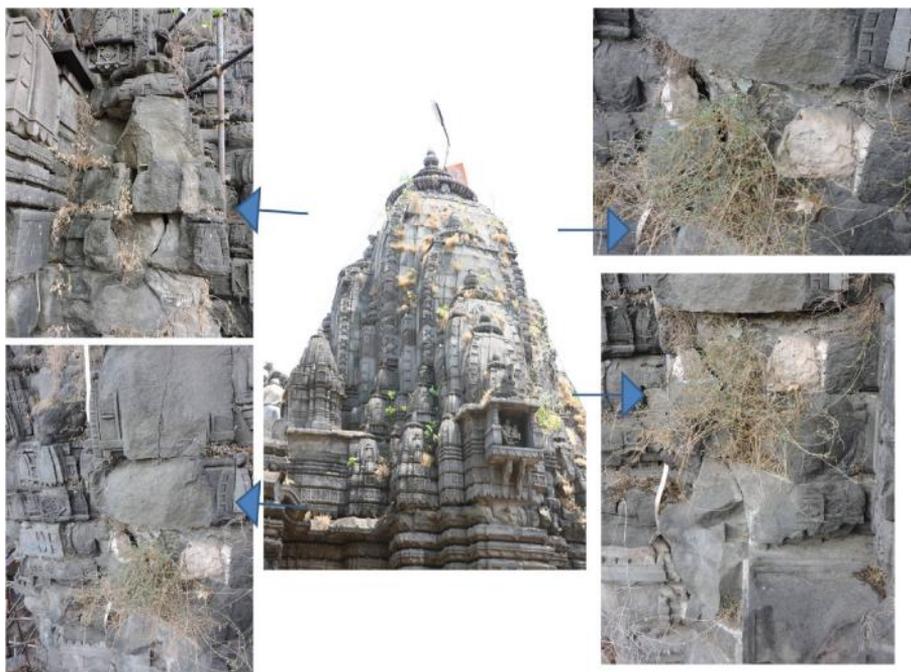
Established vegetation can cause irreparable damage to historic monuments, through root system, displacement of wall fabric and abrasion against monuments due to wind action. In some cases, the extent of the damage caused by unchecked growth may eventually present safety problems for visitors and adjacent dwellers. The higher plants can cause substantial damage to masonry as their roots penetrate into the joints and cracks of the masonry (Fig. 1).

Fig. 1. Photograph showing the effect of vegetation on the Sundarnarayan temple, Nashik

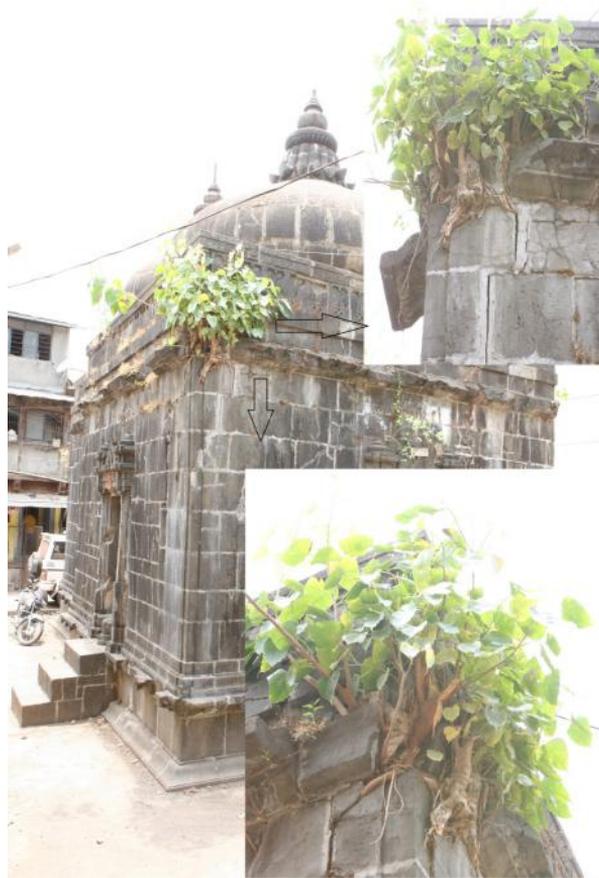
Fig. 3. Peepal tree growing on the temple

Before the commencement of work, the condition of the monument, stone masonry, and vegetation growth was recorded with written description, drawings as well as photo documentation. This was mainly done to analyze the current condition of the monument fabric, highlighting structural defects and identifying the causes [6]. The major problems noticed in the monument were vegetation growth, both smaller plants and larger plants. Growth of woody deep rooted peepal (*Ficus religiosa*) tree (Fig. 3) was observed on the upper wall of the monument which was a big threat to the structure. The roots penetrated deep into the stone blocks creating cracks, voids in the structure. As a peepal tree (*Ficus religiosa*) has the natural tendency to re-grow rigorously when they are cut, the tree cannot be cut. Hence, it was decided to destroy the tree by chemical method. According to the conservation strategy, the higher plants must never be removed alive from the structures. In accordance, attempt was made to slowly kill the tree at first in three month time. For this, a suitable herbicide solution was sprayed over the tree to get it dry. Subsequent, the main root systems of the tree were identified and suitable herbicide was injected into the root systems at regular intervals. The tree was left to dry completely for three months. After three months, the dead stems on the surface of the wall were removed by hand under care and precaution. As the woody roots were thick and penetrated deep into the masonry, it was decided to dismantle the portion to remove the woody

roots completely. As the stonework needs to be dismantled in order to reach to roots deep within the masonry fabric, the original position of stones was recorded piece by piece and marked with water based paint and the numbers noted in the photographs/drawings to help in accurate resetting.

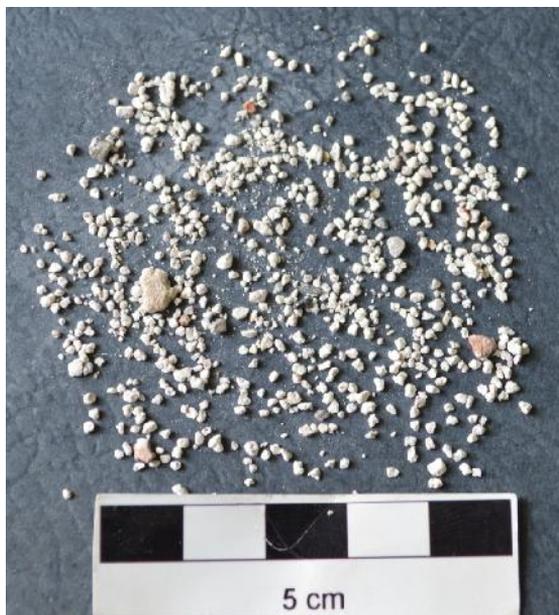
For petrological analysis, the sample of plaster was digested in 10% dilute hydrochloric acid. Digested plaster was filtered and aggregate sieved after drying. Figure 8 shows the types of aggregates found mixed in the mortar sample. From the examination of aggregates, it is observed that the sample is more or less homogeneous, uniform textured, light colours, essentially composed of sub rounded to subangular grains of silt to fine sand sized sediments, mostly composed of calcium carbonate and very fewer of silica.

Fig. 8. Showing the types aggregates mixed with the lime mortar of Ballaeshwar temple

The feldspar is lower in numbers and is recognized easily by its tubular, sub vitreous structure with two set cleavage while silica grains were identified by their sub vitreous massive forms.

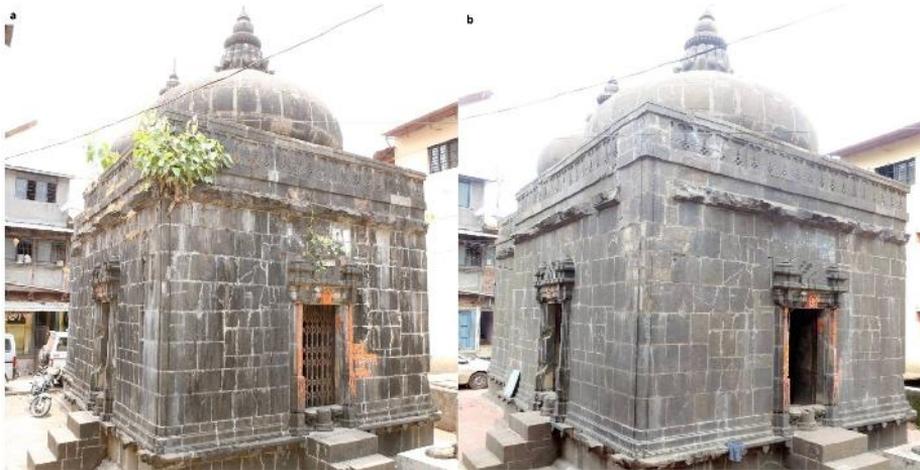
Fig. 11. Photographs showing the condition of the monument before (a) and after scientific conservation (b)

The stone members were set as per the original positions guided with the annotations and from the drawings/photographs. As the new lime mortar needs to cure slowly, adequate covering of the reset area was done with the help of netting cloth. The mortar was also covered with wet cloth for slow setting. It minimized the rapid drying caused by wind and washing out by rain. The aftercare measures also increased the performance of the mortar.

Other micro-vegetation growth like moss, lichens, etc were removed by using the mixture of 1% Liq. Ammonia and non ionic detergent solution. Then the surface of the masonry was washed with sufficient quantity of fresh water and left out for complete drying. The dried surface was sprayed with 1% sodium pentachlorophenate as biocide to arrest the further growth

of micro-vegetation. Finally, to make the surface hydrophobic, Wacker BS – 290 (a Silane - Siloxane based preservative) in mineral turpentine oil solvent, with a ratio of 1:13 was applied as preservative coat. Now, the monument is in good state of preservation. Figure 11 shows the condition of the monument before and after scientific conservation, respectively.
