CHARACTERISATION OF THE STUCCO DECORATIONS AT THE “SACRO MONTE DI OSSUCCIO” (16TH-17TH CENTURY), COMO, ITALY

Abstract

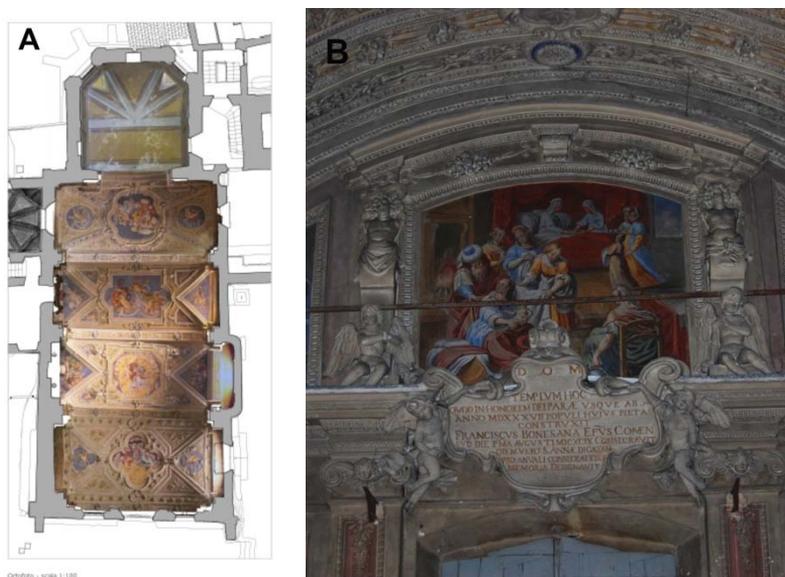
Fig. 1. The vault of the Sanctuary of Ossuccio, with stucco reliefs attributed to Muttoni: A) Digital image rectification - Image courtesy of Arch. Roberto Segattini; B) Stucco of the inner façade made by Agostino Silva.

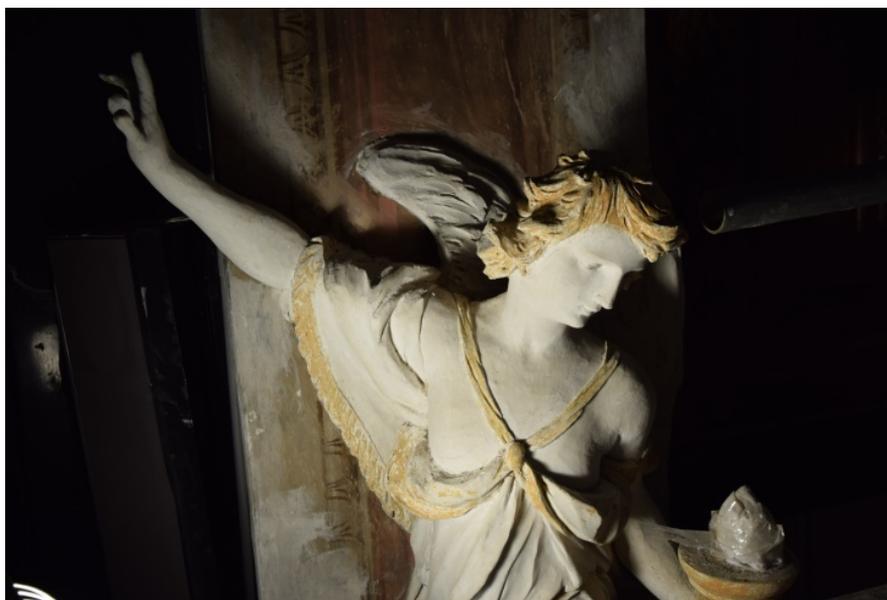
Fig. 2. Angel in the left altar of the nave. The author of this statue is not documented but from a stylistic point of view it can be attributed to Agostino Silva. The sample ST-OS 15 has been taken from the back of the right arm.

Moreover, these preliminary investigations were fundamental to select the areas for the collection of representative samples. In order to find differences and similarities between the two artists, the samples have been gathered from the vault (attributed to Muttoni) and from the decorations by Silva, as shown in Table 1. The last sample (ST-OS 15) was taken from the angel in the left altar of the nave, for which no archival documentation exists, though from a stylistic point of view it can be attributed to Silva (Fig. 2).

While the iconographic content and the single elements of the frames are substantially similar, the differences are evident in the comparison of the figures. In particular, the angels by Silva show fluency in the treatment of the drapery and fine grace of movements (Fig. 2 and 10), while those by Muttoni are characterised by massive and static bodies (Fig. 11A and 11B). Silva's style seems to be dictated by great freshness and rapid realization [20], while the Muttoni reliefs appear more rigid. Unfortunately, it is difficult to assess the treatment of the surface finishing due to numerous layers of whitewash applied over time (Fig. 10) that have essentially erased the differences and homologated the two "hands".

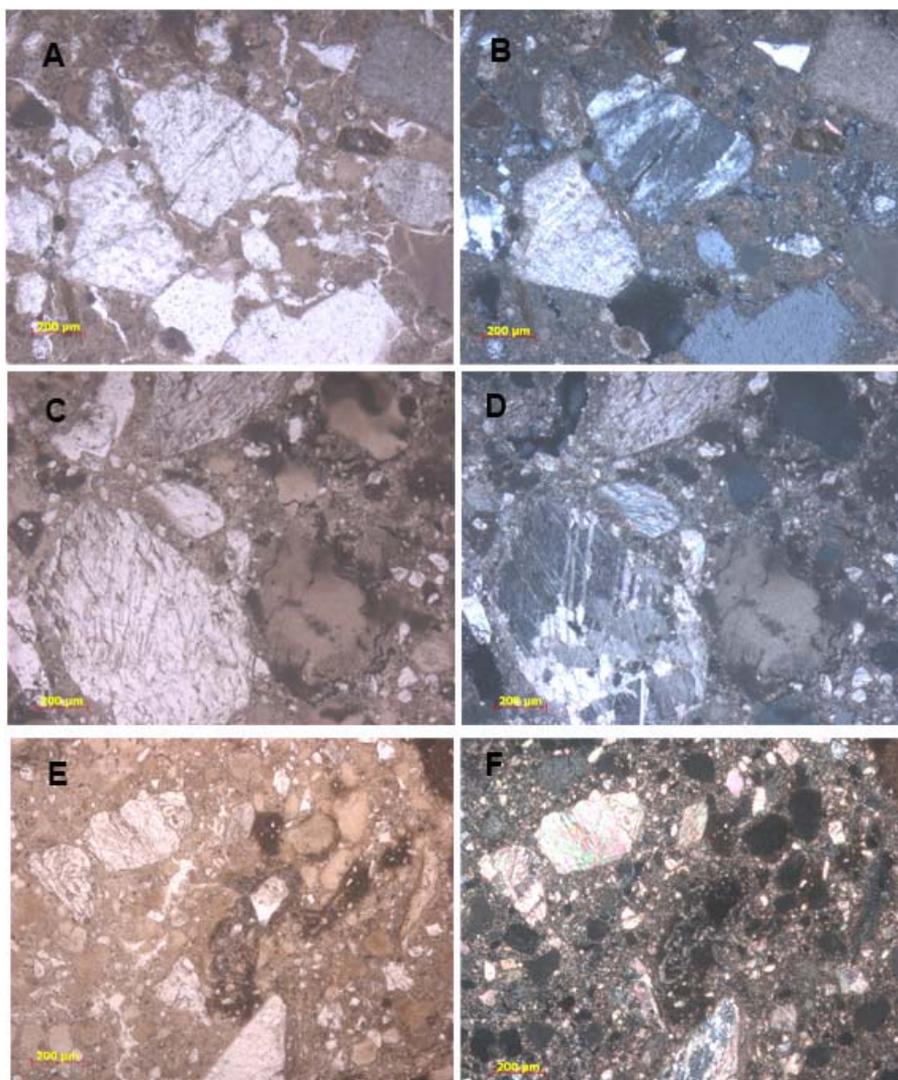
Fig. 3. Photomicrographs of Muttoni stuccoes, sample ST-OS 2: A) Shrinkage cracks are visible in the ground layer (PPL); B) The aggregate of the ground layer is composed of carbonate and siliceous sands of medium grain size. (XPOL); C) Large lime lumps are visible in the binder. The radial and rounded structure inside the lime lumps testifies Mg-enrichments in the mortar (PPL); D) Same image as C but under XPOL. E) The finishing layer is made of Mg-rich lime with lime lumps; F) same image as E under XPOL where lime lumps appear of grey colour. The aggregate is composed of sparry calcite and marble powder.

The petrographic analyses of the stuccoes attributed to Muttoni show that the ground layer is composed of a binder with many lime lumps, as large as 0.5cm (Fig. 3C and 3D). The frequent presence of lime lumps may be indicative of the lime binder slaking process. When lumps are abundant, slaking was most probably done through the hot-mixed lime technique [13]. In addition, lumps often contain remnants of the limestone used for lime production; such underburned particles indicate inhomogeneous and probably low calcination temperatures [14]. Radial, cauliflower-like structures inside the lime lumps (Fig. 3C and 3D) indicate Mg-enrichments in the mortar [15], thus their presence indicates the use of magnesian lime binder

and dolomitic rocks as raw material. SEM-EDS analyses confirm high Mg content within the lime lump and in the binder (Fig. 4B1 and spectrum SB1). The absence of gypsum in the binder is confirmed by FTIR (Fig. 5, pink spectrum) and SEM-EDS analyses (Fig. 4B, 4B1 and spectrum SB1). The aggregate of the ground layer is composed of very coarse fragments of carbonate rocks (impure and marly limestones), sparry calcite and a minor amount of siliceous sands (quartz crystals and siliceous-rich rock fragments), mainly of medium grain size (Fig. 3B).

The outer layer (finishing) is made of magnesium-rich lime (Fig. 4B, 4B2 and spectrum SB2) with millimetric lime lumps characterised by isotropic optical behaviour. The aggregate is composed of sparry calcite crystals and marble powder (Fig. 3E and 3F). The two layers (*strato di corpo* and finishing) were made with a “*fresco su fresco*” technique, namely the application of the finishing while the ground layer was still wet. Shrinkage cracks are frequently observed in both layers (Fig. 3A).

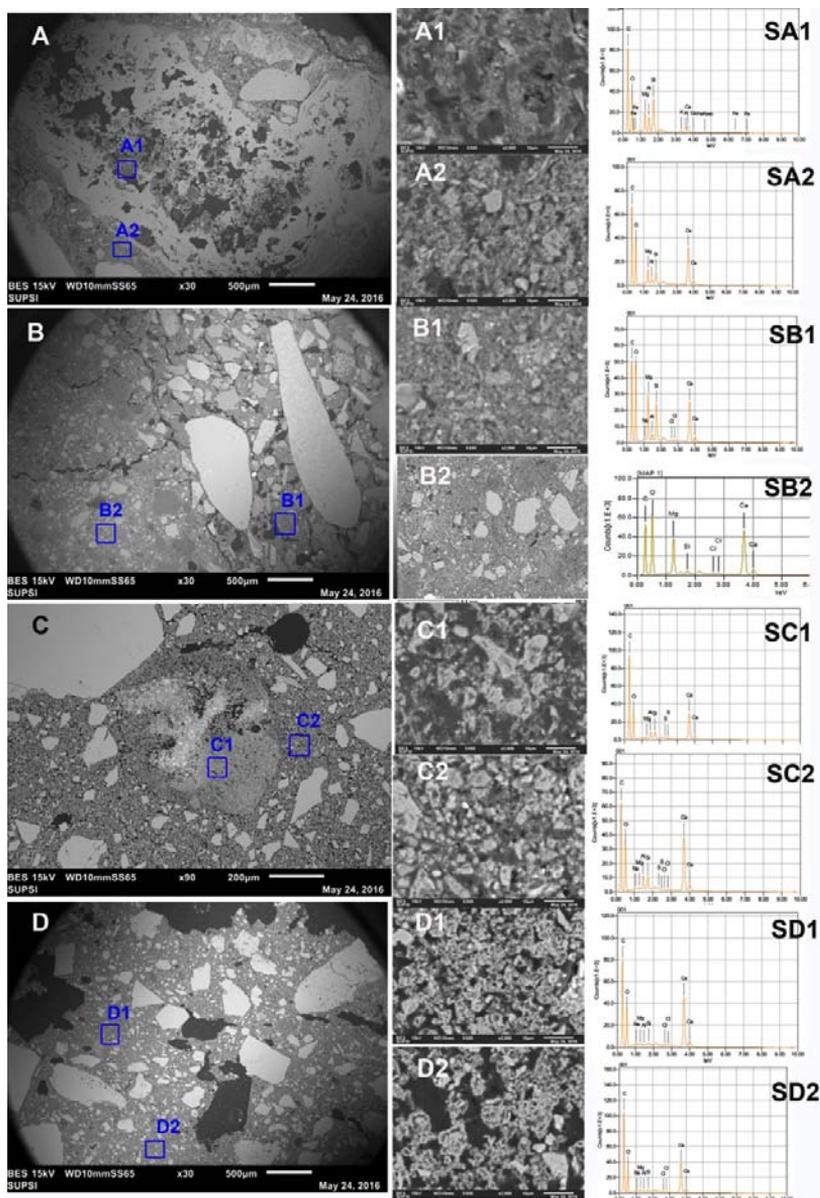
Fig. 4. SEM-EDS analysis: the first picture is the BSE image, next to it there are the two magnified BSE images of the sample portions indicated by the blue squared areas, and next to it there is the EDS spectrum of the same area: A) Sample STOS1. Underburned BRP with Ca-rich hydration rim; A1) BSE image of the rounded phase; SA1) Chemical elemental analysis of the rounded phase, Si and Al enrichment was detected; A2) BSE image of the binder of STOS1; SA2) Chemical elemental analysis revealing Si, Al and Mg enrichment in the binder; B) Sample STOS2 where the contact between the ground layer (right) and the finishing one (left) is shown; B1) Binder of the ground layer of STOS2. SB1) Chemical elemental analysis, revealing Si, Al and Mg enrichment of the ground layer binder; B2) BSE image of the binder of the finishing layer, sample STOS2; SB2) Chemical elemental analysis revealing Mg enrichment of the binder of the finishing layer; C) BSE image of sample STOS10 where a lime lump is shown in the centre; C1) BSE image of the lime lump; SC1) Chemical elemental analysis of the lime lump, revealing Ca rich lime lump; C2) BSE image of the binder of STOS10; SC2) Chemical elemental analysis of the binder confirming Ca-rich binder with low S content; D) BSE image of the sample STOS15; D1) BSE image of the STOS15 binder; SD1) Chemical elemental analysis revealing pure Ca binder; D2) BSE image of the STOS15 binder; SD2) Chemical elemental analysis confirming pure Ca binder.

On the contrary, for the angels and the cartouche of the inner façade (by Agostino Silva) the gypsum has been added to the lime intentionally, especially in the *strato di corpo*, as shown by FTIR analysis (Fig 5, yellow and green spectra). A small amount of S has also been detected by SEM-EDS (Fig. 4C1 and 4C2 and spectra SC1 and SC2). This internal layer is made of a mixture of Ca-based lime and gypsum, in order to rapidly obtain the typical projecting elements of the stucco decorations [18]. Furthermore, the gypsum additive reduces the formation of shrinkage cracks, even using, as in this case, a low percentage of aggregates (Fig. 9A). The frequent presence of large particles of anhydrite (Fig. 9B) can derive from the raw material or it can be evidence of the use of high temperature gypsum or the results of uneven temperatures within the gypsum cooking chamber. The aggregate is mostly composed of coarse fragments of impure or chert limestone, with low content of fine siliceous sands (Fig. 9A).

The sample ST-OS 15 is characterised by a lime binder with homogeneous calcium carbonate microcrystalline texture. The aggregate is composed of sparry calcite and marble fragments with fine and medium grain size, well sorted (Fig. 9D). The petrographic observations are confirmed by the FTIR spectrum that shows only calcium carbonate (Fig. 5, purple spectrum) and SEM-EDS analyses that has detected only Ca within the binder (Fig. 4D, 4D1 and 4D2 and spectra SD1 and SD2), confirming the absence of Mg.

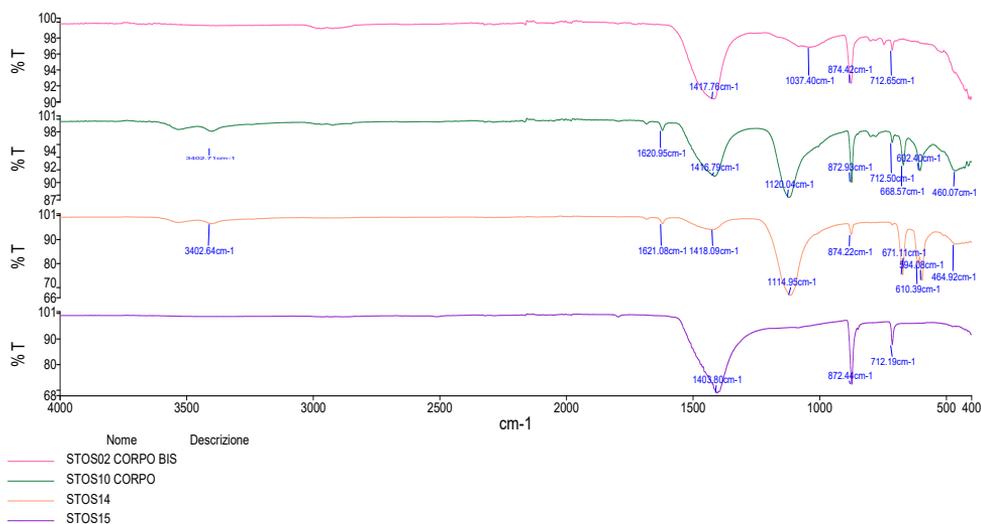
Fig. 5. All FTIR spectra show the presence of a large and strong band around $1403\text{--}1420\text{cm}^{-1}$ due to the C–O stretching mode of carbonate functional group together with a sharp band at 872cm^{-1} of the bending mode and at 712cm^{-1} . The large and strong band centered around $1114\text{--}1120\text{cm}^{-1}$ and the small peaks at $670\text{--}680$ and $602\text{--}594\text{cm}^{-1}$, assigned to the stretching and bending modes of sulphate functional group, are present only in the two spectra of STOS10 and STOS14. The stretching vibrations of the H_2O molecules of the gypsum occurring at 3547 and 3402.64cm^{-1} are also visible in these two samples.

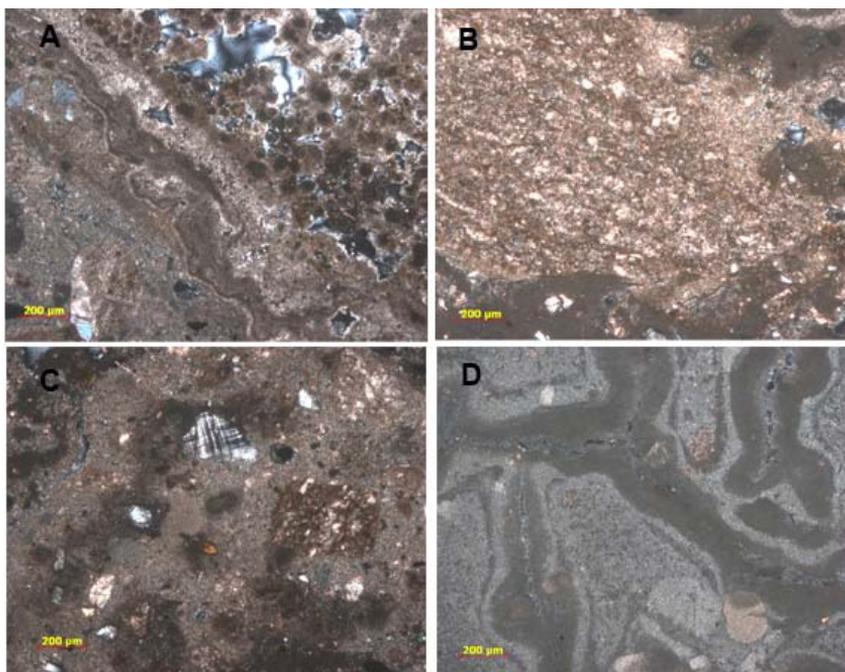
Fig. 7. Photomicrograph of the sample ST-OS 01 (XPOL): A) Same underburned particle shown in figure 4A with rounded brown hydraulic phases. Around the particle a Ca-rich hydration rim with high birefringence is present; B) A partially burnt impure limestone that gives a weak hydraulicity to the binder; C) The binder of the *strato di corpo* is inhomogeneous with low aggregate content; D) The finishing layer do not present aggregate addition. The microstructural appearance of the binder is dominated by areas with different optical density.

The appearance of the binder is very heterogeneous (Fig. 7D) that could be attributed to the use of a dolomitic lime mortar [15, 16]. In the same sample, the binder of the *strato di corpo*

is a weakly hydraulic magnesian lime and the aggregate percentage is lower if compared with the other samples of the vault (Fig. 7C). The hydraulicity of the binder derives from the burning of impure and marly limestones [17], such as the one shown in figure 7B. In fact, SEM-EDS analyses of the rounded phases in the binder-related particle shown in Fig. 7A reveal an enrichment of Si, Al and Fe (Fig. 4A, 4A1 and spectrum 4SA1), while around the particle a carbonated hydration rim, rich in Ca and Mg is present (Fig. 4A, 4A2 and spectrum 4SA2). A low amount of S, detected only on the surface of the finishing layer by SEM-EDS, can be explained by the formation of sulphates, as a result of secondary degradation processes. Indeed, the damaged state of conservation of this decorative element can be well observed macroscopically, in figure 6A and 6B.

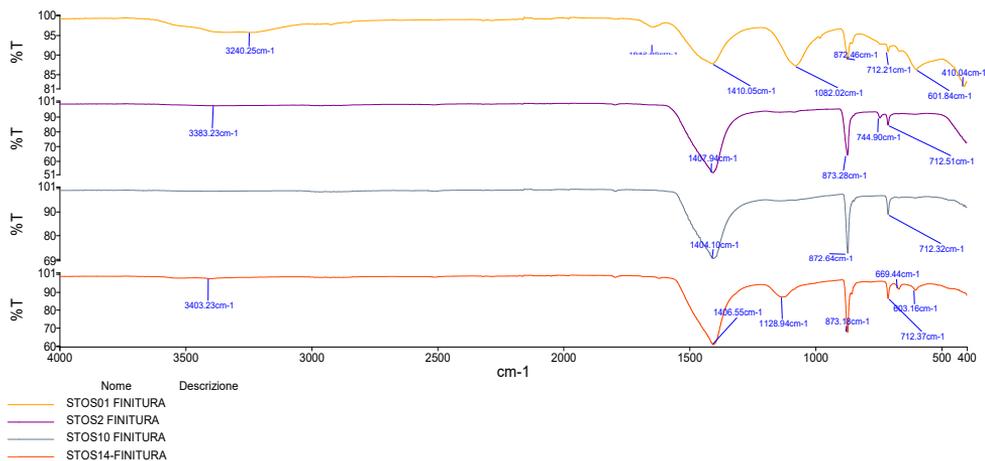
Fig. 8. FTIR spectra. All the finishing layers show a predominant presence of carbonate (peaks around 1400cm^{-1} , $872\text{--}873\text{cm}^{-1}$ and 712cm^{-1}). Low amount of gypsum is present in the samples STOS01 and STOS14 (1109cm^{-1} , 669cm^{-1} , 596cm^{-1}). The shift of the peak from 1100 to 1080cm^{-1} only in the sample STOS01 could be justified by the formation of epsomite together with gypsum.

For the finishing layer, Agostino used a Ca-rich lime binder, in which the gypsum was found occasionally and only in traces (Fig. 8, grey and red spectra). The fine finishing layer was directly applied on the still wet *strato di corpo*, as there is not an interface between the two layers. Thus, it may not have been intentionally added, but it can derive from the underlying layer, as contamination or caused by dissolution and recrystallization processes. The aggregate is composed of sparry calcite and marble fragments, mostly of fine grain size, well sorted (Fig. 9C).

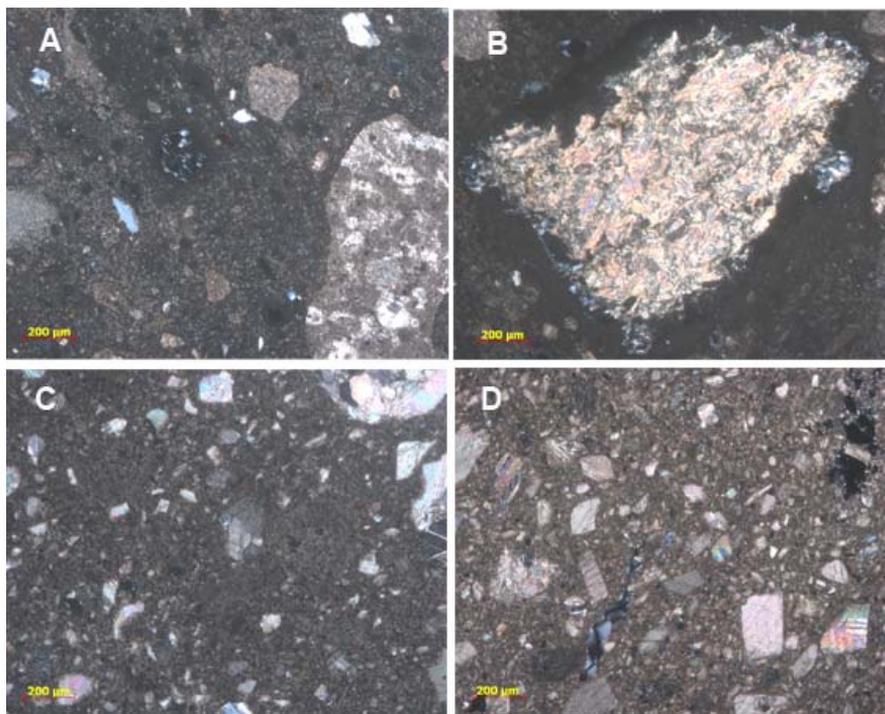
Fig. 9. Photomicrograph of stuccoes by Silva (XPOL): A) Sample ST-OS10. The binder is made of lime and gypsum in the *strato di corpo* layer. No shrinkage cracks are observed even if a very low aggregate content is present; B) Sample ST-OS11. Large particle of anhydrite with high birefringence is shown in the centre; C) Sample ST-OS 14. Finishing layer with lime binder and aggregates composed of calcite and marble fragments, fine grain size, well sorted; D) Sample ST-OS 15. Lime binder with homogeneous textural characteristics. The aggregate is composed of calcite and marble fragments with medium and fine grain size, well sorted. This sample has similar petrographic characteristic to the Agostino Silva finishing layer shown in image 9C.

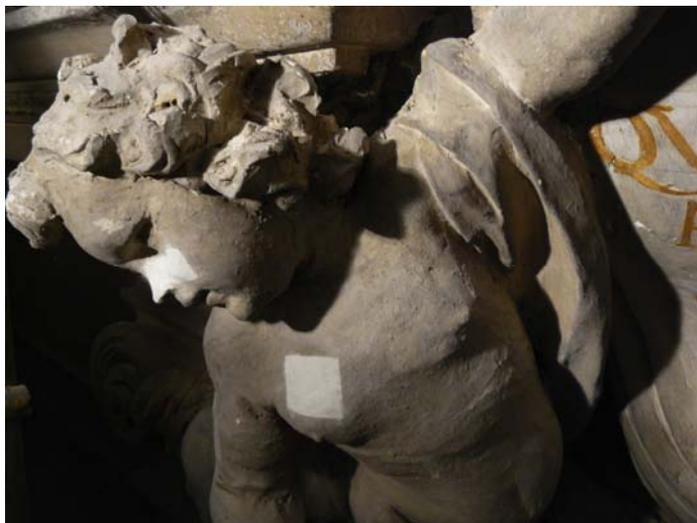
Fig. 10. Finishing layer of an angel by Silva brought to light after whitewash removal during restoration work. In this case the surface appears more homogeneous and compact if compared to that of Muttoni shown in the next figure.

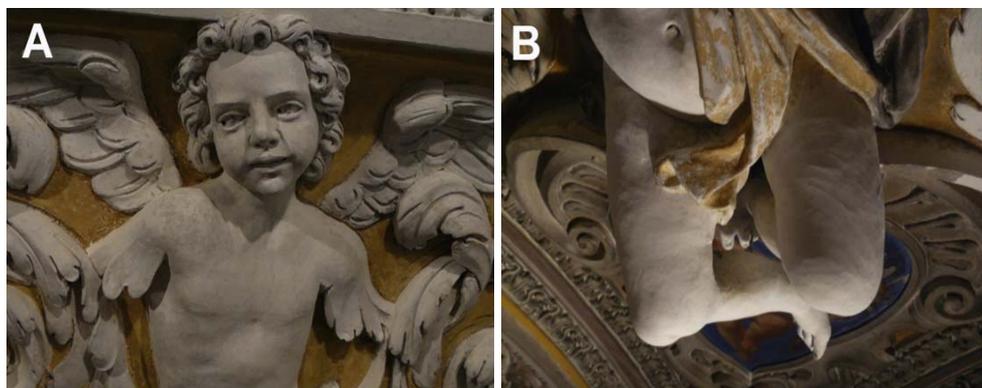
Fig. 11. The angels of the vault by Muttoni: A) Characterised by a more rigid appearance; B) Detail of legs of an angel with raked lighting, showing the surface treatment of stuccoes by Muttoni in which the imprint of the sticks used for finishing the sculpture is visible.
