THE *DOMUS* OF *OCTAVIUS QUARTIO* IN POMPEII: DAMAGE DIAGNOSIS OF THE MASONRIES AND FRESCOED SURFACES

Domus of Octavius Quartio occupies the entire insula 2 of Region II in Pompeii, representing one of the most important village of this archaeological site. An interdisciplinary approach has been adopted in order to plan conservative, preventive and restoration actions aimed at the requalification of Pompeii within the frame of “Grande Progetto Pompei” program. 3D Laser scanner surveys and damage diagnosis following Fitzner’s method were carried out. The identification and description of weathering forms was carried out using ICOMOS-ISCS and NorMaL 1/88 recommendations, readapted and reinterpreted also for frescoes. Ten different weathering forms were identified; the frescoed room and the fountain are mainly affected by fissures, convex deformations, lacuna, efflorescence, discoloration, moist areas and patinas; the surrounding wall shows back weathering due to the disaggregation of bedding mortars; moreover the blocks are interested by rounding and biological colonization (lichens). Mapping the areal distribution of weathering forms and defining the damage categories, allowed an e

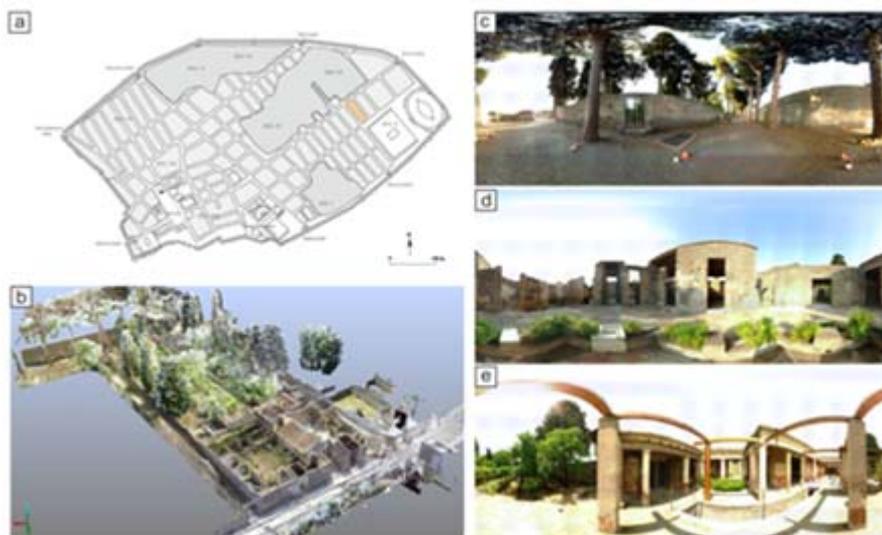
Fig. 1. The archaeological site of Pompeii and the *domus* of Octavius Quartio: a) location of the insula entirely occupied by the domus of Octavius Quartio (red filling); b) perspective view of the final point cloud 3D model of the entire insula; c) 360° panoramic view of the external wall close to the gym; d) 360° panoramic view of the peristyle; e) 360° panoramic view of the garden.

Furthermore, at the same time of the measurements, the integrated camera allowed to acquire also the colour data, in order to associate the corresponding RGB value at the coordinate of points (X, Y, Z). The result is a 3D point cloud model, measurable and coloured, of the entire *insula* (Fig. 1b).

The final outputs of the laser scanner survey were: a detailed points cloud model of the whole *insula* (Fig. 1b); a navigable project to display the individual scans as spherical panoramas or 3D point clouds (it is like a virtual tour among the scan stations); significant

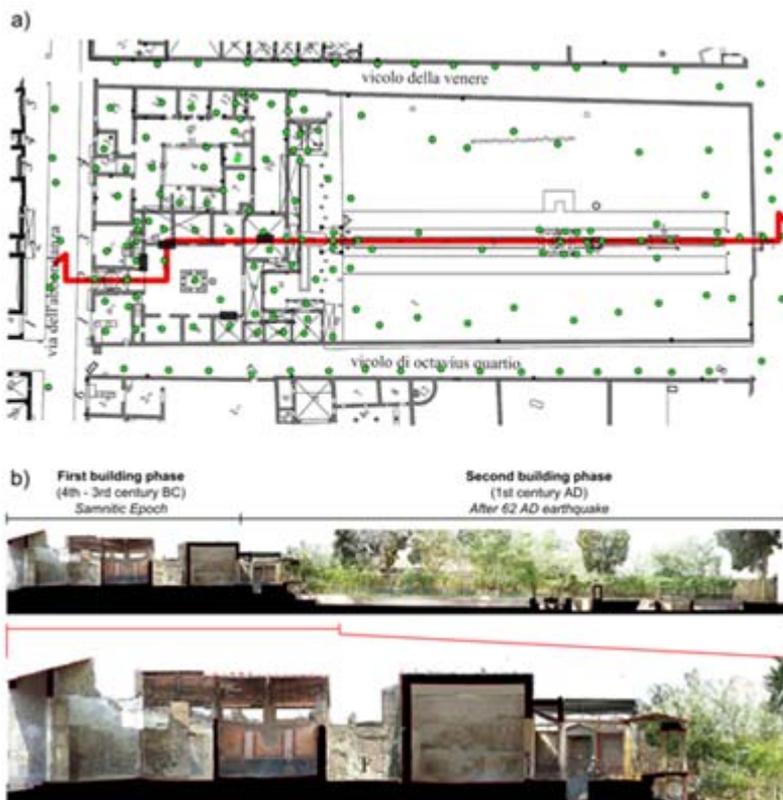
Fig. 2. The *domus* of Octavius Quartio: a) Plan view of the *domus* showing the scans station and the longitudinal section; b) longitudinal section reporting the two building phases of the *domus* with detailed zoom of a portion of the longitudinal section.

A three-dimensional survey of the *insula* was performed by means of a phase-shift technology laser scanner (Faro Focus3D-X Series) with integrated camera. In order to avoid parallax errors, the integrated camera had the same nodal point of the laser emitter. This equipment has a field of data acquisition of more than 100m (range of 0.6 - 130m) and provides resolution and accuracy in the order of millimetres. Compactness and lightness of the instrument combined with the speed of acquisition of 3D points (the maximum is 976000 points/second) permitted quick campaign operations despite numerous scan stations were needed. In fact, in order to produce a detailed and reality-based 3D model of the entire *insula*, 177 scans were performed and about 60 scan stations were required for the survey of the external perimeter wall (Fig. 2a).

elevation sections (Fig. 2b, represents one of these); orthoimages of the external walls and frescoed walls of the interior. The orthoimages have been extracted from the coloured model points, selecting planes of projection parallel to the walls. Selected georeferenced orthoimages with millimeter resolution were used for distribution of geomaterials and weathering forms mapping.

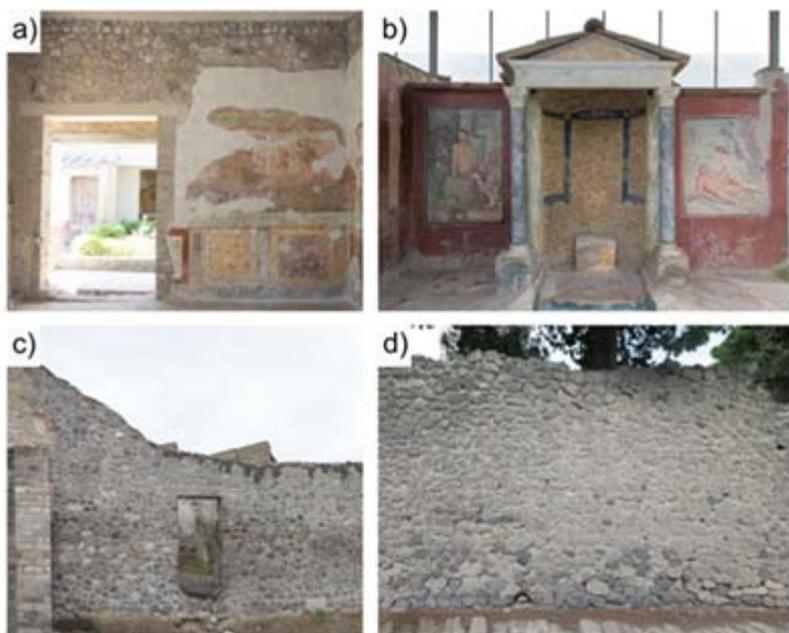
Fig. 3. Some portion of the investigated masonries by Fitzner and Heinrichs methods [14-16]; a) western wall of frescoed room h (*triclinium*); b) the aedicule with fountain; c) external wall, part 1; d) external wall, part 2.

On the basis of the type and distribution of building materials, three representative locations of the domus were selected for the implementation of the Fitzner's method: a frescoed room (Fig. 3a), selected for the extensive presence of mural paintings; the aedicule (Fig. 3b), where

more decorative elements appear; the surrounding wall on the west side of the *domus* (Fig. 3c and d). The external wall also shows all the structural elements from the Samnitic Epoch throughout the roman epoch until the modern restorations occur. Damage diagnosis of the masonries and frescoed surfaces of the *domus* of *Octavius Quartio* were carried out following the widely-accepted quantitative approach proposed by Fitzner and Heinrichs [14-16], also taking into account the presence of refined 4th style mural paints. For this purpose, an accurate mapping for a quantitative evaluation and distribution of geomaterials, weathering forms and damage categories was performed. Worth to note is that the method here proposed has never been carried out in the old town of Pompeii.

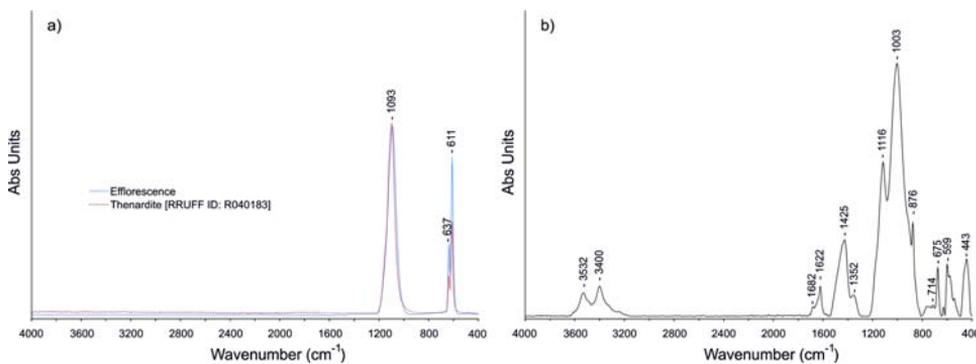
In situ ATR/FT-IR measurements (Fig. 4a) [32-33] demonstrated that the efflorescence was mainly constituted by thenardite (NaSO₄). This saline compound represents, along with other magnesium and sodium sulphates, one of the most dangerous salts affecting the durability of building materials [12, 34]. Furthermore, frequent discoloration phenomena compromising the aesthetic value of frescoes were observed (Table 3; Fig. 4c).

Fig. 4. ATR/FT-IR spectrum of: a) efflorescence products of frescoed room compared to thenardite IR spectra; b) bedding mortar from the part 2 of the external wall.

A deeper disaggregation affecting the bedding mortar in another portion of the external wall (Table 3; Fig. 8b) defines a severe damage for this surface. In situ ATR/FTIR measurements performed on the products of granular disaggregation of bedding mortars showed the constant presence of calcite and silicate phases, as well as the presence of gypsum (Fig. 4b). Calcite was witnessed by the bands around 1425cm^{-1} (asymmetric stretching of C-O) as well as by bands at 876 and 713cm^{-1} (out-of-plane and in-plane vibrations) [37]. The bands at 1003cm^{-1} and 443cm^{-1} were related to bending and stretching in SiO_4 tetrahedra of silicates. The bands at 3532 , 3400 , 1682 , 1622 , 1116 , 675 and 599cm^{-1} indicate the presence of gypsum [33, 37] likely due to sulfation phenomena [34, 37] justifying the friability of mortar in this sector of the wall.

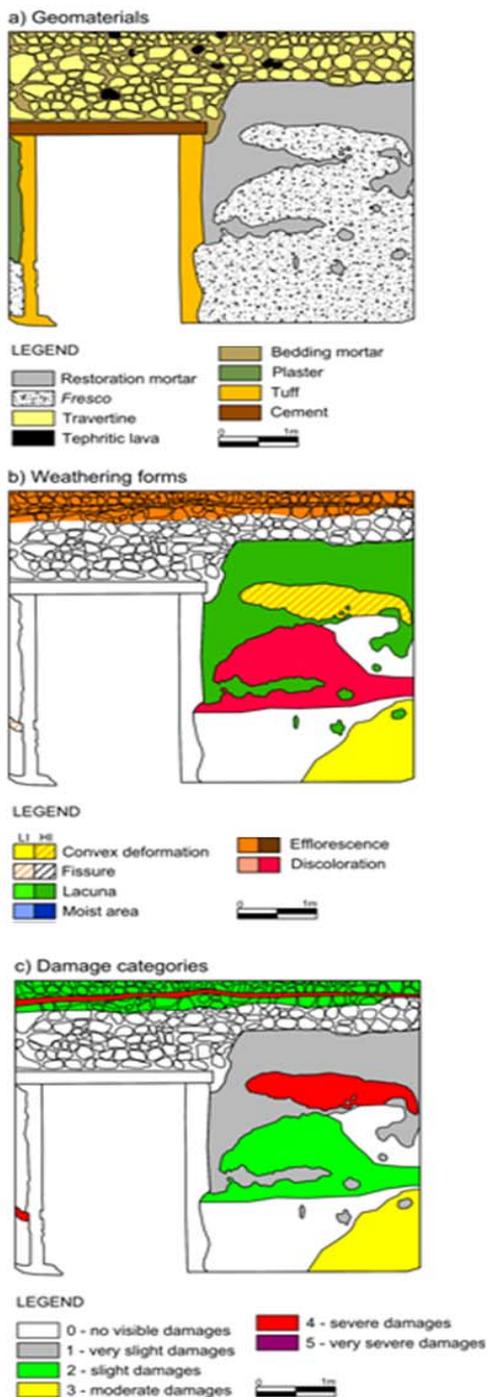
As far as the frescoed room is concerned (Fig. 3a - examined area: 74.4m²) it was almost entirely covered by frescoes mural painting and mortars from the restoration, except in southern and western walls (Table 2; Fig. 5a) where travertine and bedding mortar masonries could be observed.

In this room, six individual weathering forms were identified (Table 3; Fig. 5b). Being the walls originally frescoed, the gaps were considered as *lacunae*. This type of weathering form was the most representative for this room and reaching the higher intensity and extension on the northern wall (Table 3; Fig. 5b). Convex deformations and fissures were usually ascribed to rising damp of salt solutions as suggested by the presence of moist areas and efflorescence phenomena observed along the margins and at the base of the walls.

Data of damage categories (Table 4; Fig. 4c) generally highlighted a good state of conservation for the room h’, except for the eastern wall where damage indices reached 2.2 D_{lin} and 2.5 D_{prog} value, respectively.

Fig. 5. Damage diagnosis of the western wall of frescoed room h (*triclinium*): a) geomaterials (lithological mapping); b) weathering forms and related intensities (HI = High Intensity, LI = Low Intensity); c) damage categories and decay evaluation.

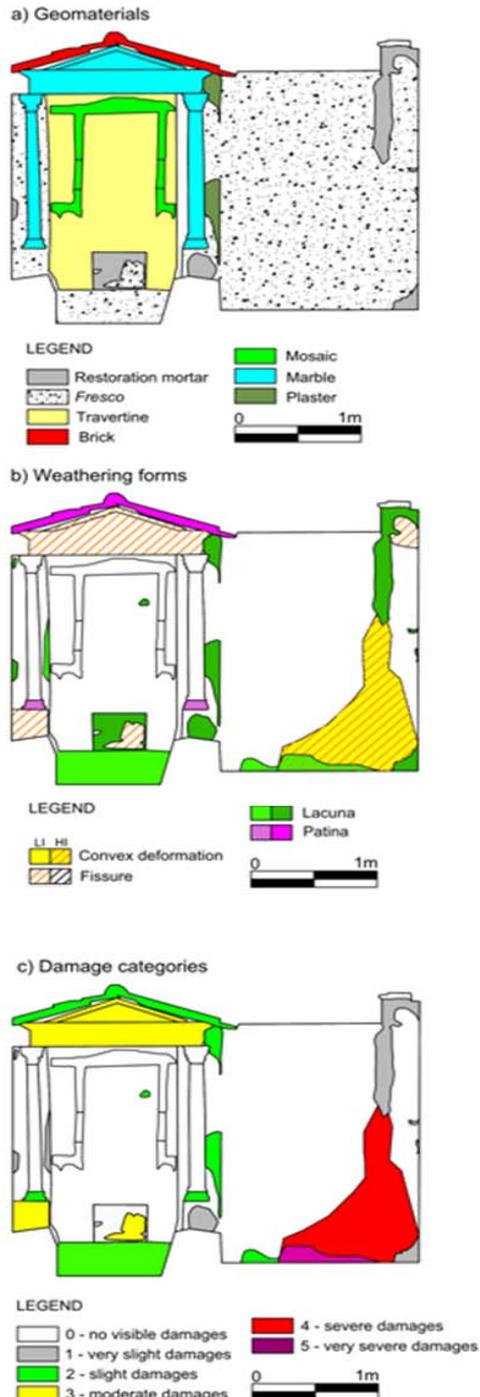
The *aedicule* with the fountain (Fig. 3b - examined area: 7.7m²) showed a wider and more selected variety of geomaterials (Table 2; Fig. 6a). The internal surface of the votive *aedicula* was covered by travertine fragments (with a diameter of about 10cm) and green/blue glass mosaic *tesserae*. Others geomaterials observed were white marble for the *capitella*, alabaster for tympanum, black marble for the columns and bricks on the top of the *aedicula*.

The weathering forms here observed were convex deformations, fissures and *lacunae* (Table 3; Fig. 6b), as well as minor *patinae* on the marbles. Although the overlapping of different weathering forms gave back some minor areas with damage categories 4 and 5 (Table 4; Fig. 6c), the damage indices were relatively low, 0.7 D_{lin} and 1.5 D_{prog} , respectively. Nevertheless, the discrepancy between the two indices is due to the fact that D_{prog} emphasises the weight of higher damage categories in the calculation [16].

Fig. 6. Damage diagnosis of the aedicule with fountain: a) geomaterials (lithological mapping); b) weathering forms and related intensities (HI = High Intensity, LI = Low Intensity); c) damage categories and decay evaluation.

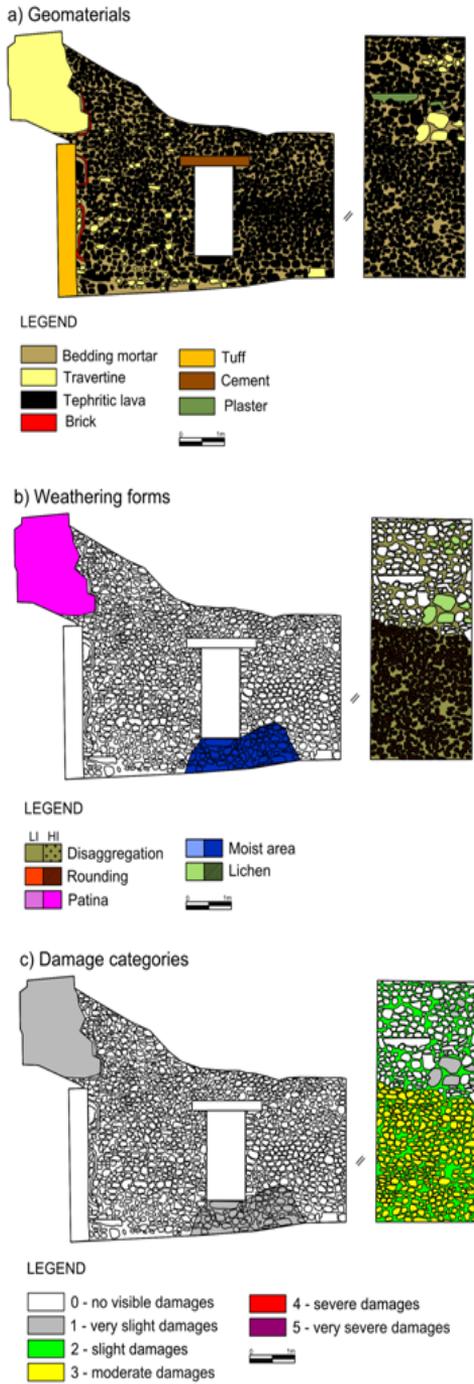
Travertine and tephritic lava blocks jointed with mortar formed the external wall (Figs. 3c and d - examined area: 266.5 m²). However, the distribution of geomaterials (Table 2; Figs. 7a and 8a) and the textural properties of the bedding mortars [35] allowed distinguishing two different parts of the wall. In the first part (alongside the rooms a₁, b₁, 4, a, b, d, e, f, m; Fig. 2a) the masonry was formed mainly by leucite-bearing tephritic lava blocks jointed by cohesive grey mortar made with abundant volcanic and cocchiopesto aggregates. On the other hand, in the second part of the wall the travertine was prevalent and the bedding mortars were yellowish, friable and frequent unmixed white lumps occurred [24, 36].

These lumps are usually referred in literature as defects in the preparation of mortar and could suggest the presence of pozzolanic raw materials that reduce the setting time of mortar hindering a complete mixing of the components [24]. In the entire external wall, minor amount of bricks and tuff (original and modern), as well as some beams of modern cement, were found within relict portions of plasters (Table 2; Fig. 7a).

Fig. 7. Damage diagnosis of external wall, part 1: a) geomaterials (lithological mapping); b) weathering forms and related intensities (HI = High Intensity, LI = Low Intensity); c) damage categories and decay evaluation.

The different types of geomaterials and their different distribution in the two parts of the external wall unavoidably influenced the conservation state of the masonry. In fact, in a portion of the external wall, a slight and localised concave-parallel back weathering of bedding mortar was noted probably due to a granular disaggregation (Table 3; Fig 7b). This pathology was accompanied by a rounding of tephritic lava blocks, as well as other less extended and less intense weathering forms, such as: patinae on travertine, biological colonisations (lichens) and moist areas (Table 3; Fig 7b).

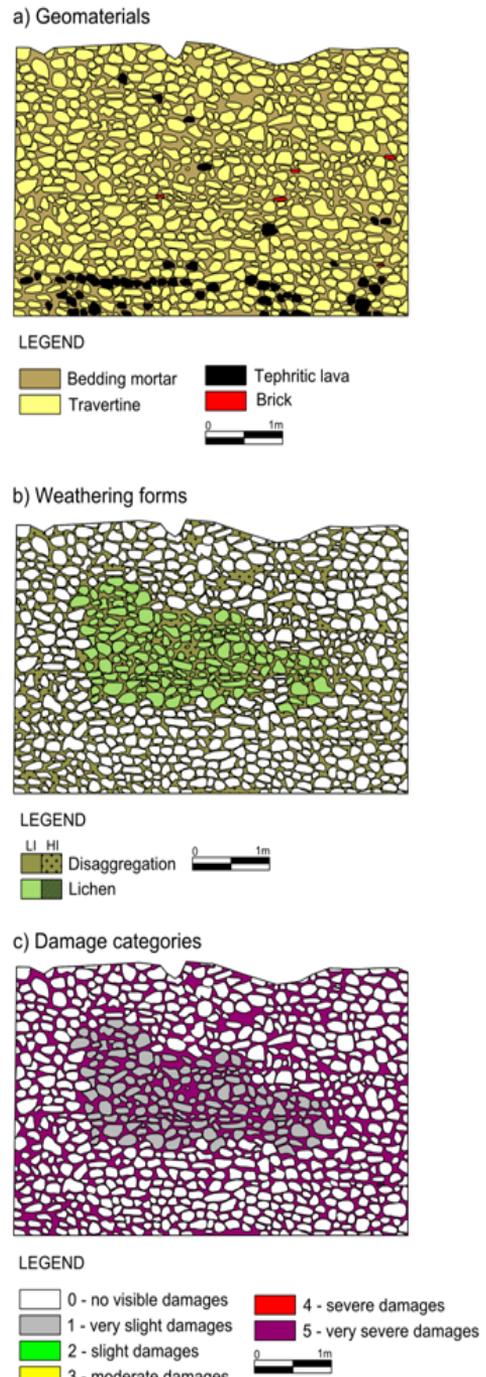
Fig. 8. Damage diagnosis of external wall, part 2: a) geomaterials (lithological mapping); b) weathering forms and related intensities (HI = High Intensity, LI = Low Intensity); c) damage categories and decay evaluation.

Taking into the account the structural role of bedding mortar in a masonry, this weathering form has been precautionary classified as a damage category 5 (Table 4; Fig. 8c) thus, the high value of damage indices ($1.9 D_{\text{lin}}$ and $3.0 D_{\text{prog}}$) infer a urgent intervention.
