CHALLENGES IN THE REHABILITATION OF THE PUSU RIVER

Md NURUZZAMAN¹, Abdullah Al-MAMUN^{2*}, Md Noor Bin SALLEH¹

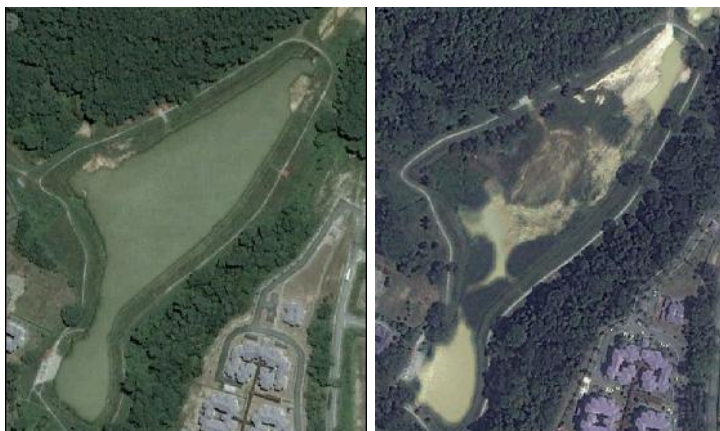
(a) Before sand mining (b) After sand mining
Fig. 4. Effect of improper land clearing and sand mining at Pond 1

Improper land clearing activities are being carried out along the main tributaries of Pusu River. As a result of disturbed and unprotected land surfaces, huge amount of sediments are deposited in the ponds. Sand mining activities are rampant at the upstream of the Pusu river. Sand is mined and washed and the silt is released to the river causing very high suspended solids concentration and turbidity of the water. Sand mine has caused deterioration of the water quality and made it very tough for fishes to survive. It has caused siltation in the ponds along the river. These ponds were excavated several times without stopping the sand mining activities. As the sand mining was going on in its regular manner, the silt and sand deposition filled the pond again making the excavation effort futile. Therefore, improper land development activities and sand mining are the main challenges to rehabilitate the Pusu River. Figure 4 illustrates that at pond 1 (P1) siltation has occurred profusely, which is due to the improper land

clearing activities for residential development and sand mining activities occurring at a few 100 meters upstream of the pond. Figure 5 shows the condition of pond 5 during disilting period and a few months after the excavation of the same pond.

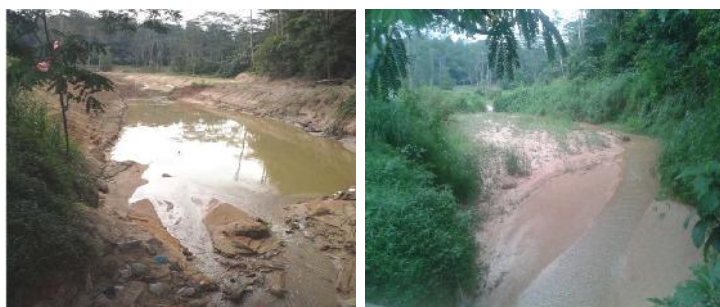
(a) Excavated pond (b) Silted pond
Fig. 5. Effect of improper land clearing at Pond 5

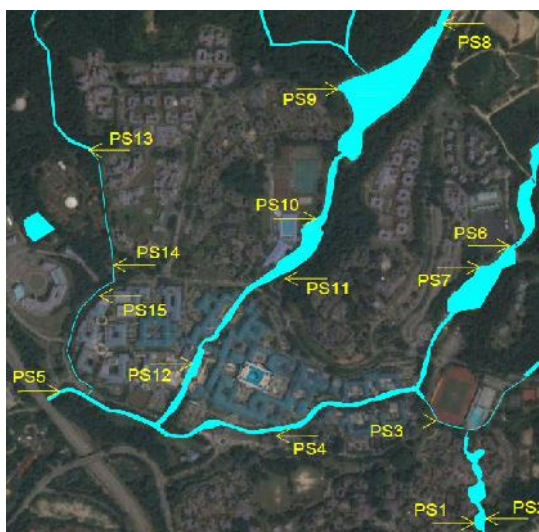
Fig. 7. Location of point source pollution discharge points within IIUM campus

Point source pollution can have a detrimental effect on a river if the pollutant concentration and flow is high enough to impact the river [33]. A huge amount of waste water is being discharged into the Pusu River worsening the water quality condition of the river. The point source pollutions discharging waste water have been identified within the IIUM, Gombak campus area as shown in Figure 7.
